Report for River Defence Committee re impact of the surge and tide of 5th/6th December.

Chapmans Creek to the Anchorage, Iken. Low tide Saturday 7th December 2013

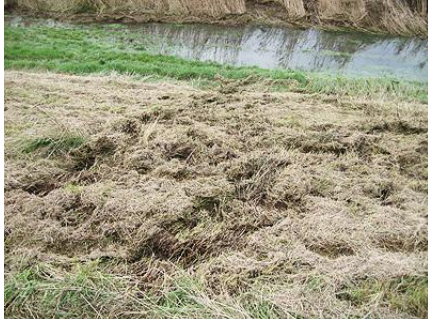
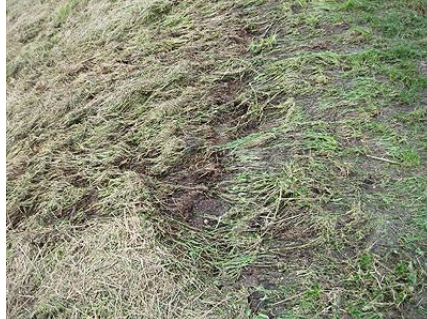
- For the first 400 m no indication of trouble reflecting the positive effect of salt marshes and the relative height of the wall
- At 44.5/55.6 first evidence of overtopping. Not serious damage since each occurrence less than a metre wide but created distinct courses down the land side bank. See pics 1 and 2. I noted that these banks had recently been cut very short. Is that good or bad ie if the grass was longer would it have protected the bank more (or vice versa?). I noticed the flood zone to the east (Sudbourne Marshes) had banks where the grass was longer. On the basis of this our flood zone (which has I understand a lower % of clay) needs some long lasting netting or matting to secure the bank. This is a priority for this zone as I will indicate later in this report.

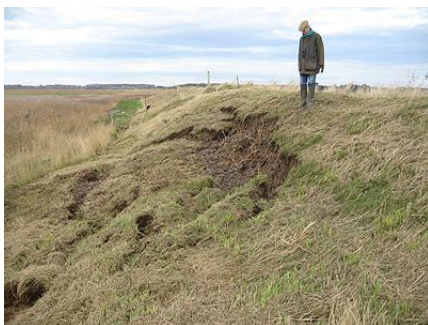
- At 44.3/55.8 a serious slippage circa 8m wide though the crest held (pic 3)

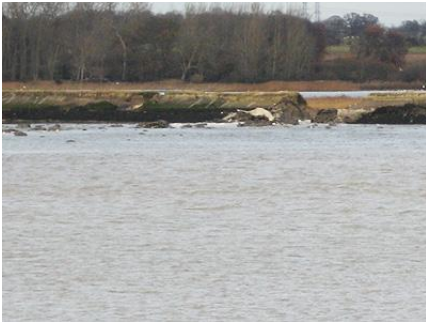
- At 44.0/56.8 a clear view of the extensive Hazelwood Marsh breach (Pic 5) **Question 2: was this wall not recently repaired and if so what lessons can be learned from the techniques, height specification and materials used?**

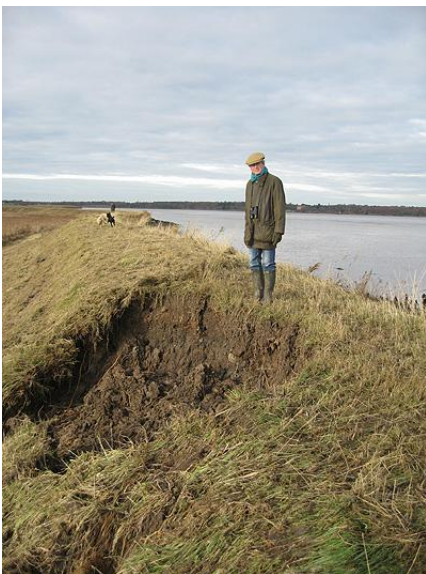
- Going east from this point widespread evidence of overtopping and the corrosive effect it has. Walls must ideally be circa 0.3 m higher with enhanced protection of the land side banks as described earlier.
- At 42.5/56.5 another serious 4m slippage (Pic 5)

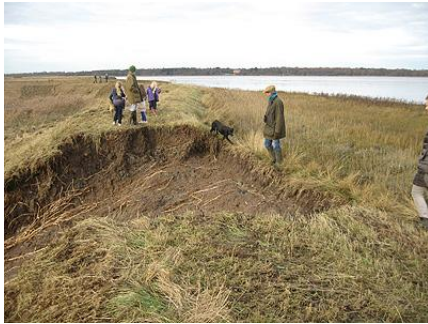
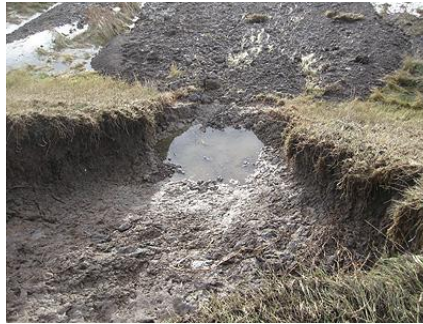
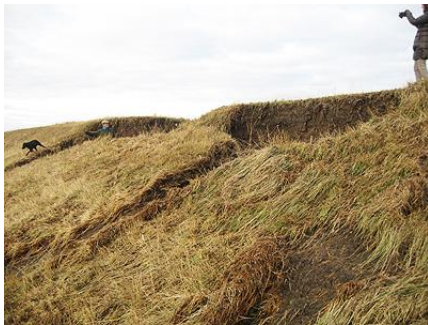
- From the Pump House 43.2/56.2 to 42.5/56.5 several near breach slippages and the worst damage on the walls of this flood zone. I found these pictures truly shocking given the apparently solidity of the wall. **Question 3: It was good to see the bags and digger at this spot preparing for the subsequent full scale repair of these devastated section, has that work also included the slippages reported above further east. Question 4: Why did this section suffer so badly? Was it due to low height therefore facilitating overtopping or was the content of the wall inferior? Question 5: I and others in the RDC have walked this section many times, what if anything did we miss in alerting the EA to this risk?**
