THE ALDE & ORE ASSOCIATION

RIVER DEFENCE COMMITTEE REPORT APRIL 2009

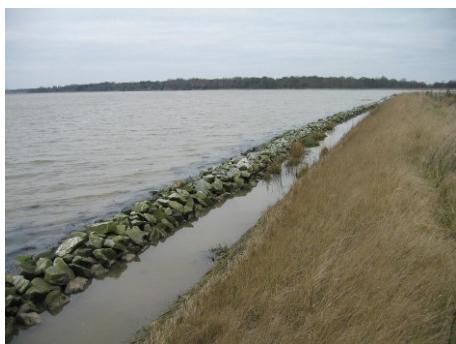
Barber's Point repairs complete

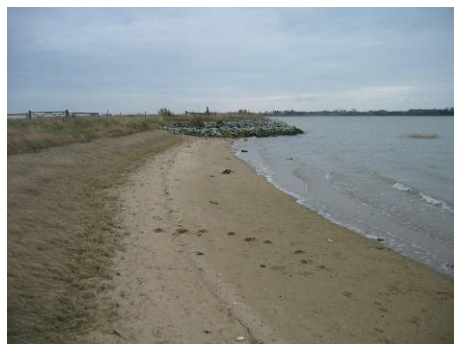
Beach Area at Barber's Point

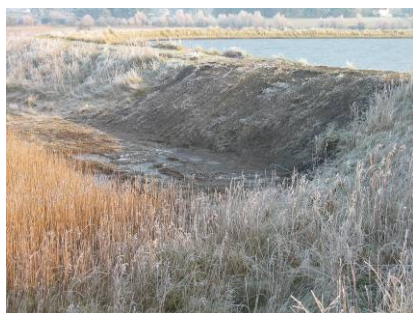
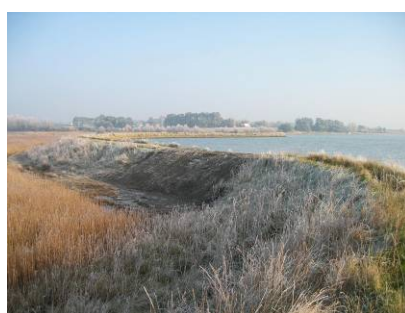
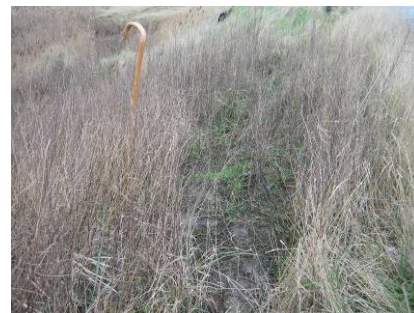
Overtopping repairs complete east of Barber's Point, with fissures filled in

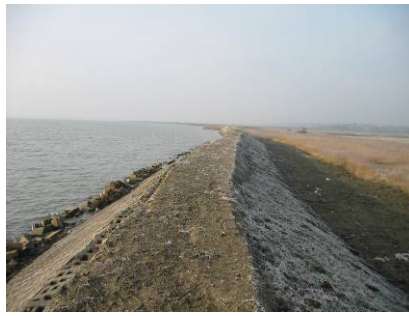
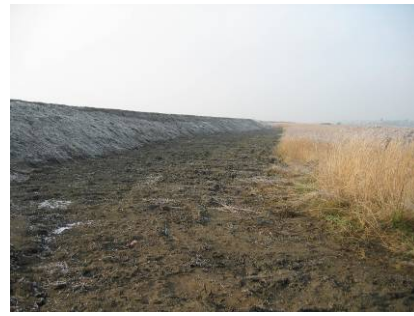
Repair work complete to the west of Roundhill

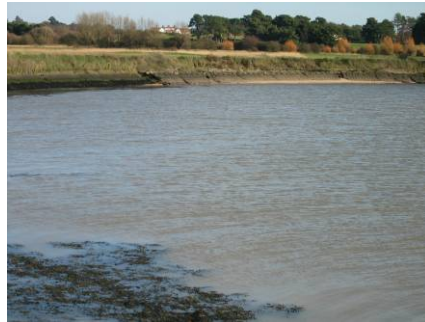
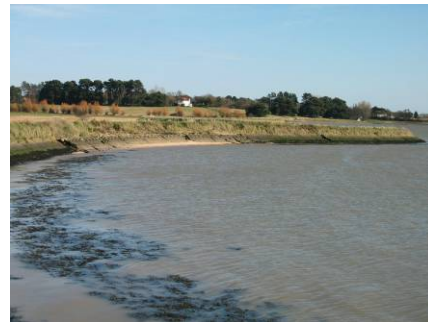
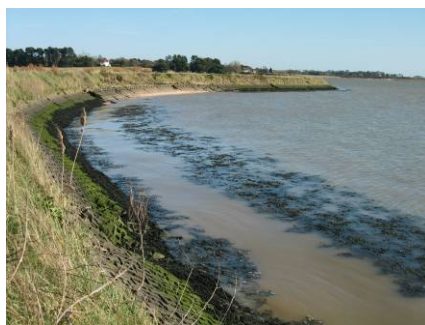
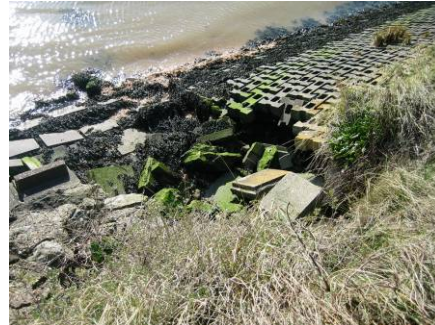
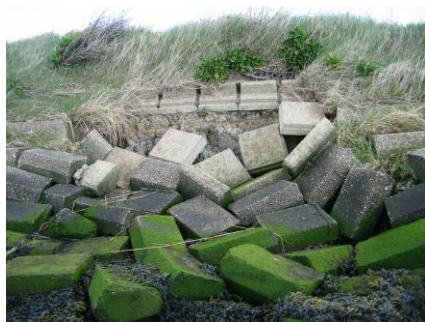
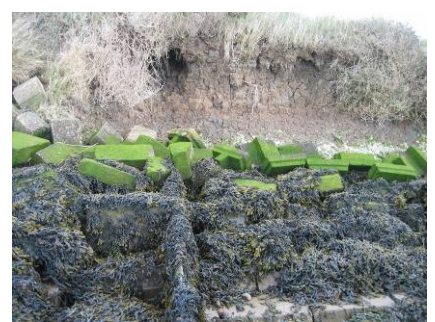
However, some sections around Collier's Hole require **urgent repair work** as water level erosion and brickwork displacement continues. (see below)

Fissures have appeared E of Colliers Hole; these will be monitored as they will become deeper with drying out over the summer. At present they are less than 18 inches deep.

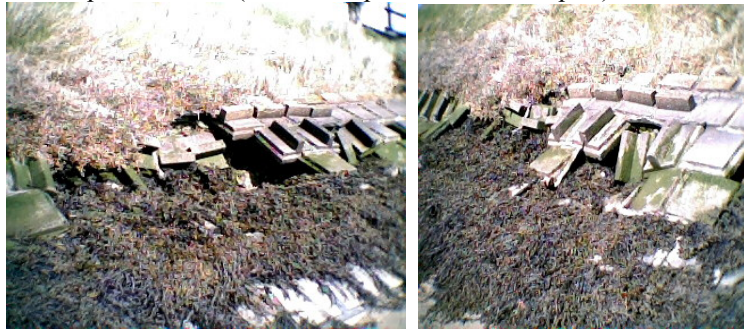
VERY SERIOUS CONDITION - As reported in 2007 and 2008, the river wall either side of Aldeburgh Corporation Sluice (TM45857), continues to be increasingly in need of repair (grid reference 458556)

- i 17-25 feet to west of Sluice steps, broken defence now rather more than 10-12 revetment blocks wide (a revetment block is about 15 inches square wide) (was about 6 in 2007, 8-10 in 2008), 2-3 blocks deep, with bank mud exposed behind (see below photos of 2008 report)

This is a useful indicator - the longer maintenance is delayed the more hours work to repair it.

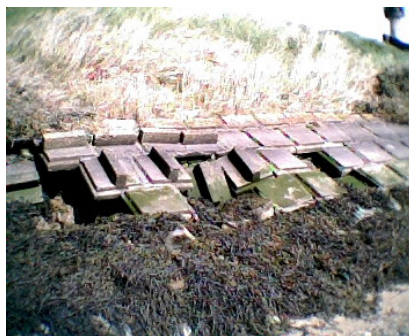
- ii similar within 10 feet of Sluice (see 2008 picture below)

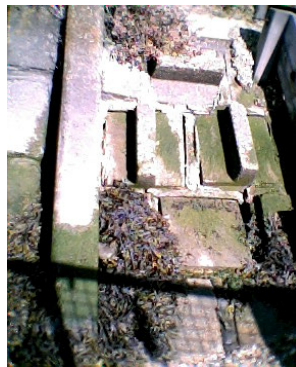
- iii blocks coming loose near steps

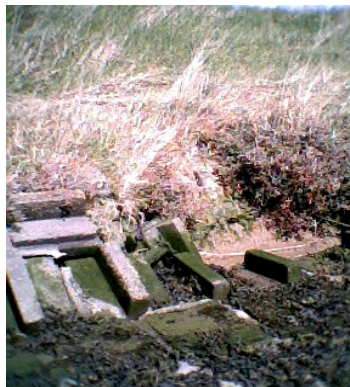
- iv 30 feet east of steps, about 8' of revetment wall broken (see photo 2008 report below)

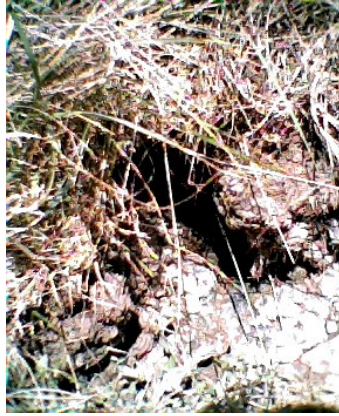
- v. 40 feet or so to east, 2 block wide gap with mud bank exposed above including 15 inch crack into the river bank (photo in 2008 report)

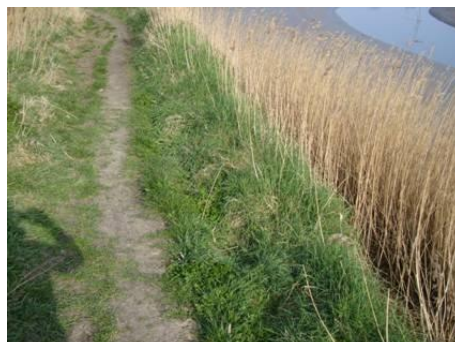
No areas on either side of the river are likely to breach in next 12 months but on OS212 at 5759 3983 there was an area of wall under the grass which needs watching. It will be interesting to see the LIDAR report for the north bank here as there were several points where over topping occurred in 2007.

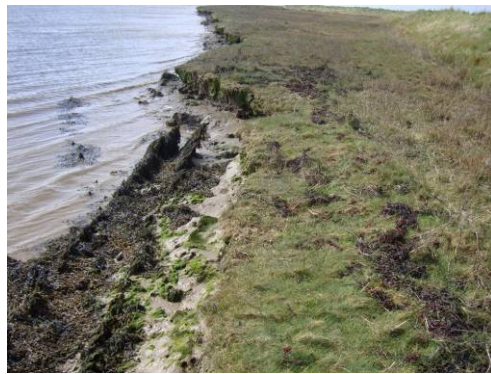
6.1 The Skepper bank was walked from the Pump House on the West bank of Home reach to where the river wall footpath turns away from the river to Ferry Farm. Only at one point, N 52 07 844 E 001 35 321, does the wall need maintenance to avoid significant deterioration in the next year-see photo below.

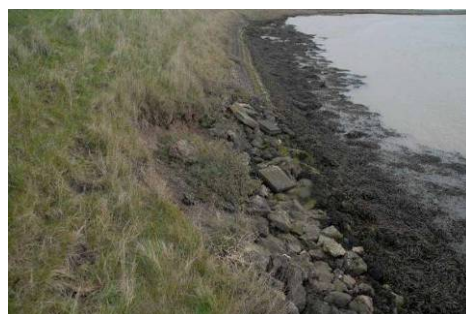
6.3 Blackstakes Reach Landowner: John Grimsey/David Black boundary
Grid Reference: TM 442 523
Erosion, cutting into the wall.
