THE ALDE & ORE ASSOCIATION

ASSESSMENT REPORT FOR THE BANKS OF THE ALDE AND ORE ESTUARY APRIL 2011

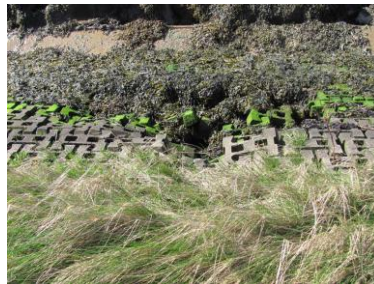
Further west, there are still several breakdowns in the revetment blocks, as has been reported in previous years (photo 1).

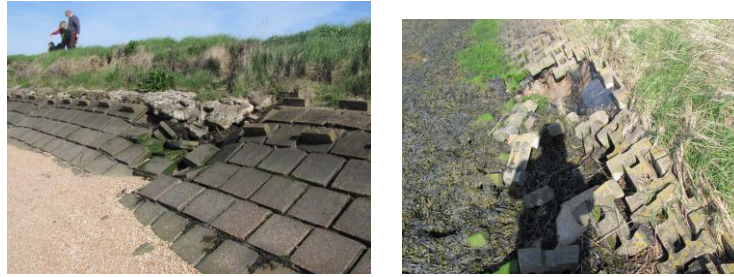
The worst damage at Colliers Hole has had a temporary infill of gravel to prevent further erosion, see photo 2.

It is hoped that the Environment Agency will effect more substantial repairs in this year's programme following the breeding season (photo 3 and 4 are examples).

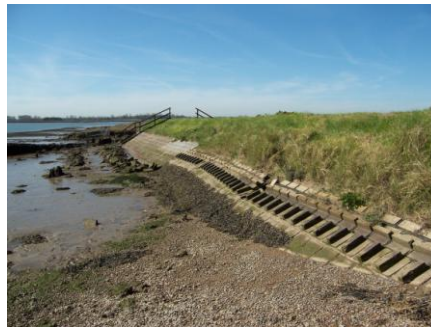
Very good to see repair work around Aldeburgh Sluice completed apart from one outlier of a breakdown of the armour (see below)

but no danger of breach at present. Twice in the year vandals have thrown down a few of the new blocks but these have now been edged by grass and so are less tempting.

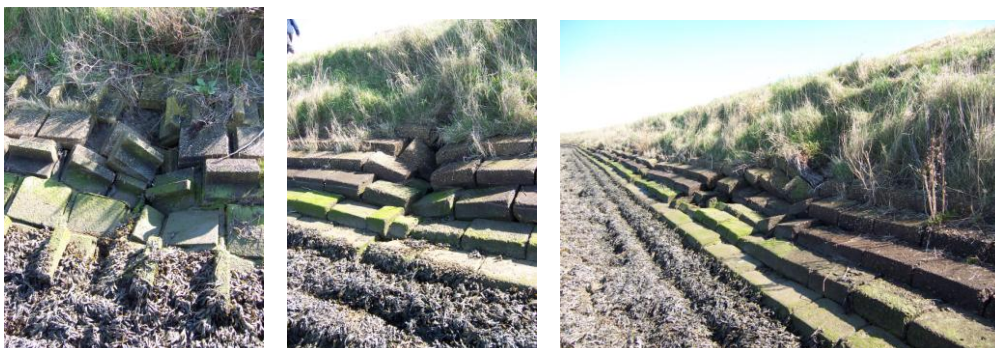
Poor condition: As last year, the most noticeable breakdown of defences is the series of incipient degradation of the armour every few feet all along the curve of the bank from the old oyster beds where the westerly fetch of winds is strong. These are becoming more marked, as a few photos show.

Previous reports: Hard defences stretch behind former oyster beds flanking south eastern edge of Brick Dock area (449565 – 448563). Wall protection is built of foot wide concrete 'steps'. These blocks are falling in about every 6-10 yards in at least 5 places and at south end three blocks have fallen out exposing mud bank. See Photos from 2008 RDC 13.4.08 nr Brick Dock

Note: at March 2010 'at least 5 places' is now about 8-10 places. At March 2011, now in 12-13 places

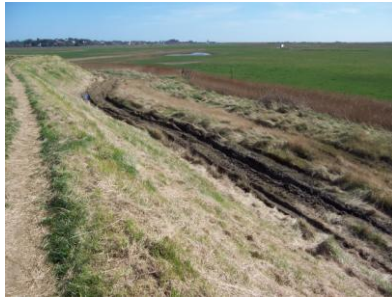
Also, behind the wall at this point, tractor marks had dug deep muddy paths at the base of the wall

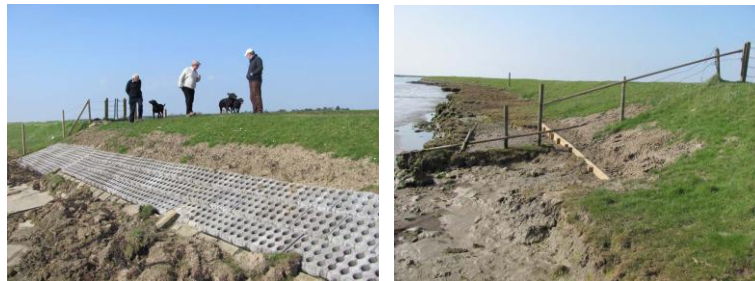
With the exception of two areas, the Town Marsh stretch of bank and saltings are in good condition. Revetment work has been repaired close to Orford Sailing Club and a further section has been improved with wood stretchers inserted into the seabed. The damaged path in this area has also been repaired.

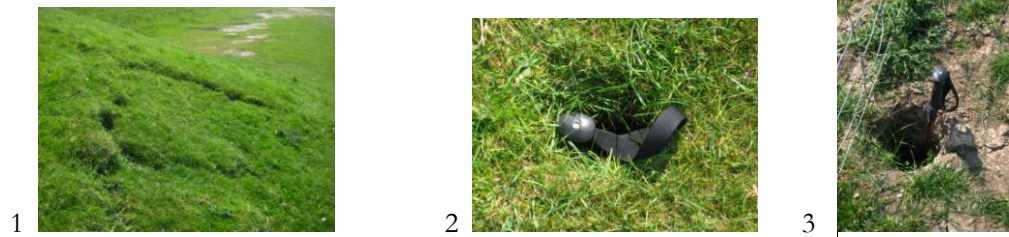
At approx 413479 on landward wall there is a slip as shown below 1 (on the corner where loose rock and revetments meet). At approx 409475 there is a deep hole about 3-4' deep on the path by the fence – about 6-8" in

diameter – photograph 2 below shows top of walking stick in the hole. There is a similar hole on the path just past the entrance to the Butley at approx 440474 photo 3

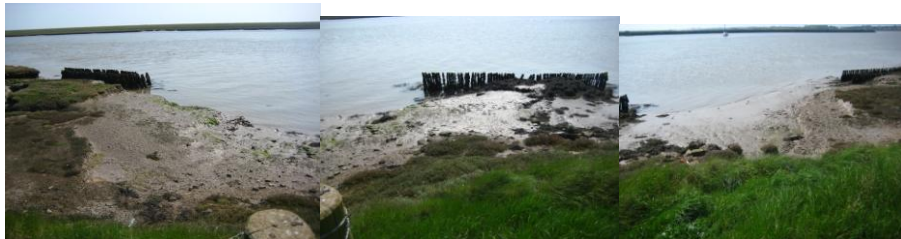
Inset Point – further photographs taken to compare with previous years but it is obvious saltings are eroding. This area should be considered for a trial regeneration site as it could be easily fenced off on the bend following previous NRA posts line.

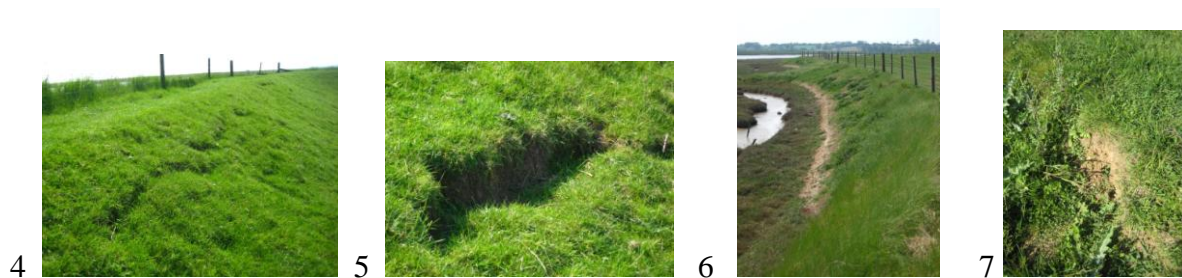
The landward wall just before the corner looks to have suffered some slippage – see below 4. And further areas (5) directly in from entrance to Butley River (402473). Work completed last year at entrance to the Butley River is grassing over well (6). There is a large ?rabbit burrow and bare earth at the start of the wall in the field beyond the Butley beach area (7).

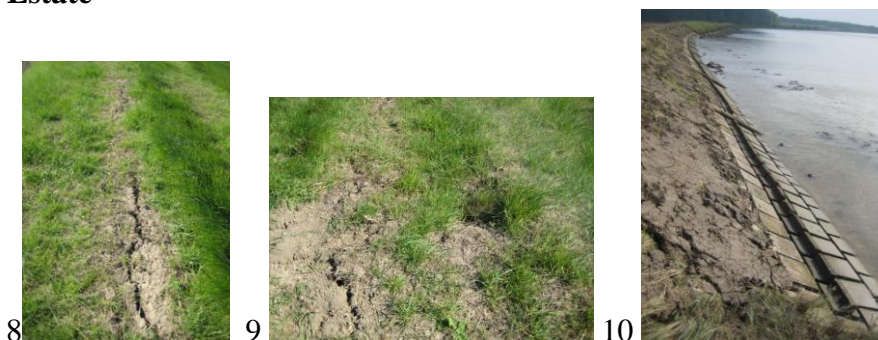
6.3 Watson Estate

Apart from a small area of fissures (8 and 9) on the top of the wall by the area that was maintained by the EA last year there is little to report on this stretch. The photo (10) of EA work was taken last year and this work has vastly improved the bank.

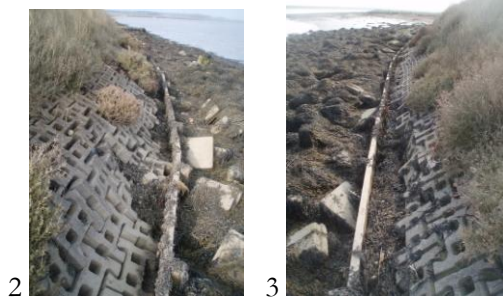
Two damaged areas to be kept under review (see also remarks on same areas in previous year's reports)
Position 397465 immediately north of Flybury Point opposite south end of Havergate Island. Two short lengths where concrete armour partially exposed, timber footing undercut leading to erosion (photosRDC2011.1)

An in situ concrete repair half way up slope has cracked, bulging at this point suggests movement (see photos RDC.2011. 2 and 3 below)

Approx 2.75 M on Lidar survey. I expect that this point is subject to considerable flow pressure at the confluence of the two channels.

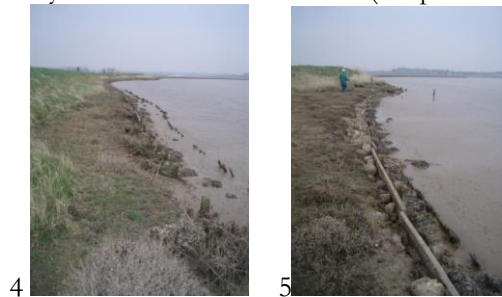
Position 394496 to 393495. Part timber footing missing, part deteriorating timber footing backed by loose concrete fill. No obvious change since last year but defence not robust (see photos 4 & 5) How long will it last ?

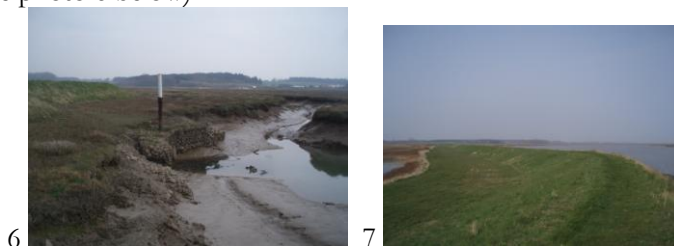
Stone filled gabion defence to outflow from electric pump into saltings at 393486 (bank app. 2.8 on Lidar Survey at this point) (see photo 6 below)

Banks generally in good condition, see typical landward slope app. 35 degrees above (7)
