THE ALDE & ORE ASSOCIATION

7 ORFORD TO BUTLEY CREEK (Amanda Bettinson)

8 SHINGLE STREET TO BUTLEY MILLS (Brian Johnson)

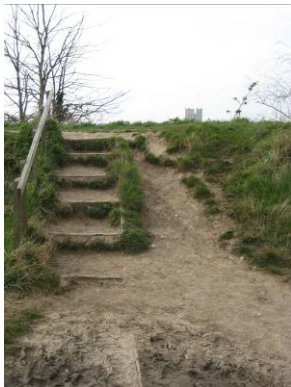
Before/2008

7.2 Steps and Saltings by Quay House, Orford. Work on the Steps and fencing has just been completed thanks to the SCHU and Rights of Way team.

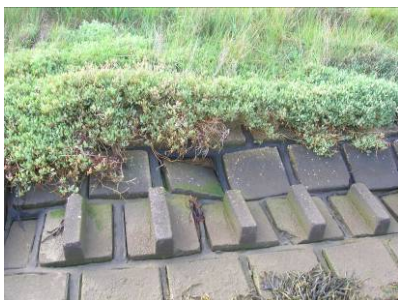
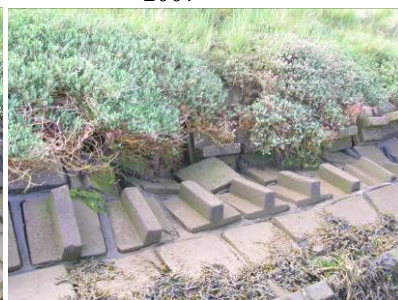
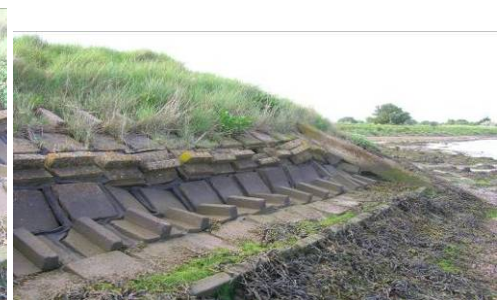
2007

7.3 Small point west of Orford Quay: Serious deterioration of armour with 6 dislodged revetments on 2nd section and collapses in 3rd -7th sections.

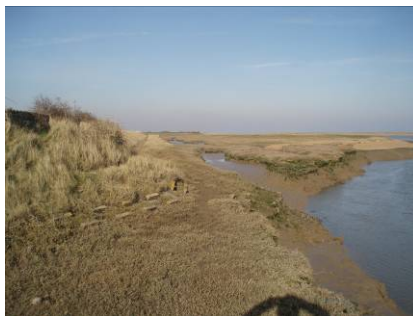
1 Barthrops Creek: close to confluence with the main river below pill box 376446. Comparison of 2008 and 2009 photographs shows some minor erosion of salting has taken place in last year, sea wall intact. Salting at this point 2M wide only.

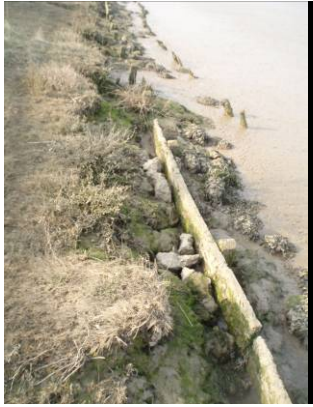
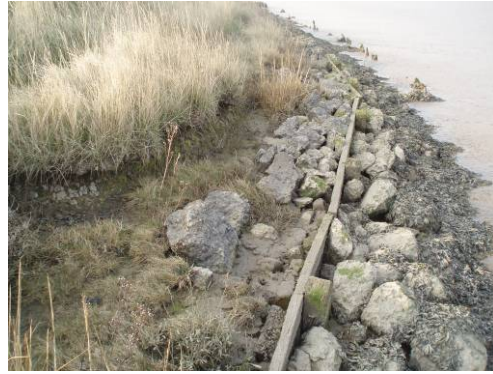
Actual state of river bank – March 2009

3 Butley River: (from 395496 to 394497) Minimal saltings behind derelict timber edging. Comparison of 2007 and 2009 photographs shows no significant change in state of this edging or in the minor undercutting of bank at northern point of this stretch. Part of river wall along this stretch is less than 1.5M in height above saltings, check absolute height when LIDAR survey is available.

The saltings on this stretch are on average 2 metres wide or less and are app.150mm above river mud. This minimal depth of water in average tides against the saltings means little scouring of saltings occurs. Butley marshes are mainly contained below 3metre contour and are lower than the saltings. This is an area to watch.

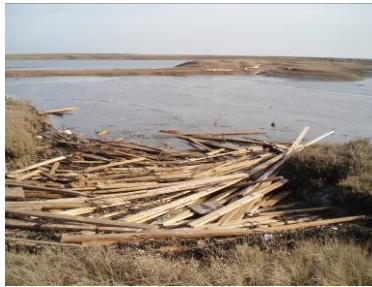
Hollesley Marshes are now in the ownership of RSPB which has erected fences between the river wall and fields and renewed styles and cross fences. RSPB and Suffolk Wildlife Trust between them now own 2/3rds of the river bank from Shingle Street to Boyton Dock. Considerable amounts of timber from sunken vessel off the Sussex found its way into the mouth of the river in early February.
