# THE ALDE & ORE ASSOCIATION

## RIVER BANK ASSESSMENT FOR 2012

### FLOOD CELL 10 Aldeburgh and Haven Marshes

DATE OF SURVEY 24 AND 25 MARCH 2012 Flood Cell 10S + part of sea wall Map references Explorer 212

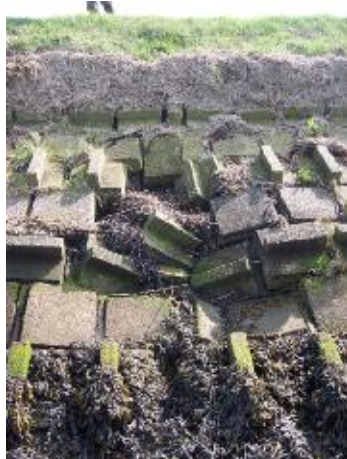
1. Map Ref 448563 Two parts of curve near Brick Dock missed by repairs done this winter, one relatively slight but similar degradation had been repaired further along, and one more serious which was worse than some of the newly repaired parts had been prior to repair (missed by the contractor?) Note also debris within 20-24 inches of the top, see photo

1. Map reference 448564 where a poor armour condition is in same place is where the debris was within 20 inches of the top of the wall , photo as at first reference on serious condition of wall above.

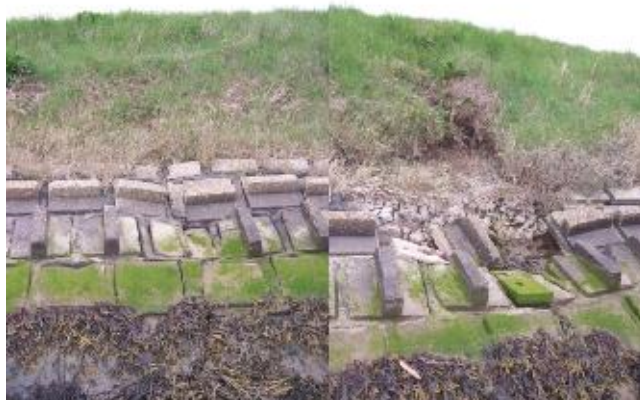
2. Map ref 458557 East of Aldeburgh Sluice, one 10 strides from where 2011 wall re-armoured, the worst patch is a further 4 strides and has clay wall exposed to water at every high tide see photos

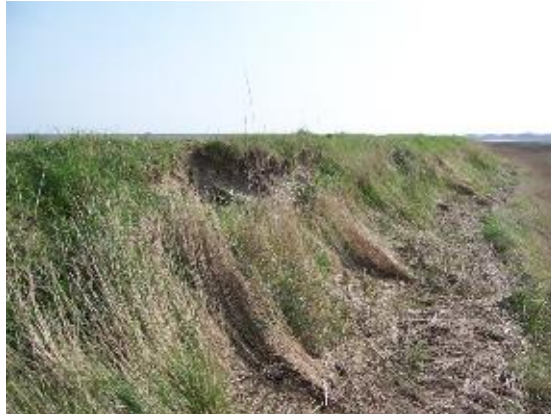
3. Map Ref 445559 Bare face of river wall 15 yards downriver from Stanny gate. Wall has a width of saltings before the river and high tide debris lies at base of wall but sheer bare earth overhung by grass. Photo, but not very clear

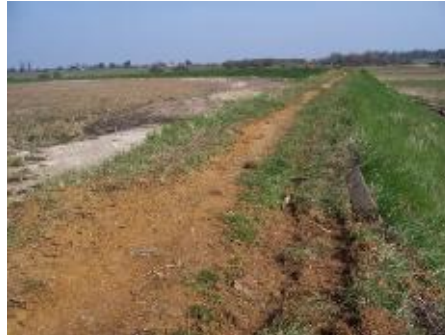
1. At 446555, in Brick Dock curve, wooden boarding broken by armour repairs machinery, and land at base of wall, landward side heavily entrenched mud from heavy vehicle traffic.

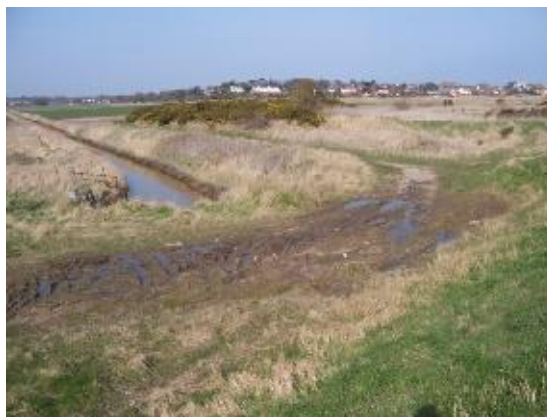
2. 458557 wet area behind wall, close to Aldeburgh Sluice. It seems to stay wet even when there has been no rain for some time

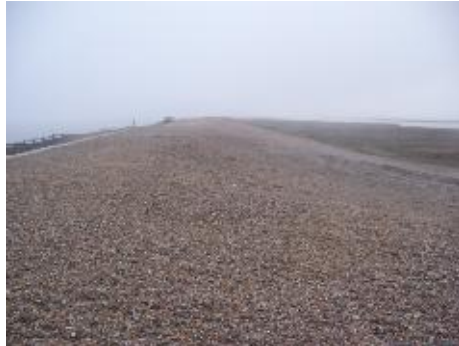
3. 463548 shingle wall behind cement sea wall, about 13 foot in width max to slope down, eroded by vehicles

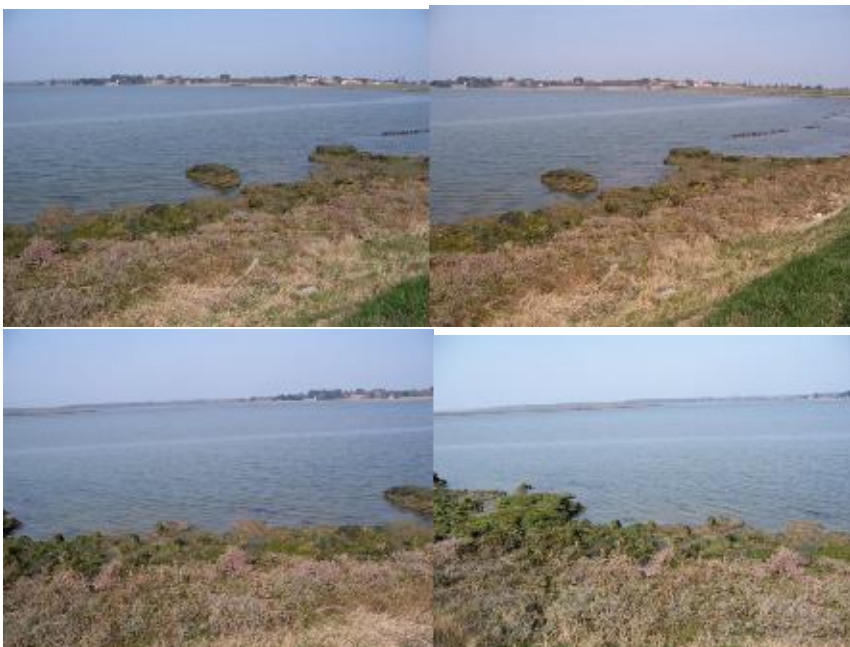
1. Map Reference 446562 Degrading saltings on curve of Brick Dock, just down river from former oyster beds- 4 photos in a line

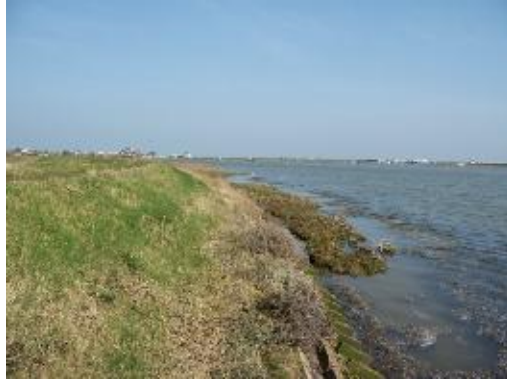
2. Map reference 447555 little left of saltings next to armour, see photo

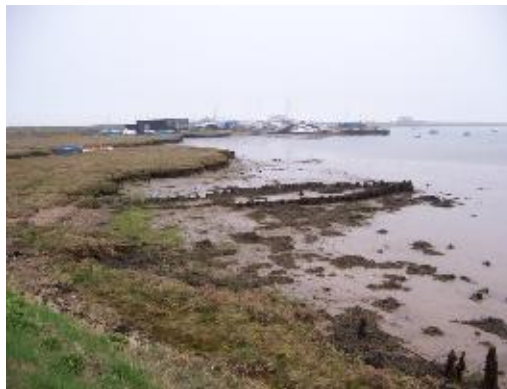
3. Map reference 460558- 460556, next to the river wall protecting the town, saltings gradually degrading

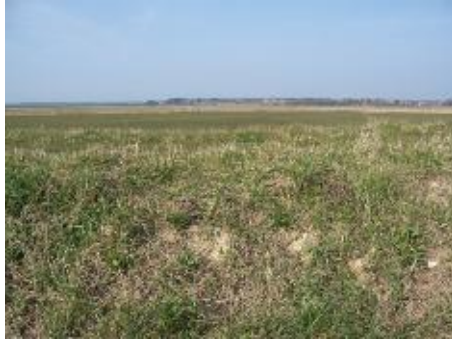
2. 453554 opposite Skepper land ( BBQ site) debris within 20 inches of the top of the wall for 20 yards and some bare earth.

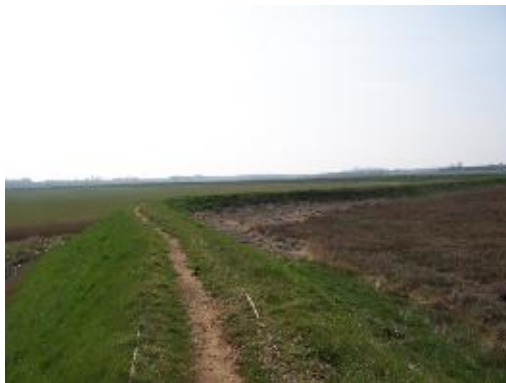
3. 448563 approx Photos of corner of curve of Brick Dock showing where debris piles up but mostly 3 foot clear of the top.

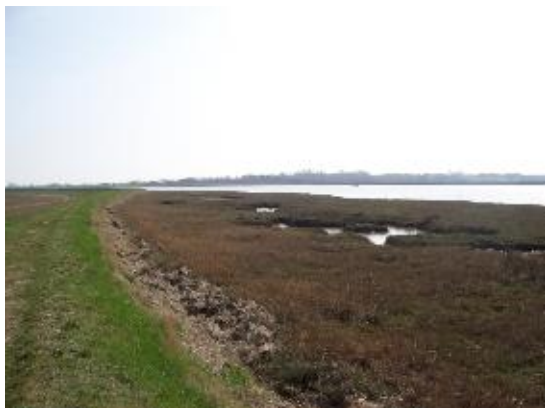
4. 446556 Debris along the river wall base just down river from Stanny

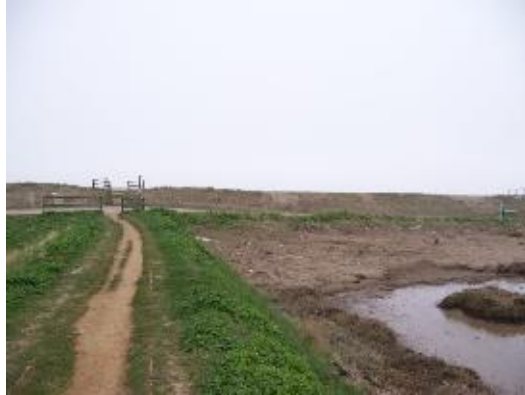
5. 464557 Where river wall meets Slaughden road, photo shows debris close to Slaughden Road, but still more than 3 feet below top on adjacent river wall

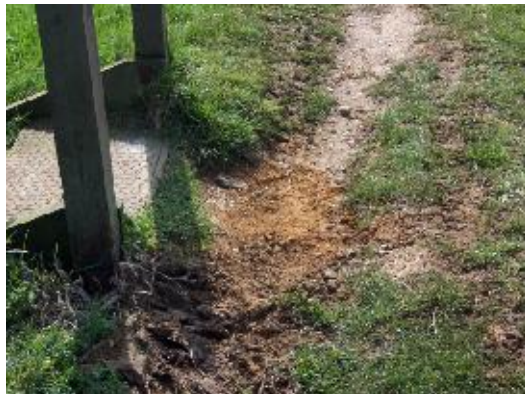
### **1. Around Brick Dock**

**Much of the river wall path is badly worn.** Very poor around gates and steps up on to the river wall. may be for SCDC as well as EA?

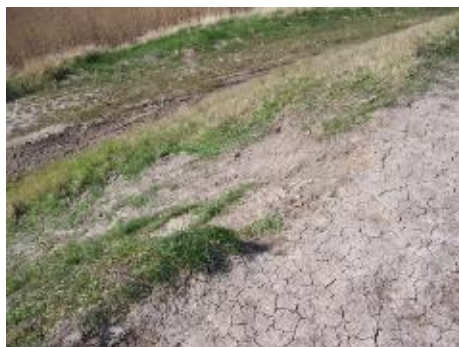
2. 455556 at the back of the loop inland the wall has a large area of bare earth at the edge of the top

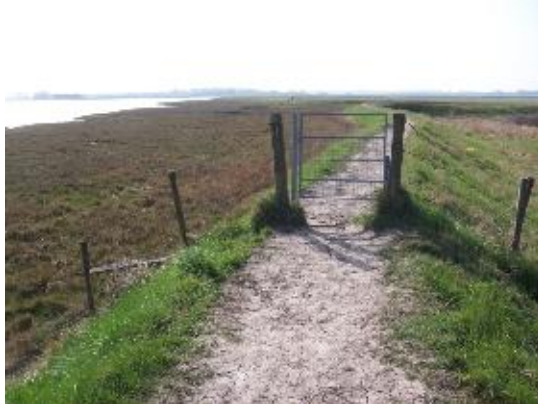
3. 458557 Near Aldeburgh Sluice where very heavy walking wear, the most serious where there is a drop of 9 or more inches in the wall from wear around the gate. photo

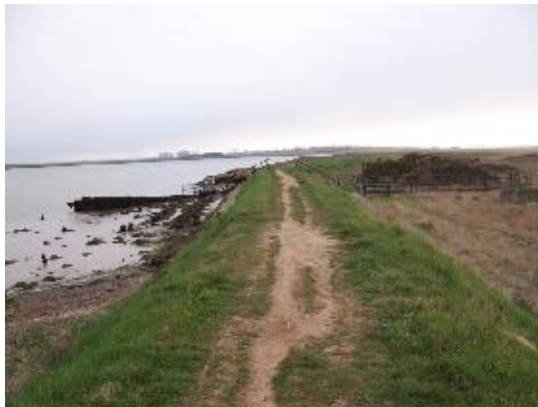
5. 458556 path near Aldeburgh Sluice gets a great deal of wear

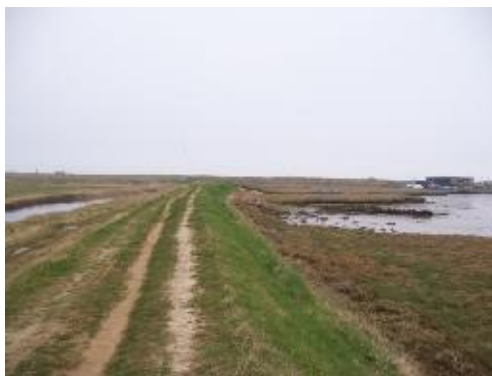
4. 460558-460556 between sewage works and Slaughden road, the path has more than doubled its width from the old boarded track, query is the wall being trodden lower by moving outwards?
