THE ALDE & ORE ASSOCIATION

Maintain our Coast and River Defences

FLOOD CELL 2 Butley Mills

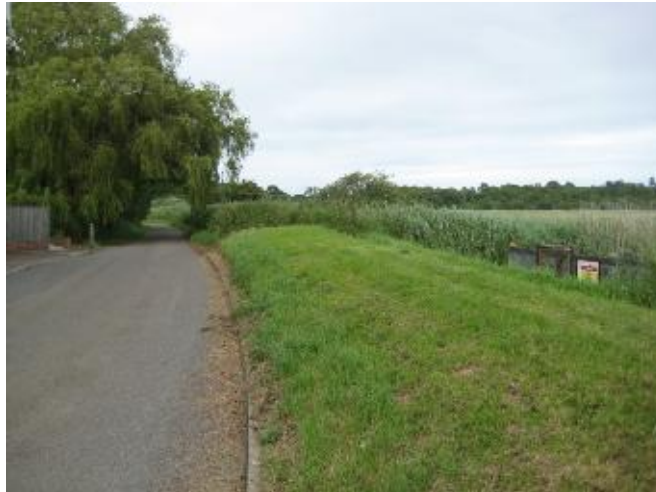
1 The defences (386517 - 387522) on this flood cell have not been previously photographed but should be classified as very poor. The area of bank on the road opposite Butley Mills Sluice (No. 2) is mown and clear see below.

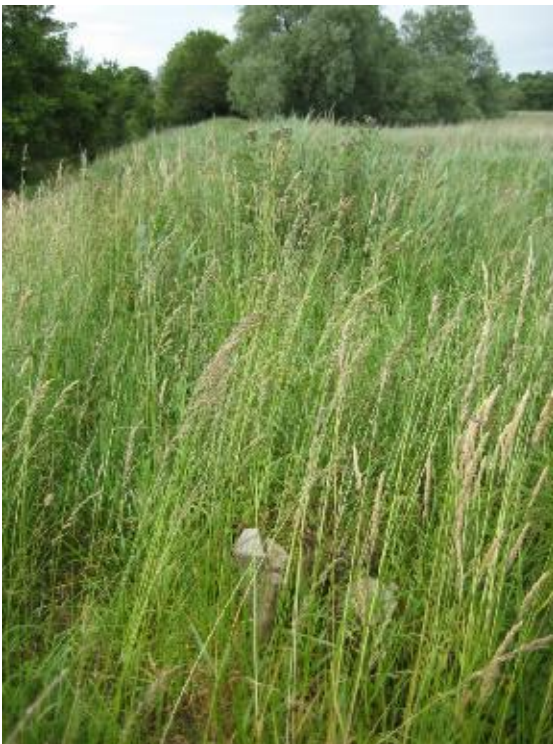
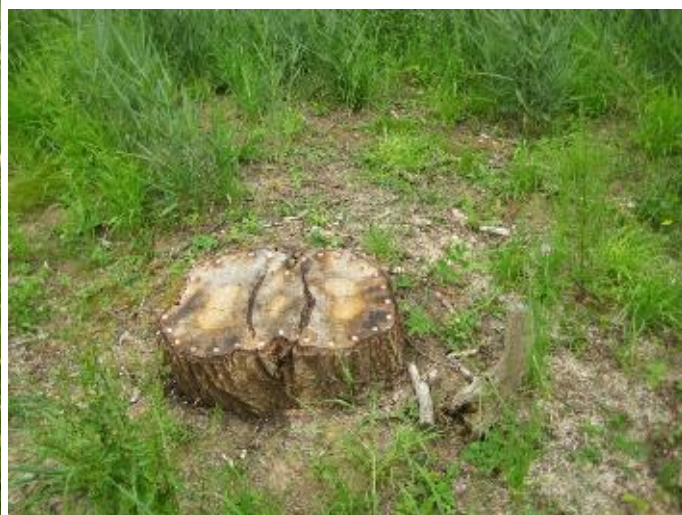
2 Beyond the sluice the grass and reeds are very overgrown (3-4' high) and make any inspection of the walls extremely difficult. Some scrub clearance has been started on a short stretch and work is due to commence here later in the year.

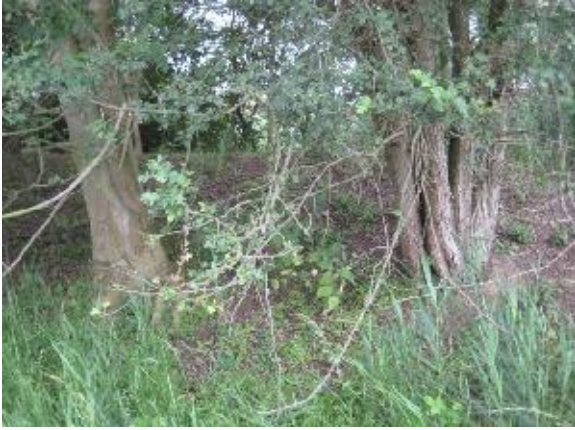
1

3 Beyond the cleared stretch the bank is very overgrown with large trees - the circumference of one trunk must be approximately 10-12ft. (see photo 4 below)

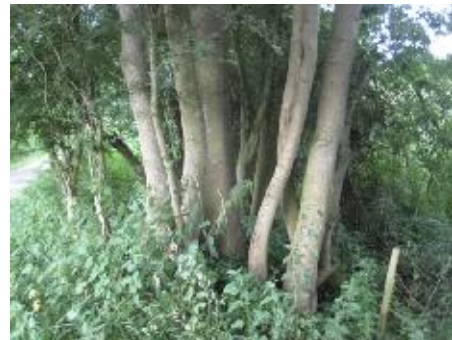
5

4 In the last 200 metres to the main road at Chillesford the bank is nonexistent and the area overgrown with reeds.

Please could the EA detail the work that is due to be undertaken on these flood defences.
