THE ALDE & ORE ASSOCIATION

RIVER BANK ASSESSMENT FOR 2012

FLOOD CELL 3 - CHILLESFORD LODGE MARCHES

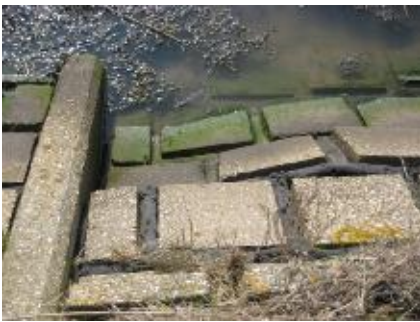
Bay 9

2 The early part of the revetments are in good condition with minor collapses on Bay 9, 11 and 12

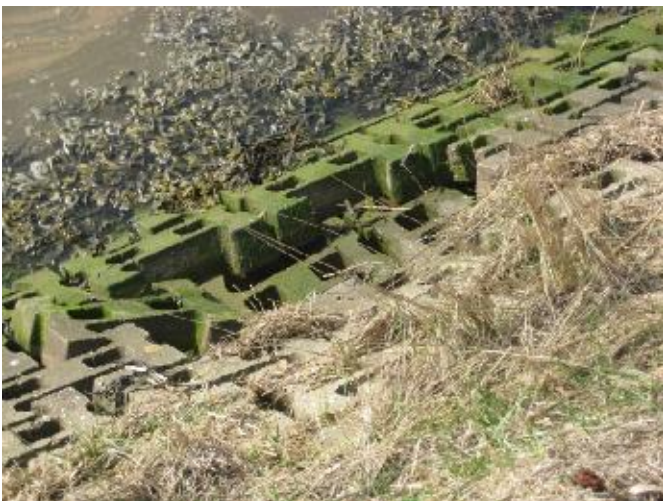
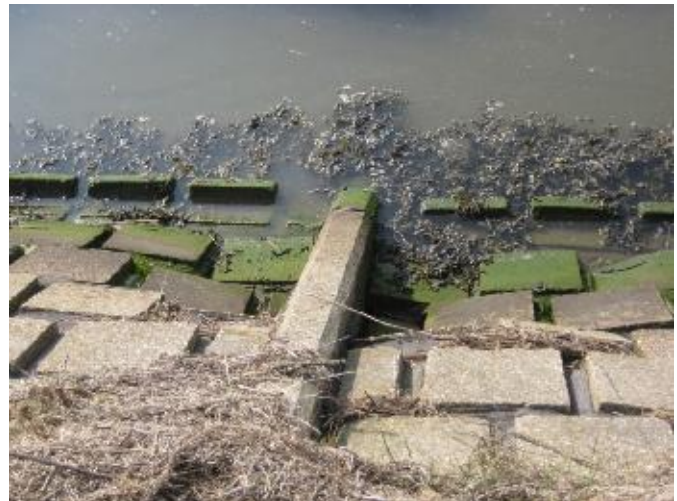
3 Area of approx 2 metres of interlocking revetment collapse ()

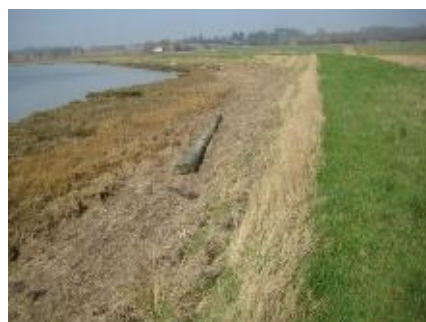
4 Considerable debris so unable to inspect toe.

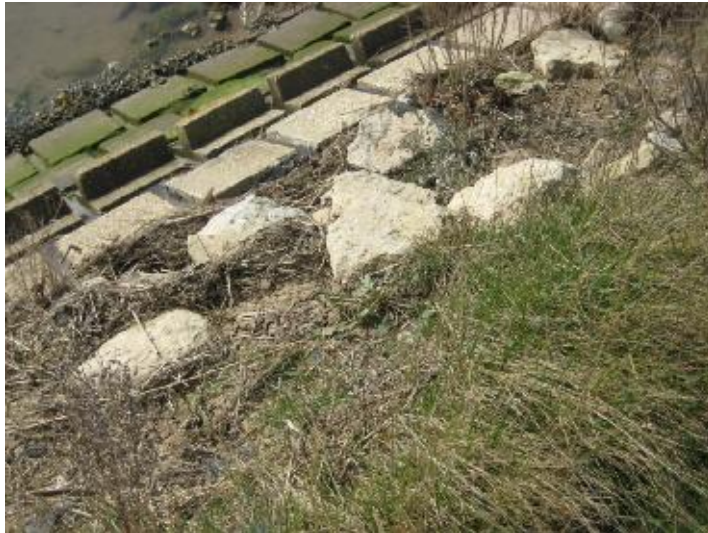
5 200 metres from Greenwell Estate boundary there is an area of bare earth above the revetments and just before the boundary on the landward bank several mole hills.

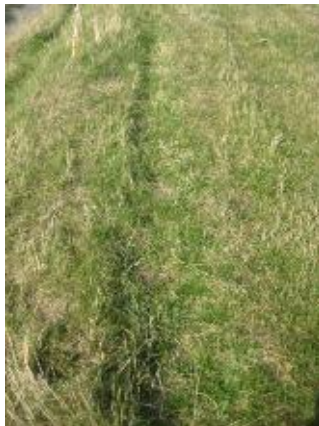
6 The landward slope is good with a tight sward. Approx 150 metres from Watson Estate boundary there are vehicle tracks in the crest.

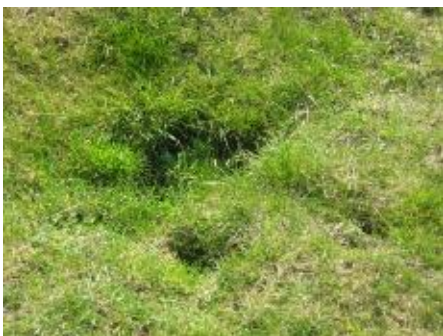
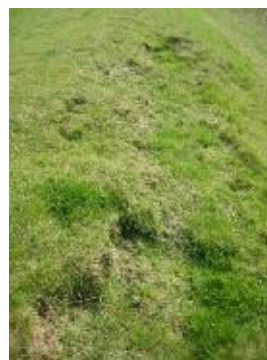
7 100 metres from the field gate there are burrows and minor slippage to the river frontage of the wall.
