THE ALDE & ORE ASSOCIATION

RIVER BANK ASSESSMENT FOR 2012

FLOOD CELL 4 – ORFORD, GEDGRAVE AND SUDBOURNE MARSHES

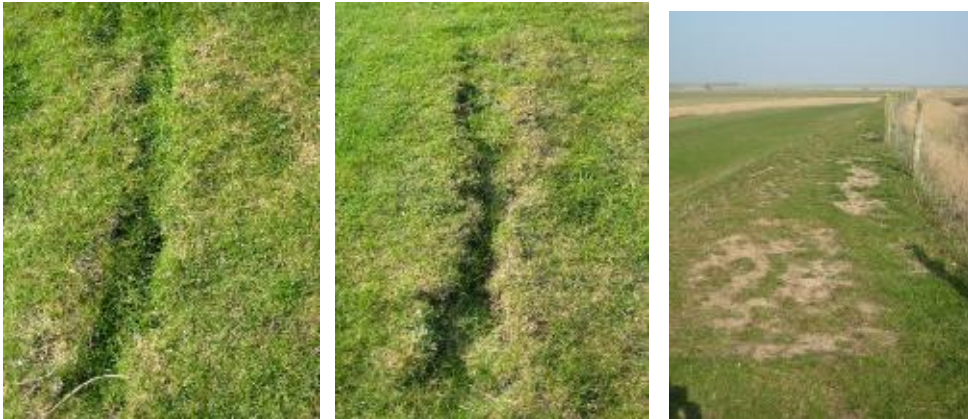
- 1 **Butley Creek** Cracks on the bend (just past Butley Ferry approx 394481) and worn footpath on crest

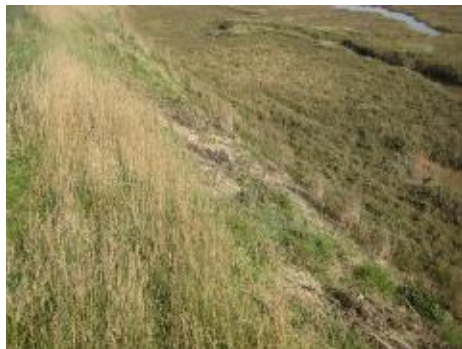
- 2 Area where repair was carried out last year at mouth of Butley showing considerable bare earth patches

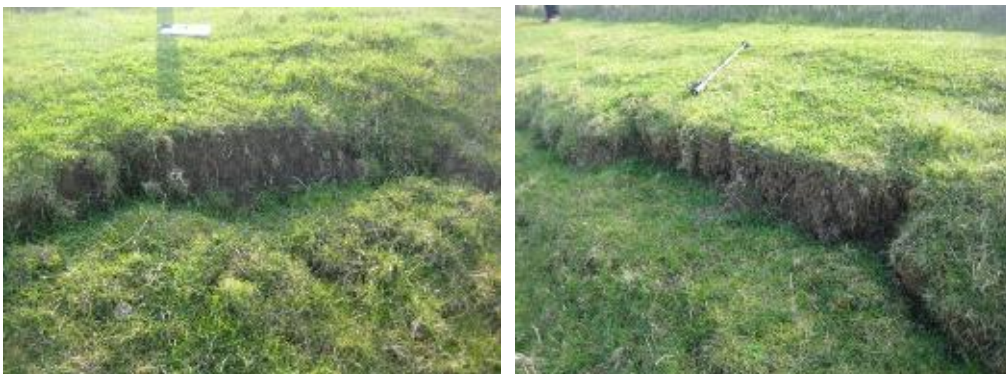
- 3 Area of slippage just below crest on landward side close to Inset Point (402474) – viewed last September with EA.

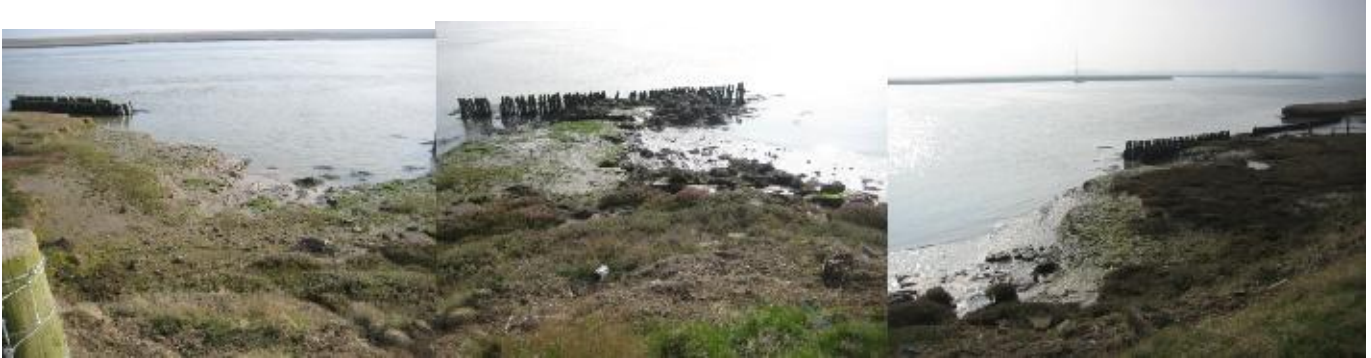
4 **Inset Point** - Area for consideration for saltings regeneration project

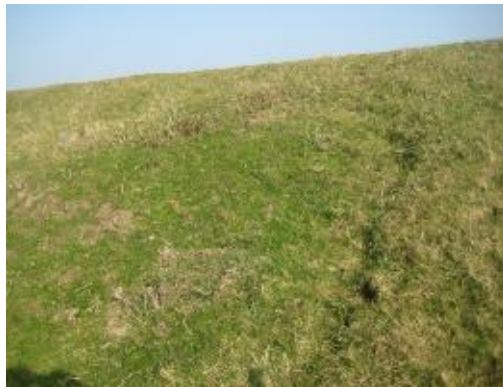
5 **Slip on Landward side (seen by EA September 2011)** approx 413479

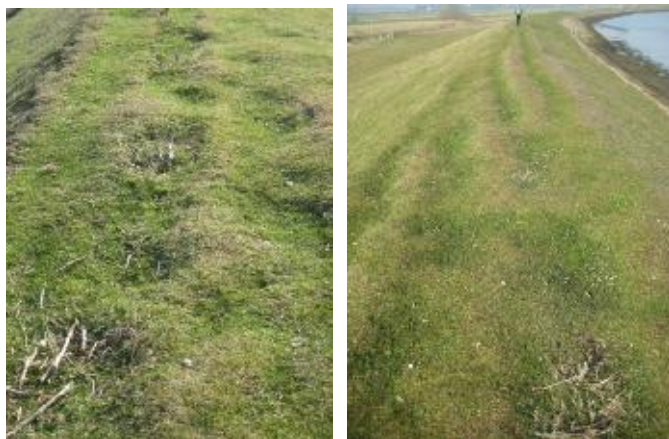
6 **Uneaven crest (i) and tyre marks on (ii)** 413480 approx

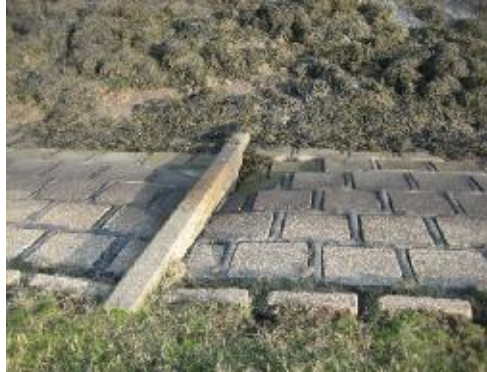
- 7 Minor collapse of revetments (approx 412477)

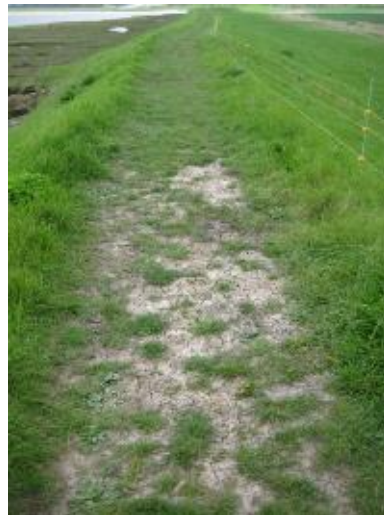
- 8 One or two areas of bare earth by the drain (414484)

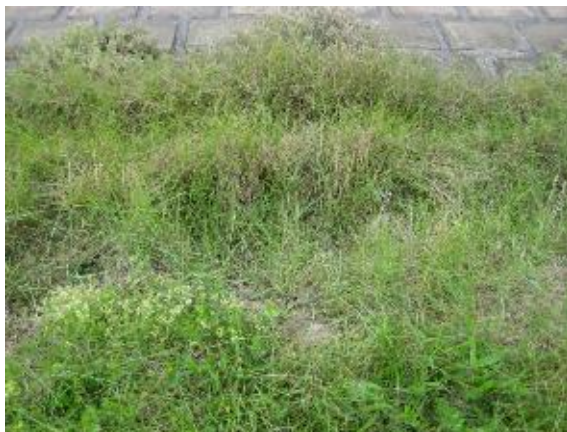
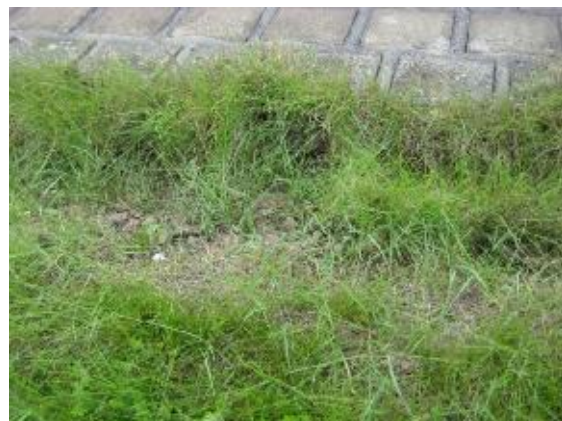
- 9 18 mtrs of erosion above the revetments 100 mtrs from Cordle Boundary (424491)

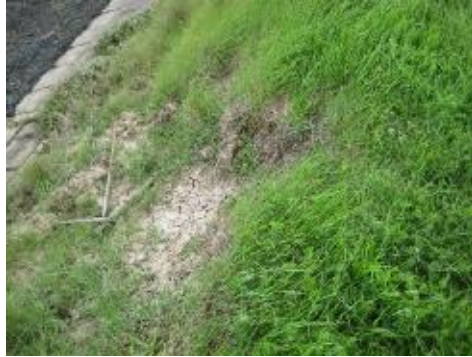
- 10 Area of erosion approx 2mtrs in length reaching to 1' of the crest and further 2 metre area half way up the wall 50 ydrs from Cordle boundary.

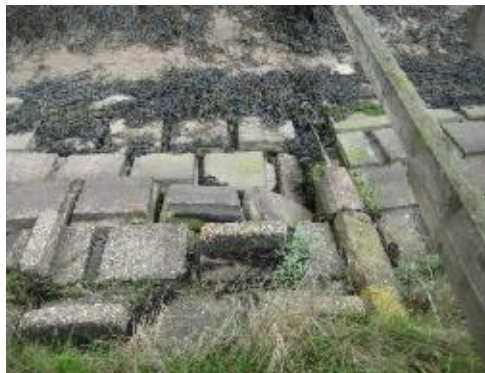
- 11 Small revetment collapse on Cordle boundary

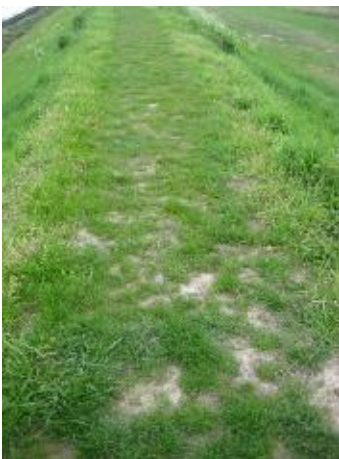
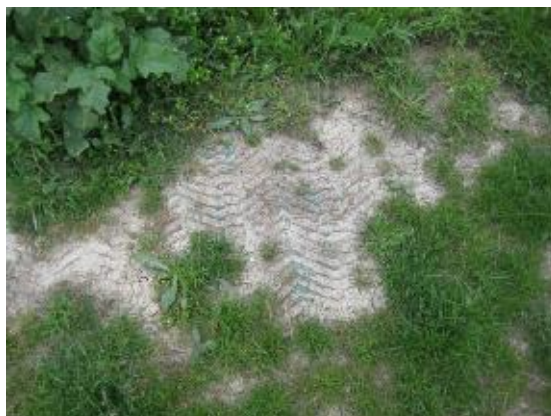
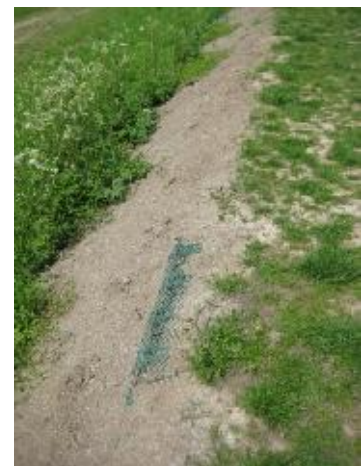
- 12 The work on the Orford wall last year has no doubt benefited from the recent rain and is grassing over well. There are patches of bare earth (middle picture) and a stretch roughly 60 metres of bare earth on the landward side of the crest.

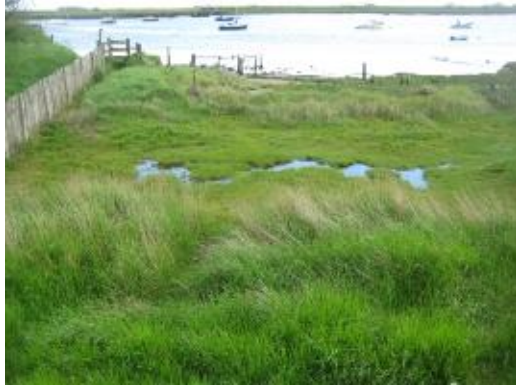
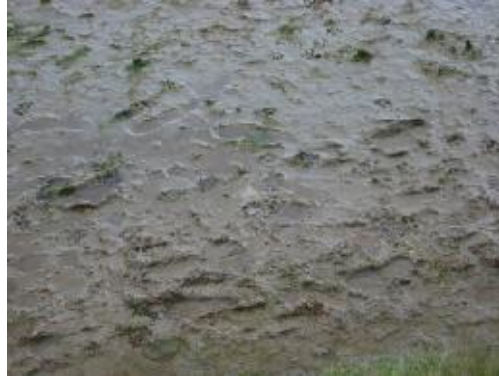
- 14 The saltings at the start of Orford Beach are recovering well (i) but are still being walked on by dogs and owners (ii).

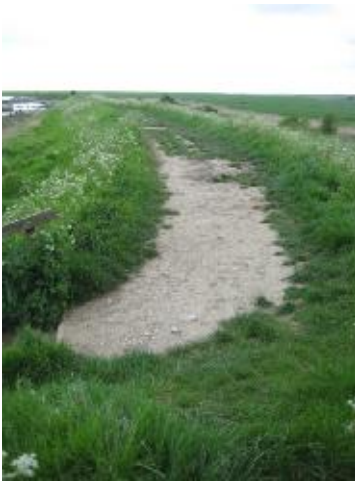
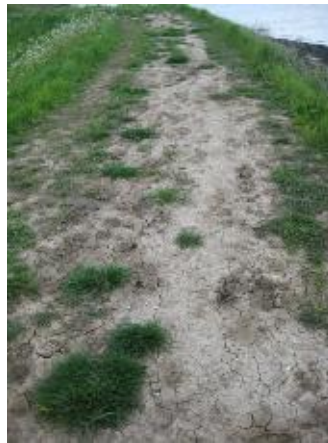
- 15 The area above the steps is very worn and significantly low and the path is very worn (photos taken 12 May)

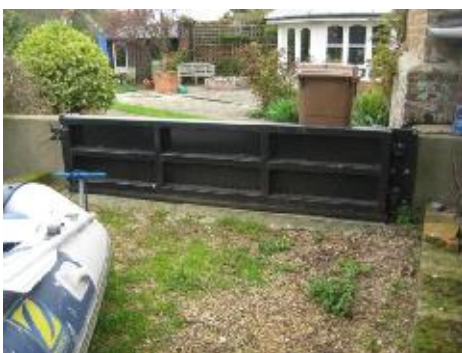
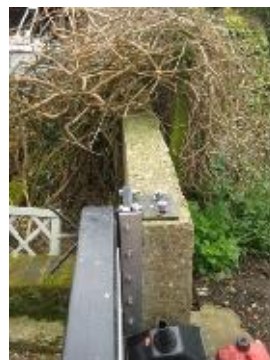
- 16 Some time ago it was confirmed the new flood gate on The Old Granary, Orford was now closing properly and that there were no problems with the wall. However, the engineer that spoke to David Andren (property owner) remarked that it was a much thinner wall than he has seen elsewhere. DA had received an oral assurance from ?Mike Steen at the time that it was fit for purpose but he kindly said he would check with the structural engineers that this was their view. **Action EA: has this been done?**

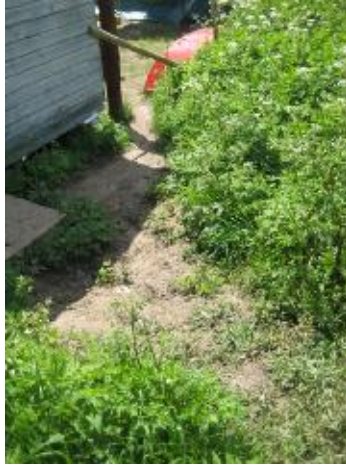
- 17 A walkway behind a shed on Orford Quay is making a dip at the toe of the wall

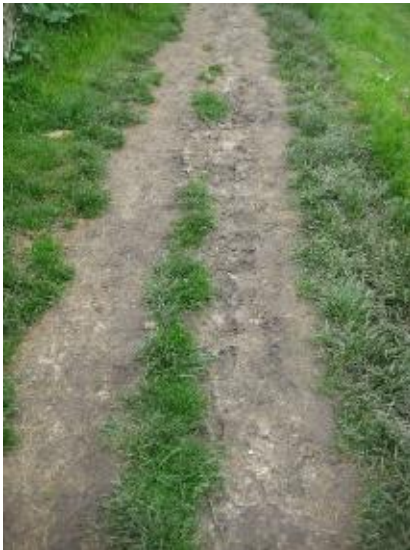
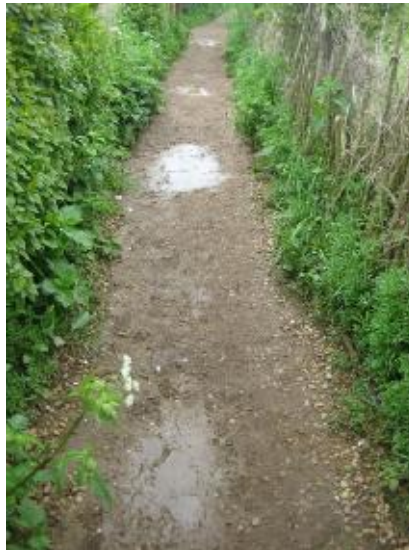
- 18 The foot path past Orford Sailing club (i) is very worn and the footpath in front of The Pavilion (ii) is dipping in several places forming muddy puddles.

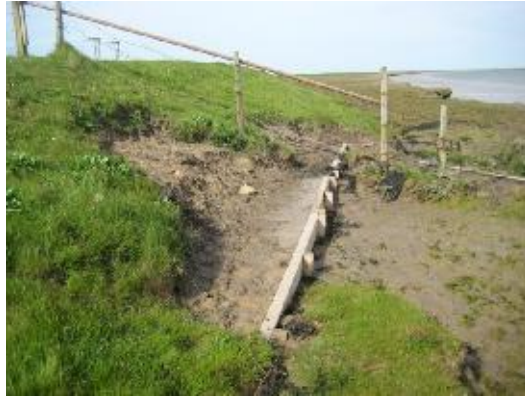
19 Area of erosion () that does not seem to have been arrested by the wood at the toe ?further maintenance required

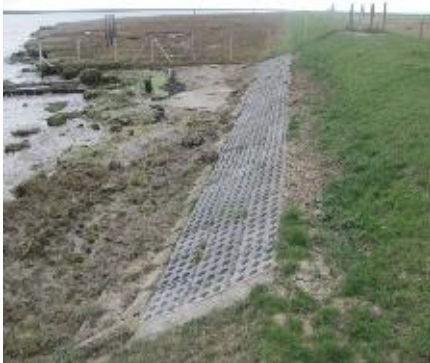
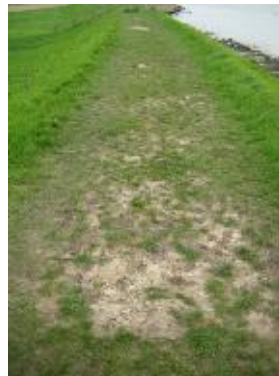
20 Very good repair, but bare earth above revetments where cattle still have had access and footpath quite worn.

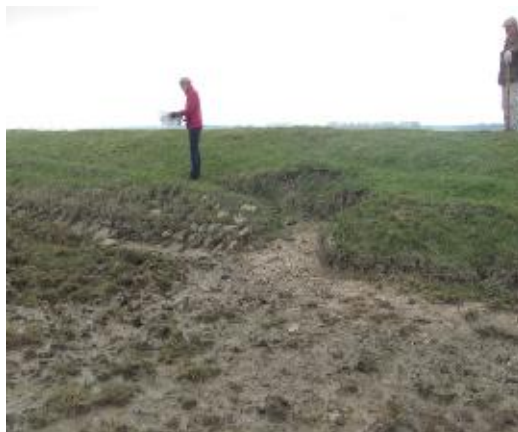
21 Start of asset erosion due to cattle trampling - Grade 2

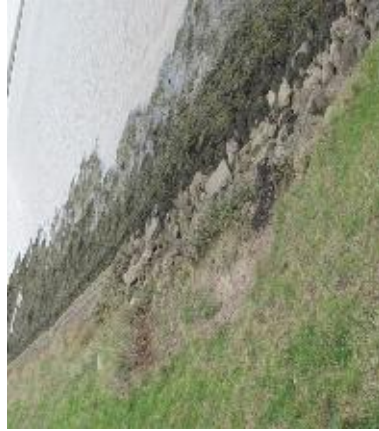
22 Break down of concrete armour Grade 3

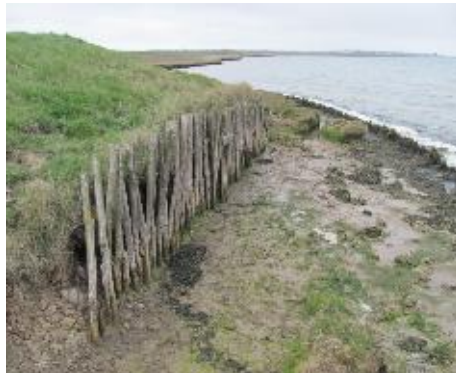
23 No toe, sticks only holding up asset Grade 4

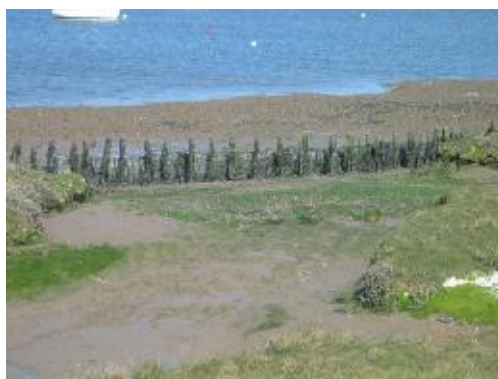
24 458554 Attenuation screening in place to trap silt in order to re-establish Saltings. To be monitored twice per annum for progress
