ALDE AND ORE ESTUARY ASSESSOR'S REPORT

NAME: Brian Johnson	DATE OF INSPECTION 9th and 14th April 2014
LOCATION: Flood Cell 1	MARCH/SEPTEMBER/TIDAL EVENT
Area of Assessment: 366440 to Butley Mills	Send to

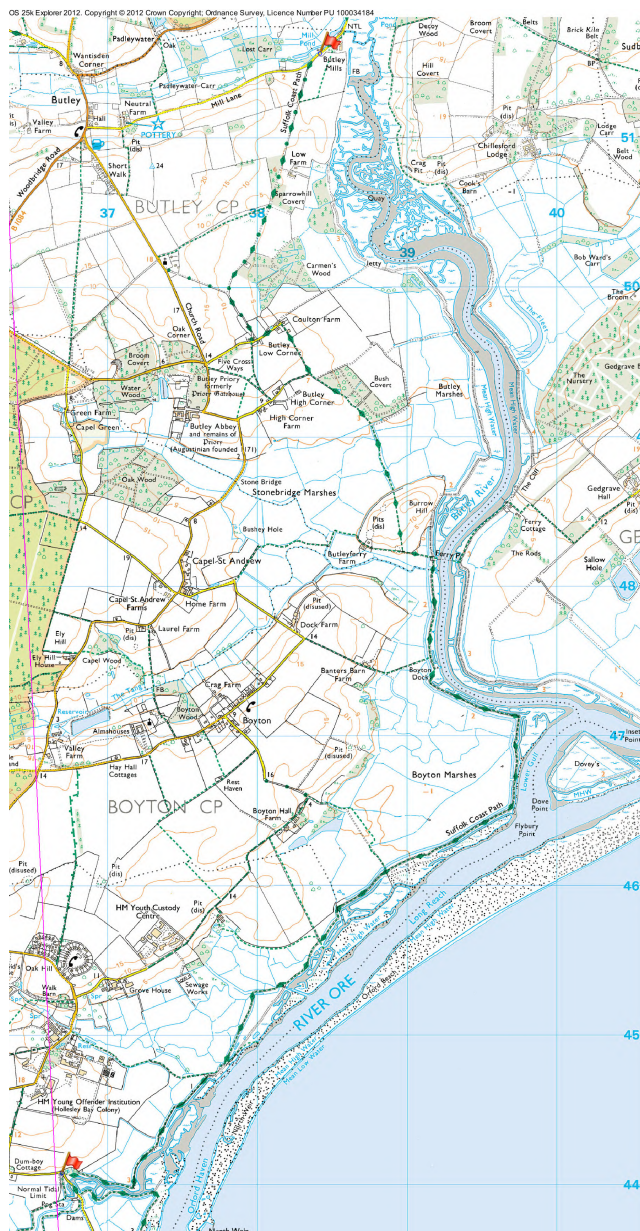
From 366440 to 385458. No significant change since 2013.

No repairs to broken fence around Simpson's Saltings carried out since 2013

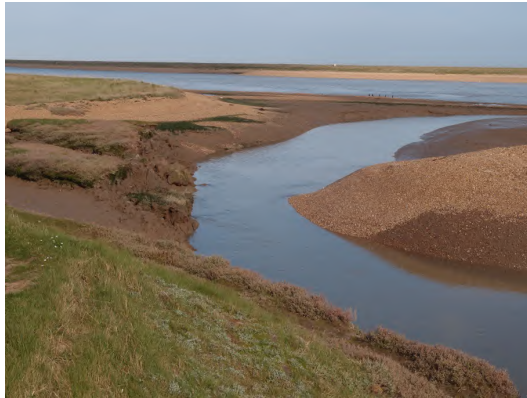
Saltings at mouth of Barthorp's Creek show increased erosion,

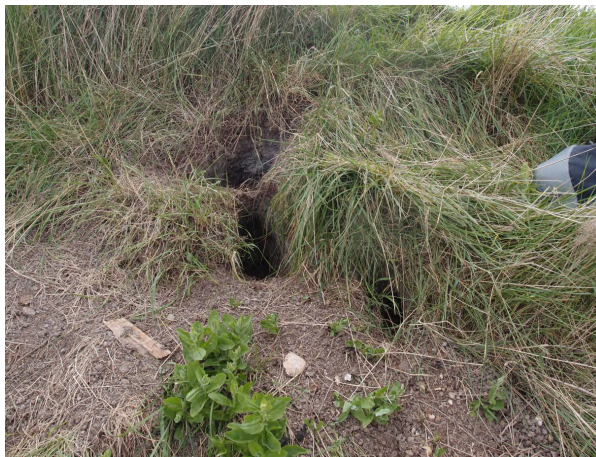
Unusual burrowing on river side close to top of levee 393464 see photo could lead to damage in full tide conditions.

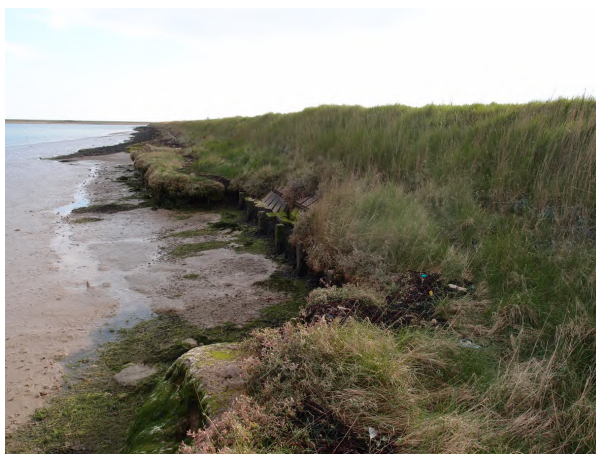
Foot of armouring at 397466 more exposed since last year, see photo (refer to 2013 report for armouring condition)

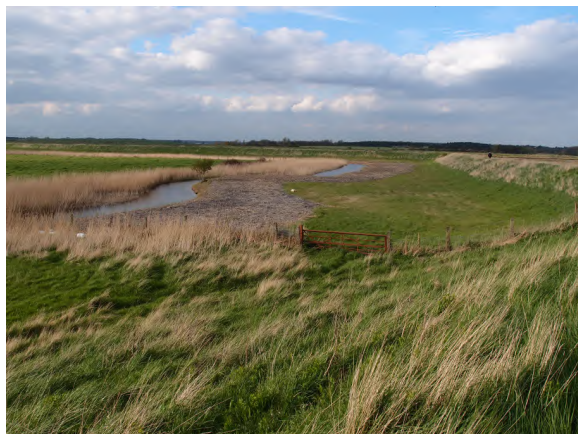
BOYTON MARSHES: RSPB has carried out extensive dredging to dykes to improve habitat – clay borrowings are laid out on foldings.

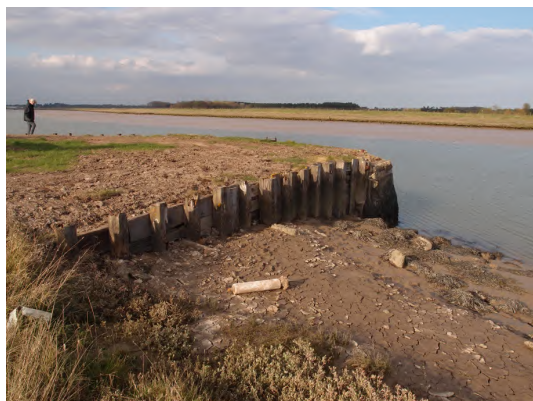
BOYTON DOCK South side

BOYTON DOCK North and South faces of quay wall repaired 2014 using existing timber on south side and new tree trunks as piles on north side. Protection improved but visually poor.

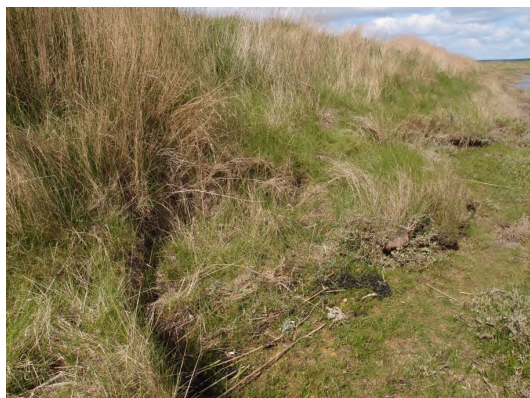
Levee generally protected by extensive saltings except 395496 to 394497 (see 2013 report) Foot of levee only 1M from timber footing which floods at spring tides.

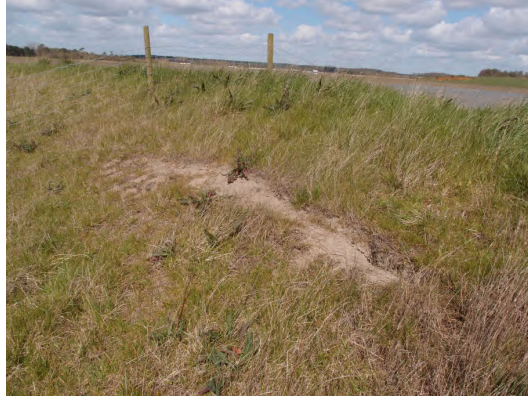
Some undercutting of bank more marked since 2013
