**ALDE AND ORE ESTUARY ASSESSOR’S REPORT**

<b>NAME:</b> Brian Johnson	<b>DATE OF INSPECTION</b> <b>April 2015</b>
<b>LOCATION:</b> Flood Cell 1	<b>March Equinox</b>
<b>Area of Assessment:</b> 366440 to Butley Mills	<b>Send to</b>

FLOOD CELL ONE 368440 to 387502  
From south to north.

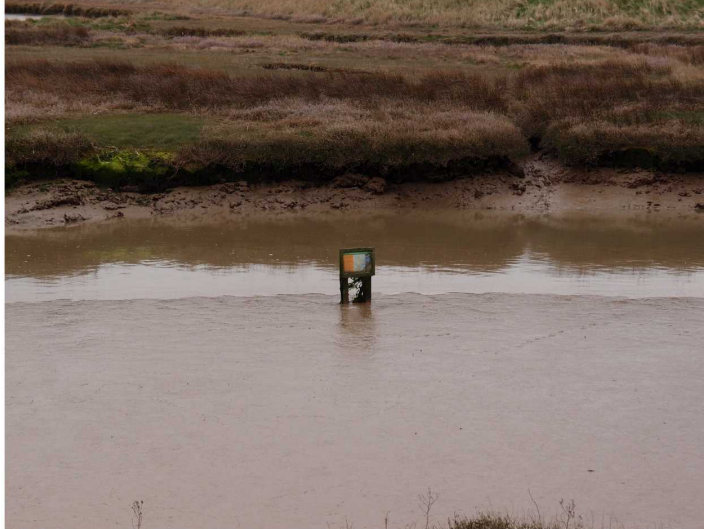
Chainage 100 Start of RSPB Hollesley Marshes reserve.. RSPB sign used to be on levee now in mid stream of Barthorp's Creek !

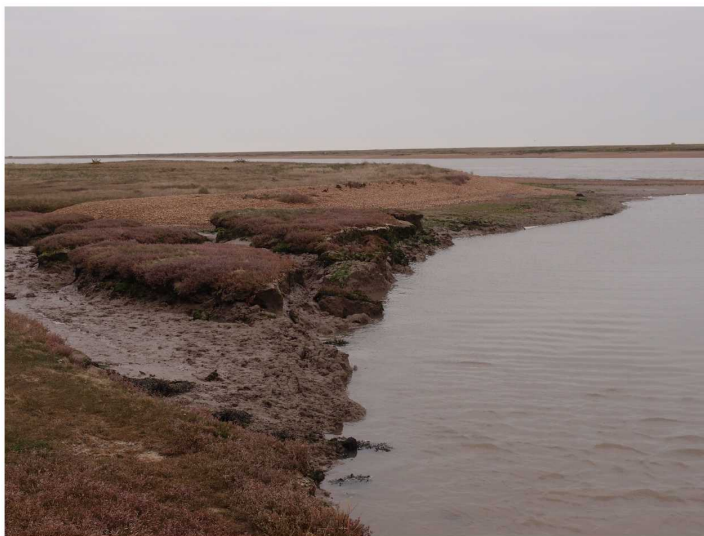
Mouth of Barthorp's Creek: some further salting erosion of north bank since 2014 but some shingle accretion in front of salting. See photo below

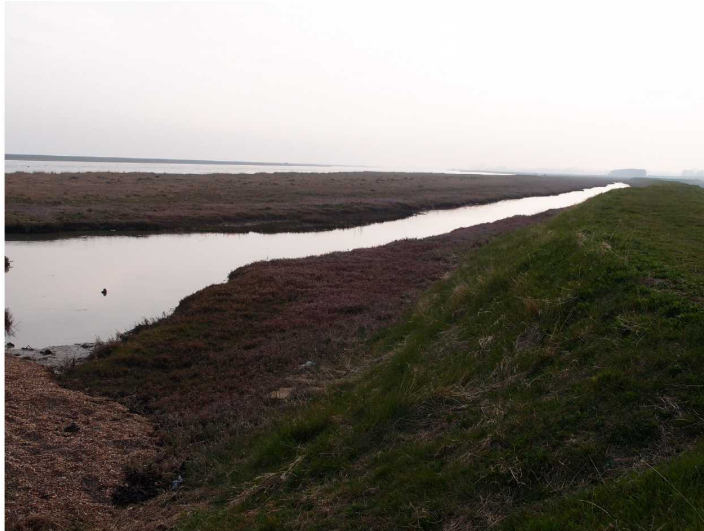
Extensive saltings from chainage 2100 to 4200 is divided by wide creeks resulting in saltings appearing like a series of islands. Riverside inaccessible, should be inspected by boat see photo below

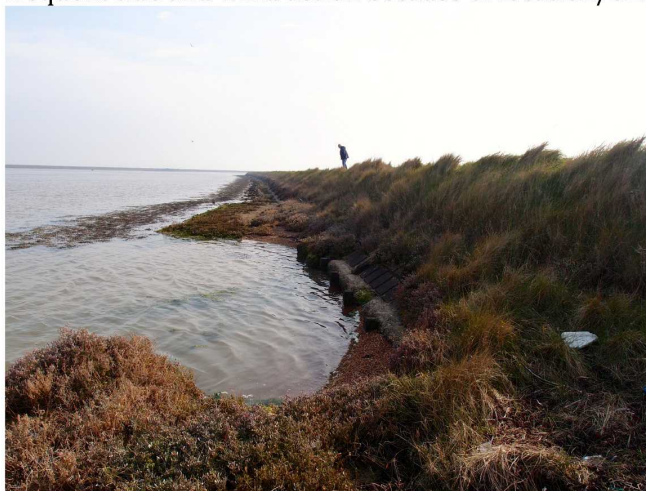
Flybury Point, Little change but armouring remains in poor repair, subject to frequent tide and wind action because of location/orientation.

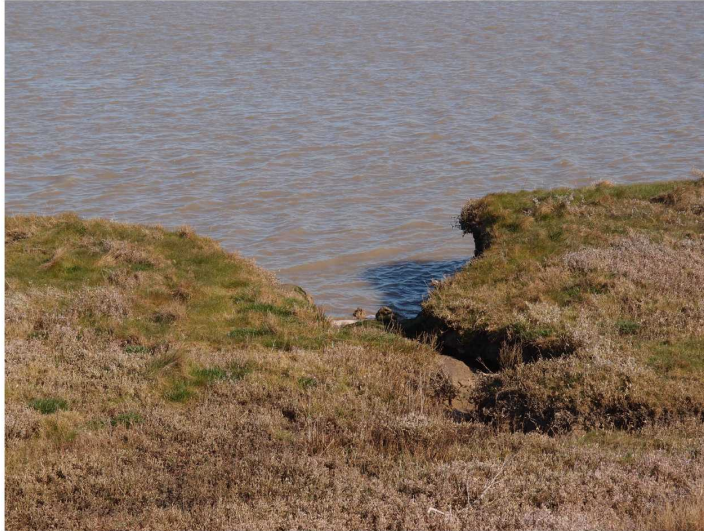
Possible start of erosion into salting, just south of outflow from river Tang/ Butley Ferry.

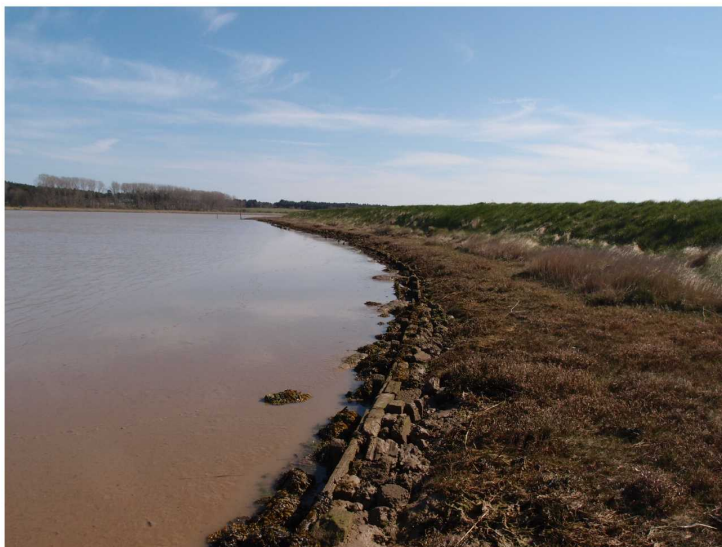
Timber edging to bank from 395496 to 394497 little change but remains in ruined state and does not provide much protection to levee which is only 1 to 2 metres from timber edging.
