THE ALDE & ORE ASSOCIATION

ALDE AND ORE ESTUARY ASSESSOR'S REPORT

NAME: Alison Andrews	DATE OF INSPECTION 2 April 2014
LOCATION : Flood cell 10 Brick Dock to Martello, river side TM 450565 to 463548 All map references from OS Explorer 212	MARCH/TIDAL EVENT
CO-ORDINATOR: Amanda Bettinson	Send to email: John Grayburn

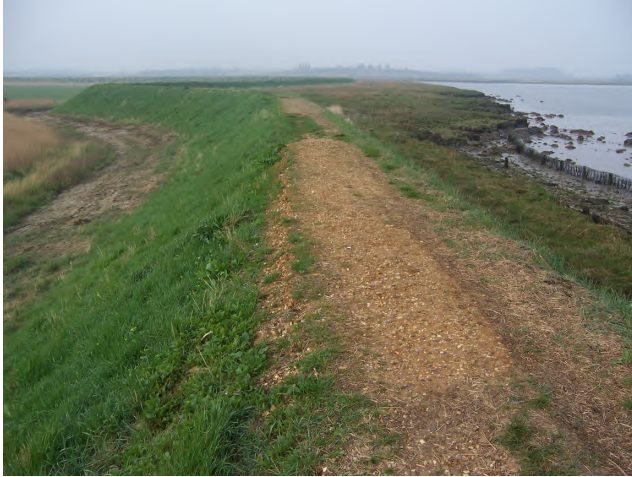
A 1. Footpath- several places where the bordering wood planks have been broken.

Hoggin spreading down the back

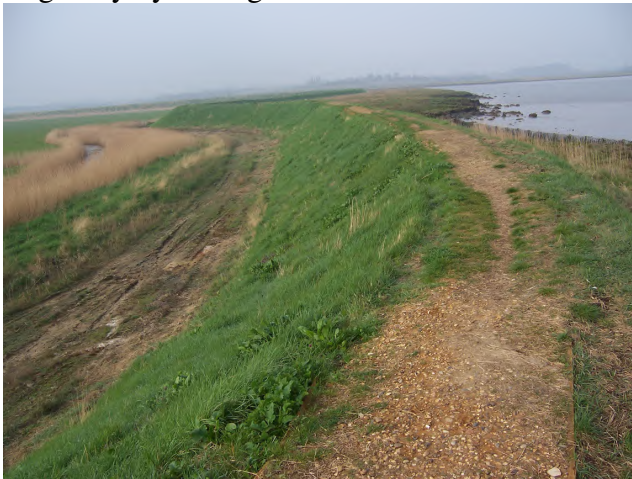
Messy mix path and works tracks in the area behind the river wall. That tack damage was done originally by the big works in 2012/13 and made worse by the November 2013 grass cutting.

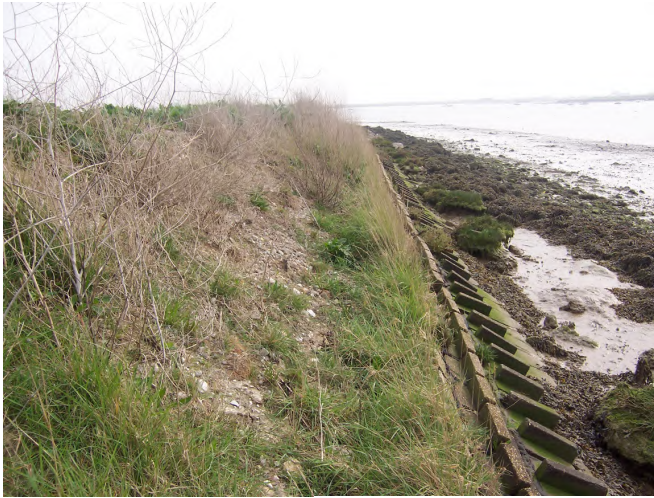
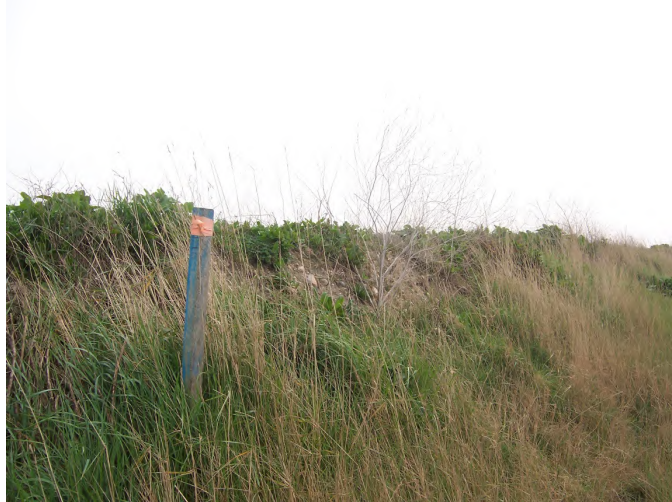
A 2. Bare face of upper wall : for some 150 plus yards the vegetation has not grown from the top of the path side down the bank to a depth of at least one foot, more in places, as the slope is too steep. This problem occurs on both the river and land side of the path. This endangers the holding capacity of the wall should it be overtopped. All this applies where the poor work was done, including making the new width of the path cover the top of the wall, in 2012/13
Photos, first two show the bare wall between TM 44556 and 456555

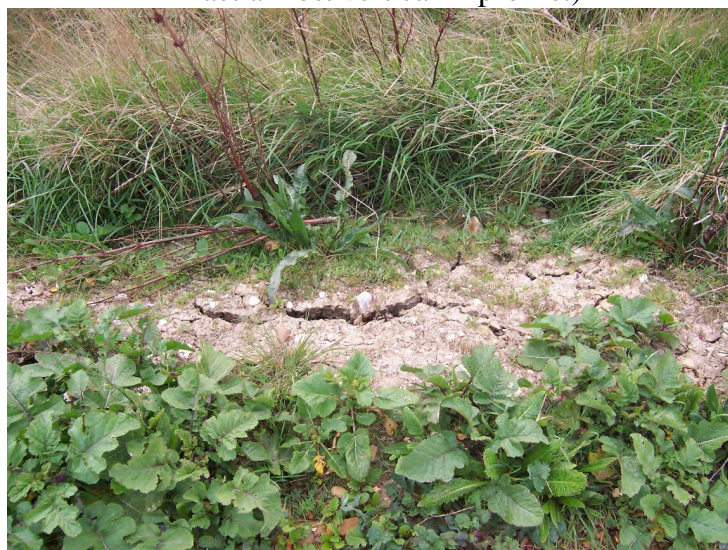
A.3 Third photo shows where the bank is cracking along its length and beginning to slide down, the start of more serious erosion. (Note photo is taken looking directly down but the wall is in fact almost vertical in profile.)

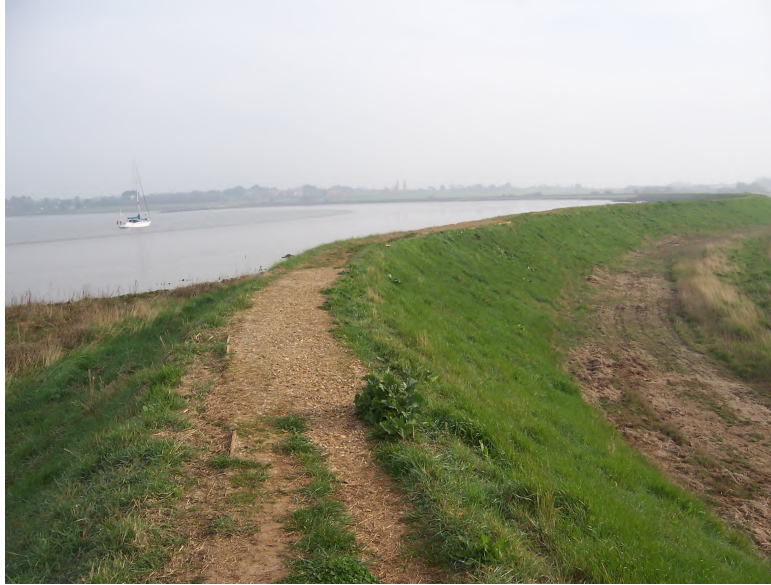
A.4 near vertical back/land ward slope of almost 1/5th of a mile of river wall TM445561 - 459564. In some places, in the distance on the photo below, the slope :height of bank ratio is near to 1 in 3 and clearly while there is some grass there are bare patches which would not withstand overtopping, just as steep slopes failed at Hazlewood marshes

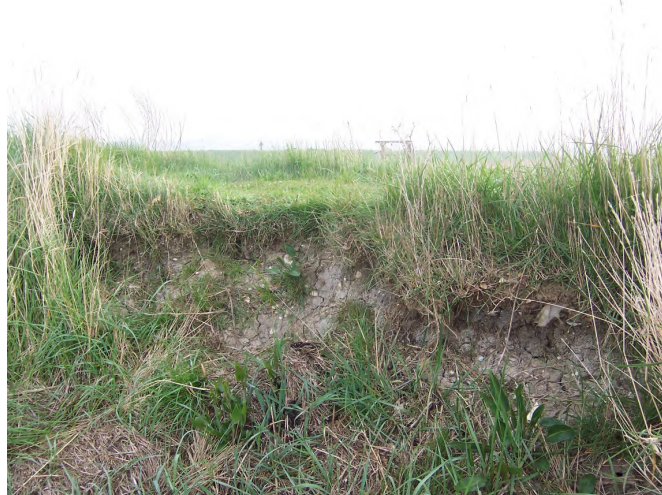
B.1 Bare face of wall previously reported. This 20 yard long stretch is protected from the river by saltings but the erosion is increasing and in one place is beginning to undercut the path **TM**

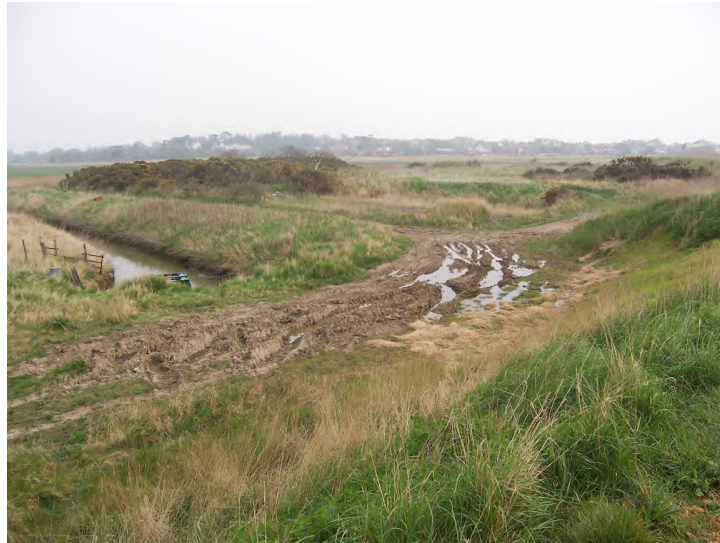
B2. Rear of bank at Aldeburgh pump. The land behind continues to remain muddy and wet long after all other parts of the walls have dried out. There is evidence of slumping near the base, hidden in the vegetation. (recently cleared by EA to get a better look which is good)

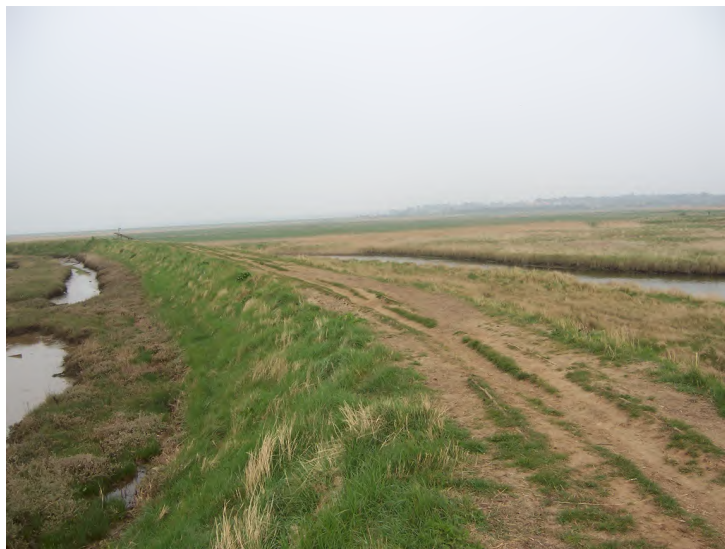
B.3 Slumped wall on the most walked stretch between Slaughden and the steps TM 460558
This part was overtopped in the December 2-13 surge. It dips below the rest of the wall and suffers a lot of heavy walking wear.

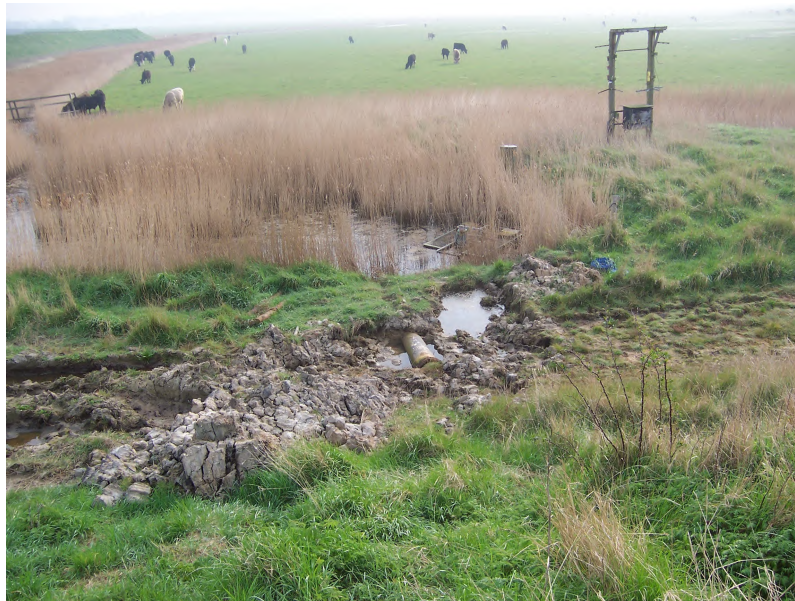
C.1 Pump at 'West Row Point as marked on OS TM454560 Some work must have been done on the pump and is not yet finished or has been left as a complete mess.
