THE ALDE & ORE ASSOCIATION

ALDE AND ORE ESTUARY ASSESSORS REPORT

NAME: Alison Andrews	DATE OF INSPECTION 25 April 2013
LOCATION: Flood Cell 10	MARCH equinox
Area of Assessment Brick Dock to Martello TM 450565 to 463548 All map references from OS Explorer 212

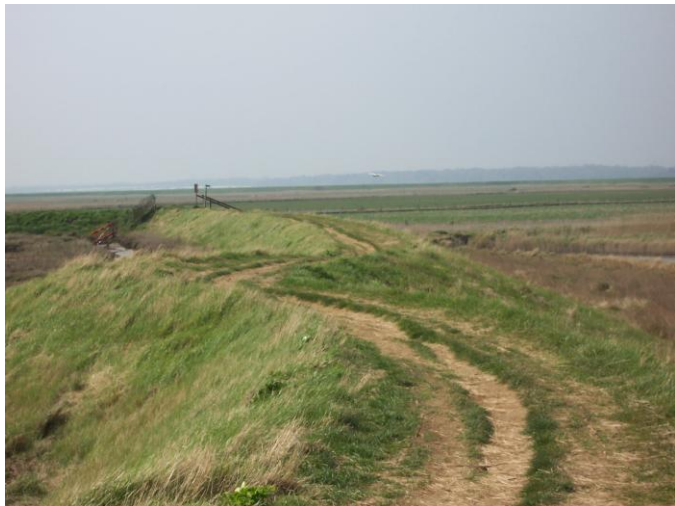
1. New: lower sunken patch to the east of the major works , 20 yards long, 75 yards east from river walls steps, ref 460558, photo looking west NW

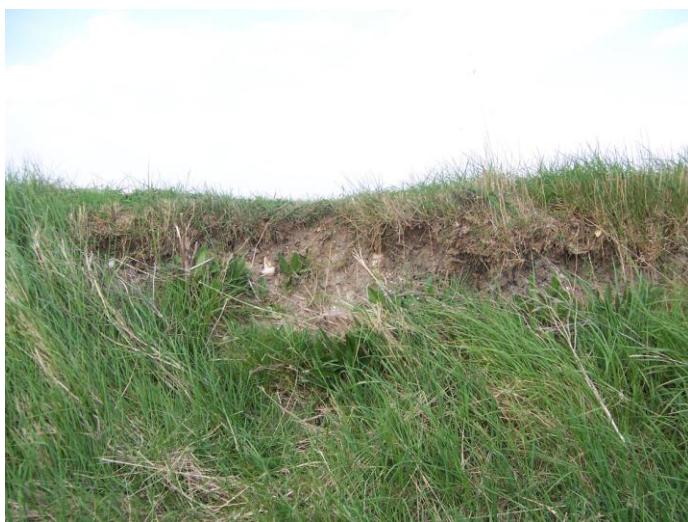
2. continuing. Still bare front of wall facing river, near Stanny, 445559. Photo but raw part seems less extensive, may be hidden by longer vegetation

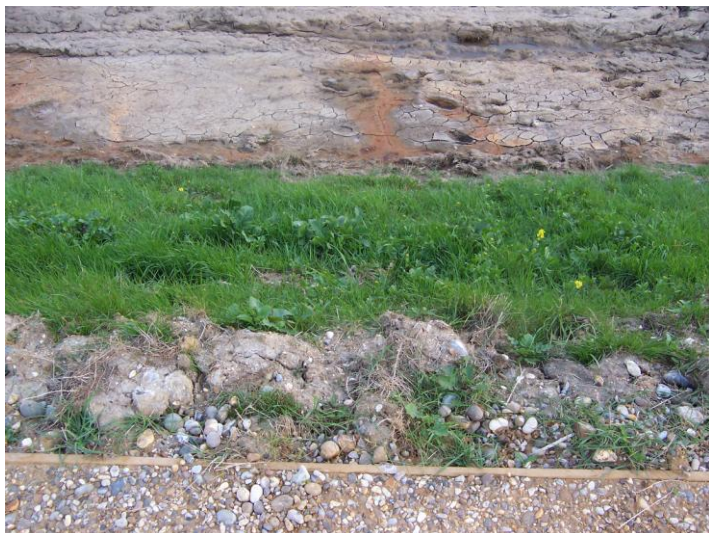
3. Major repairs. New development resulting from extensive repairs between Brick Dock and Aldeburgh Sluice to deal with slumped areas from Brick Dock to Aldeburgh Sluice. The works have resulted in some places with very steep back walls, loose earth through which grass has yet to establish and grow.

Photo below shows 3+metre deep fall from land side of wall:

Comment: It is not clear that the changes will work at a time of overtopping because the shape and loose cover may not withstand overtopping.

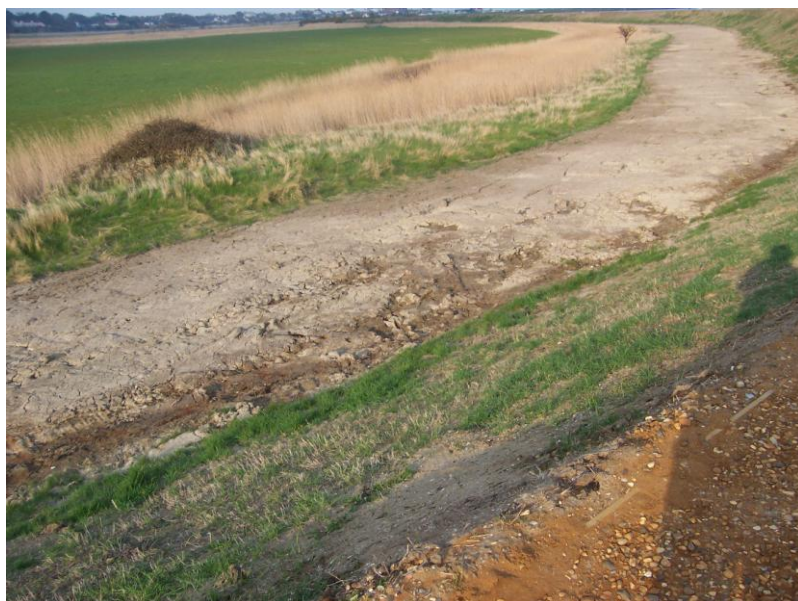
The damage at the base of the walls on the land has left a broad track area of puddle and compacted, now dried out, mud. See photo Ref from 448563 following the river wall east then south to 448555 approx

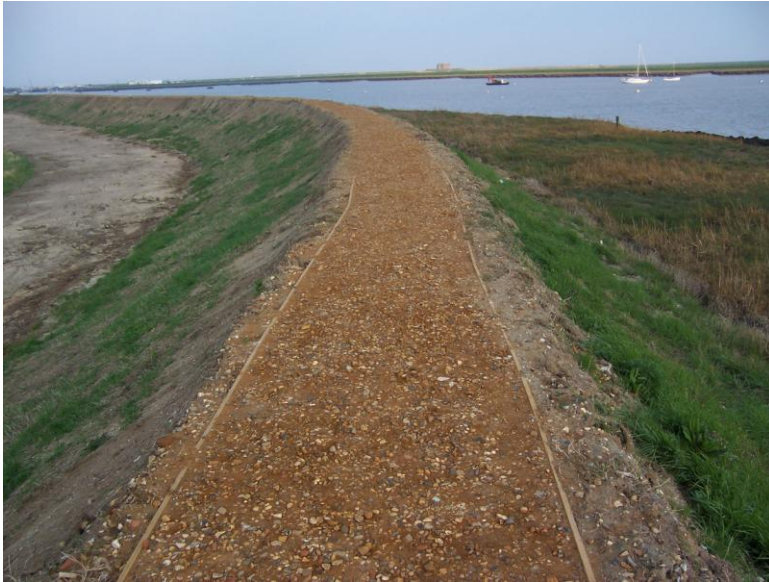
It is to be hoped that the very urban look of the new path (1.3 metres wide) will mellow as vegetation grows. See photo below taken at about 446556 looking southeast.

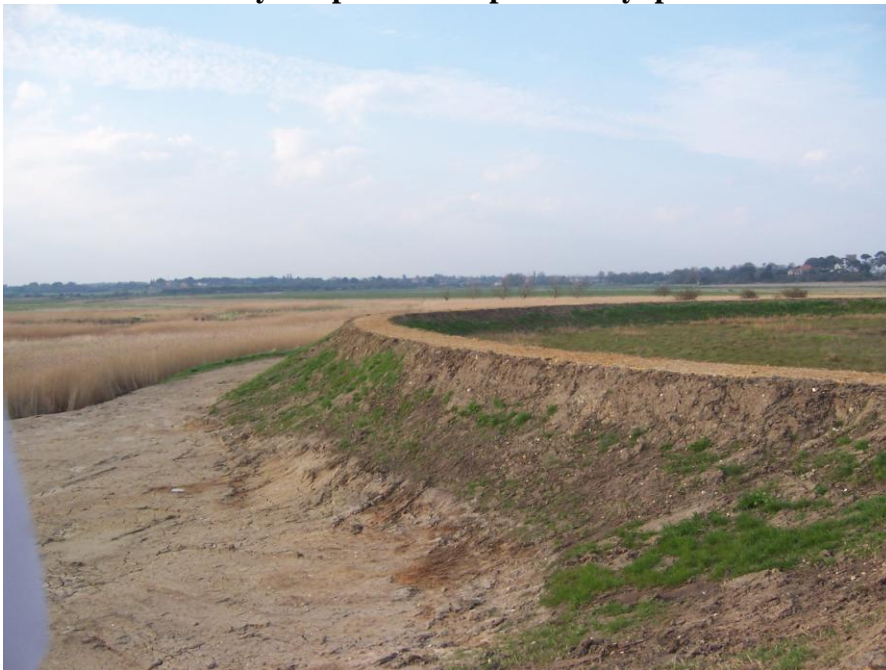
Photo at 456556 shows steep walls around the off river curve of e wall. It was in parts bald and steep before, now after repairs a better shape providing it can hold in heavy rain and with walkers. The bit just by here where the footpath also goes off at right angles across the marshes is still very steep if not steeper so may poach when wet.

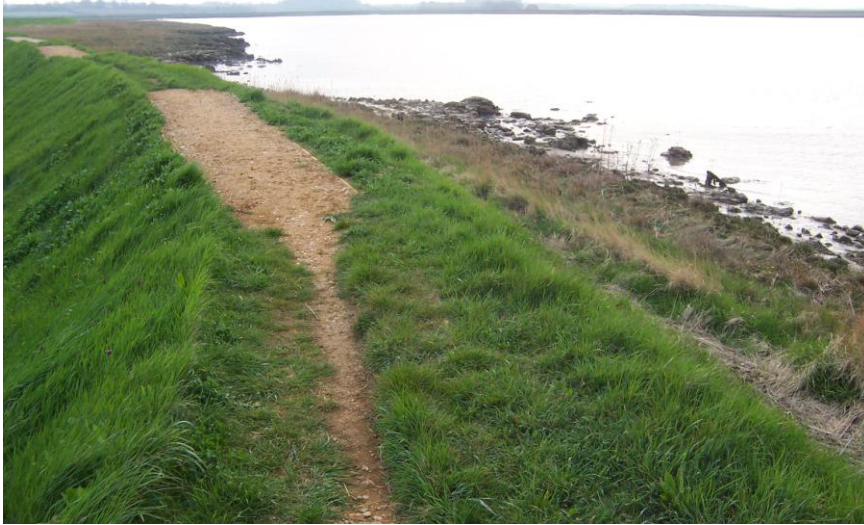
New pathway patchy, presumably where walls have been increased in height path has been restored to a width of 1.3metres but where the walls height was acceptable the path remains. See photo below ref 449563
