THE ALDE & ORE ASSOCIATION

ALDE AND ORE ESTUARY ASSESSOR'S REPORT

NAME: Alison Andrews	DATE OF INSPECTION 23 March 2015
LOCATION : Brick Dock to Martello, river side TM 450565 to 463548 All map references from OS Explorer 212	MARCH/Equinox Spring tide
CO-ORDINATOR: Amanda Bettinson	Send to email: John Grayburn

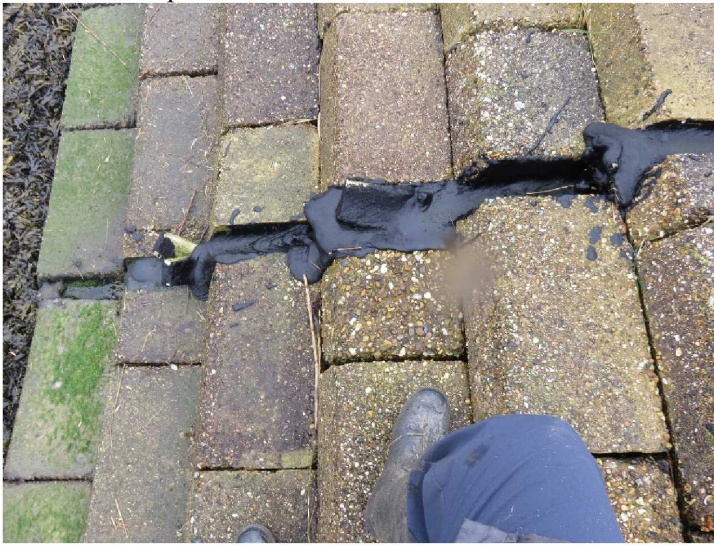
A.1 Brick Dock Curve Repaired (2011)stretch (TM 450564 to 446551) The repair to the armour facing Brick Dock curve done in 2011 is mostly standing up well. But in a few parts the tar/mastic is sinking away and the polystyrene filler below it is coming out, and the concrete blocks beginning to twist out of place.

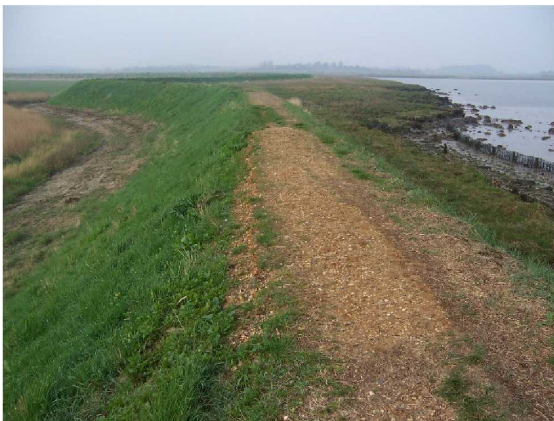
A 2. Footpath- several places where the bordering wood planks have been broken, and is now further dilapidated.

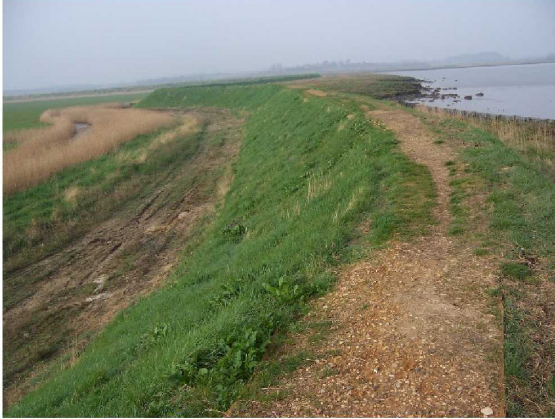
A 3. Track at base of landward side.

The track damage at the back of the wall originally done in 2012/13 works is in many parts appears permanently full of lengths of water as there had been no rain for the month before the survey and all other ground was very dry. Where the water has dried out in the tracks the mud left is so compact that vegetation struggles to grow. What grass there is not green but brown and yellow unlike grass away from the tracks. At around TM446556 the profile from the top is vertical down to slightly less steep ending at a boggy bottom.

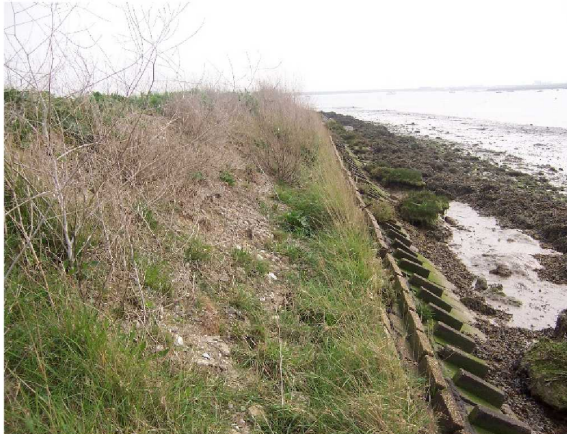
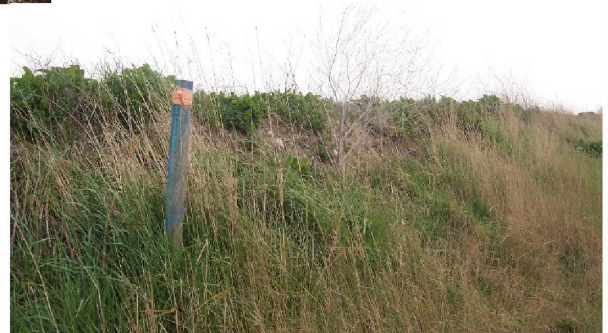
A 4. Bare face of upper wall : TM446557 to TM 4534556. This **repeats** the report of 2014 as the bare surfaces are the same as last year, that is there has not been an improvement in vegetative cover on the steep sides of the path (where the path was expanded to fill the entire width of the wall top and no allowance made to modify the steepness of the slope in 2012/13). This problem occurs on both the river and land side of the path. For some 150 plus yards the vegetation has not grown from the top of the path side down the bank to a depth of at least one foot, more in places, as the slope is too steep. This endangers the holding capacity of the wall should it be overtopped. See photos from last year as no change in situation , first two show the bare wall between TM 446556 and TM 456555

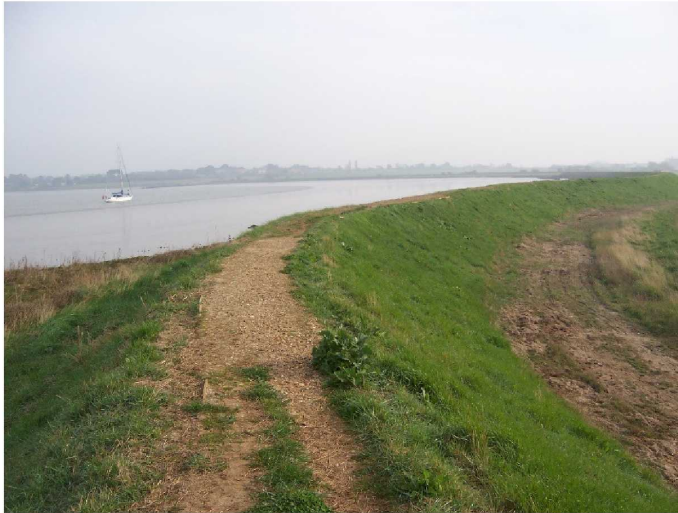
A.5 near vertical back/land ward slope of almost 1/5th of a mile of river wall TM445561 -449564.

This is repeating the report last year as there has been no structural change in the wall but the waterlogged landward side base is of new concern as it is not a one off appearance as there has been no rain.

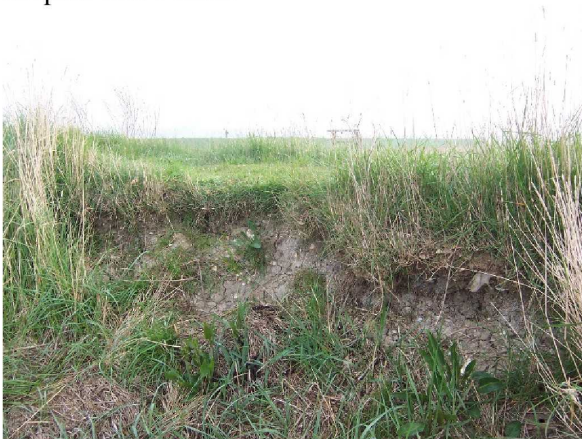
B.1 Bare face of wall previously reported in 2013 and 2014. This 20 yard long stretch is protected from the river by saltings but the erosion is increasing and in one place is beginning to undercut the path **TM 445559**

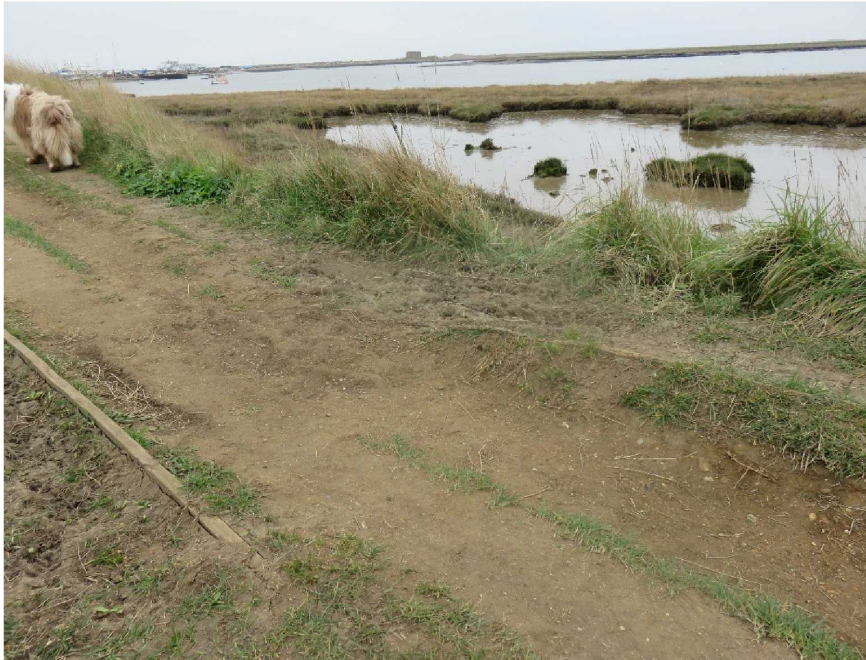
B.3 Slumped wall on the most walked stretch between Slaughden and the steps TM 460558

This part was overtopped in the December 2-13 surge. It dips below the rest of the wall and suffers a lot of heavy walking wear. During the 2014/15 winter further heavy wear on the path has lowered the top surface further.

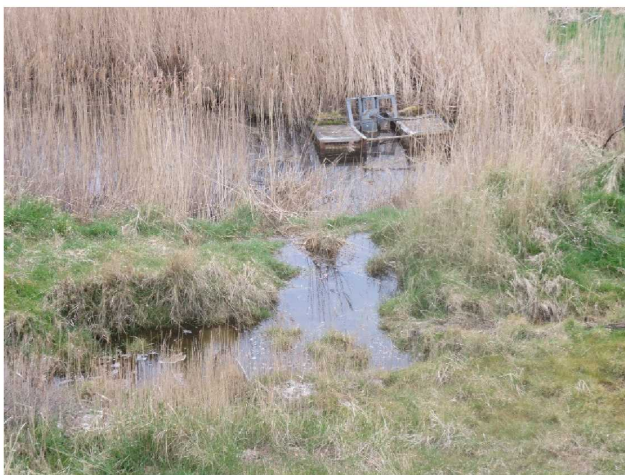
B.4 Pump at 'West Row Point as marked on OS TM445 560 Some work was done on the pump in 2014 but the land between it and the river wall is damaged and waterlogged, see photo.

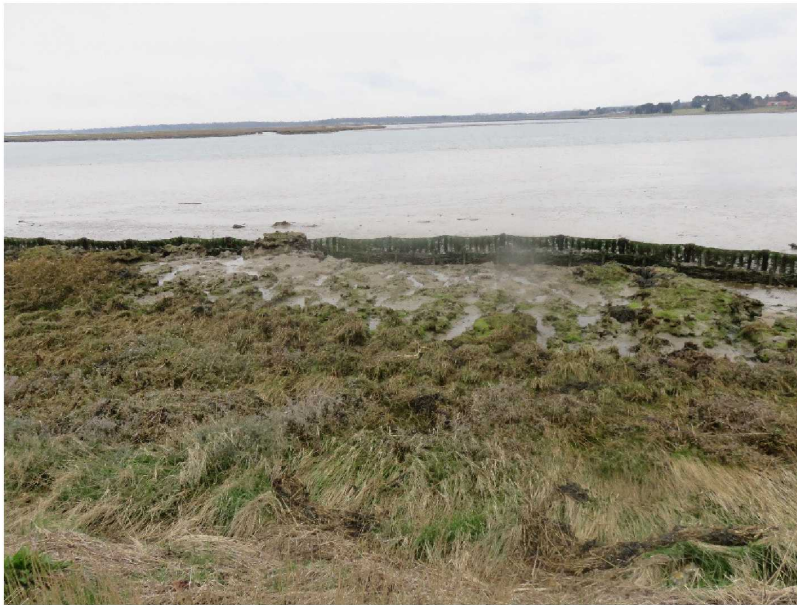
General comment- along the entire stretch the vegetation on the saltings appears to have been more severely battered by the tides, which have been noticeably higher covering the saltings around the spring highs more than in previous years. At numerous points the saltings are also eroding at the edges (perception of both walkers) Concern also relates to edges near new Aldeburgh Sluice outflow but that may have been addressed by the extension of the pipe once concern had been expressed. Photo shows as an example the saltings vegetation behind the Brick Dock Saltings trial TM 449564. .
