RDC survey 2014 Flood Cell 2 – Butley Mills

Section inspected by Frances and David Barnwell 27 April 2014

River bank surveyed

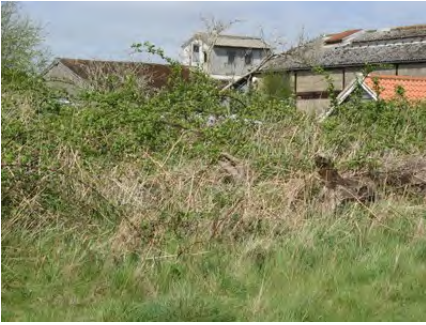
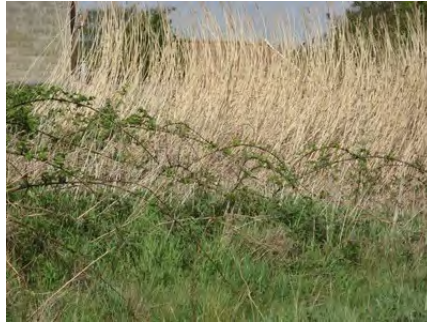
Walking north from Butley Mills at TM 3863 5158, the river wall is covered in brambles and detailed inspection is not possible.

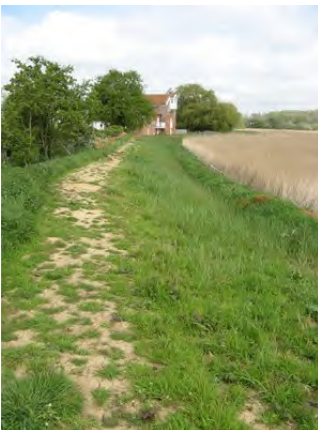
The brambles end at TM 3858 5162. There is a new clay path on top of the wall, and recent work has been done either side.

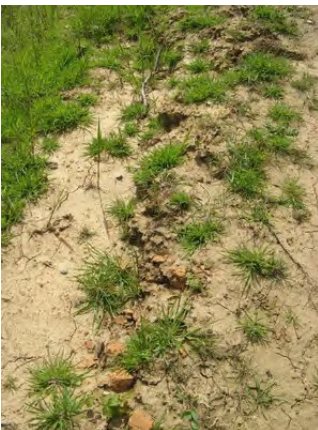
There is some erosion to seaward in the clay at TM 3858 5166. The trees to landward have not been removed.

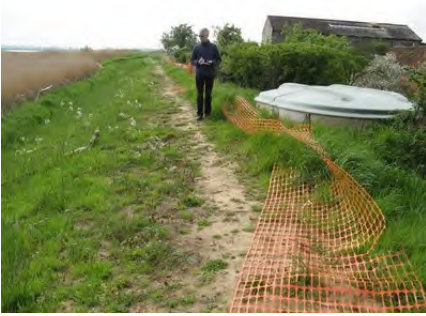
There is a Klargester set into the bank at TM 3857 5168. A broken plastic pipe passes through the river wall.

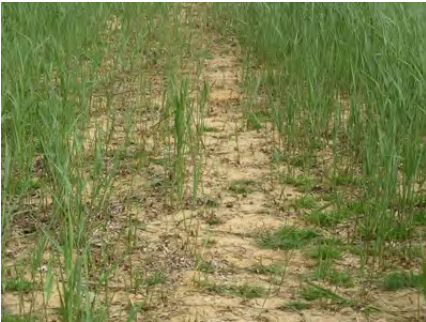
After Butley Mill Sluice No 2 at TM 3858 5172 the wall still has a clay surface. Tall grasses are beginning to grow through the surface.

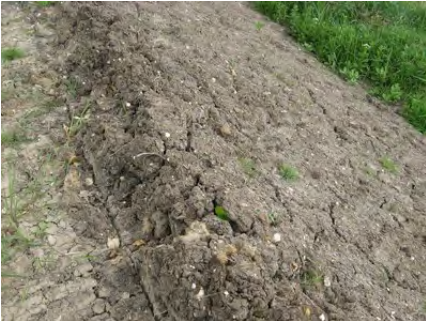
After TM 3861 5178 an earth layer has been added to the seaward face. It consists of large uncompact clods.

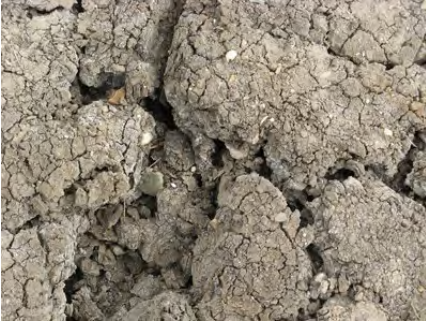
After TM 3861 5182 there is an earth topping some 30 cm higher than the clay. There is no long grass growing here.

There is deep desiccation cracking north of Butley Mill Sluice No 21 at TM 3860 5186.

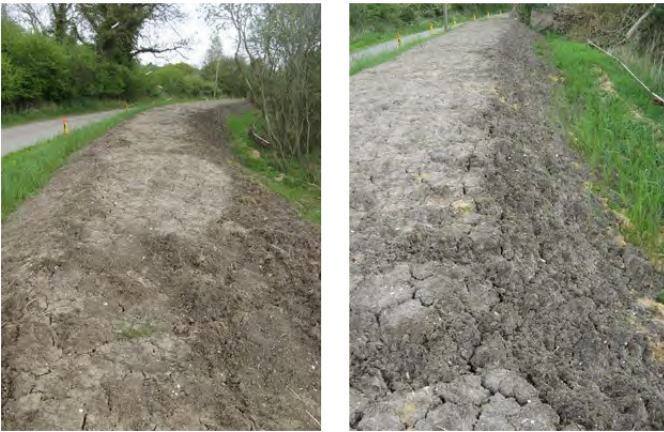
After TM 3858 5199 the earth has been built up. There is no vegetation.

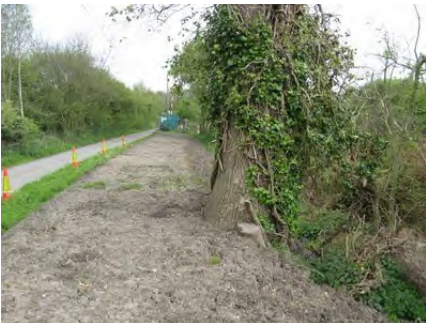
At TM 3859 5204 there is a very large oak trunk in the seaward face. The top of the tree has been lopped off and other trees and bushes have all been cleared.

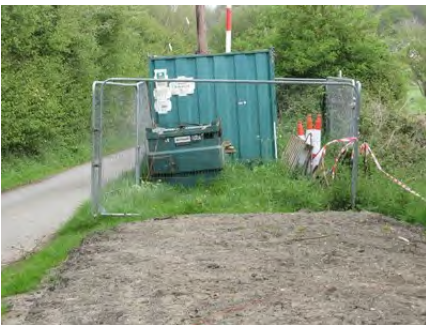
Approaching Chillesford, the wall ends at TM 3861 5209. There is a temporary equipment area, fenced off. There is no maintenance north of this point.
