THE ALDE & ORE ASSOCIATION

ALDE AND ORE ESTUARY ASSESSORS' REPORT

NAME:	Roger Baxter Jane Salter	DATE OF INSPECTION:	April 2015
LOCATION:	Flood Cell 2	March Equinox	
AREA OF ASSESSMENT:	Butley Mills, Mill Lane, Butley

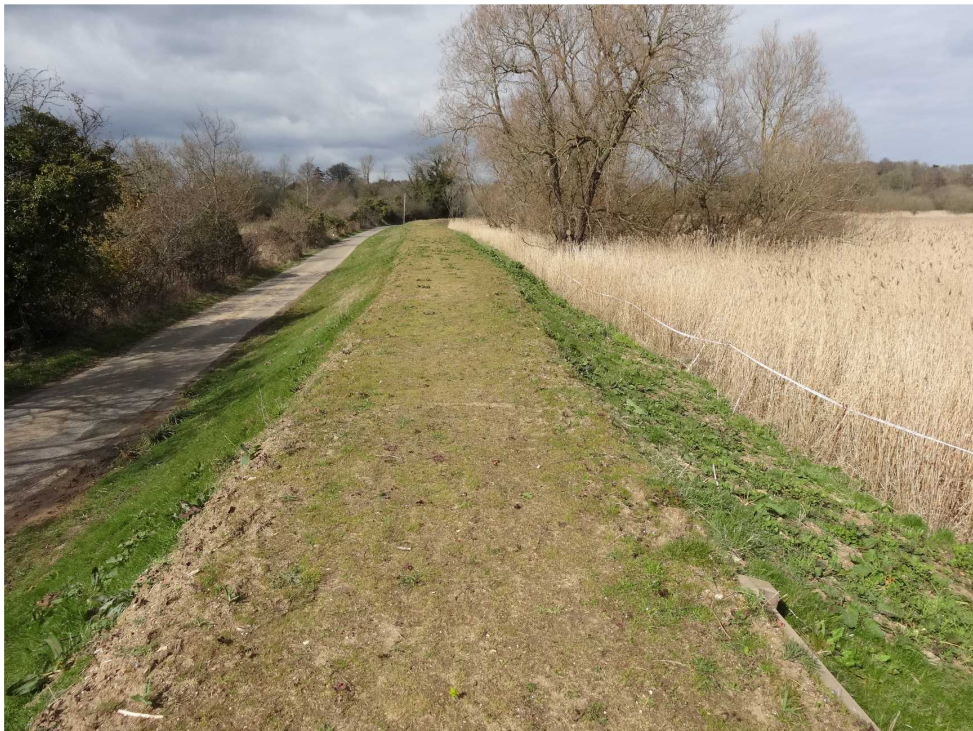
Wall top with good width and vegetation coming through. TM386515

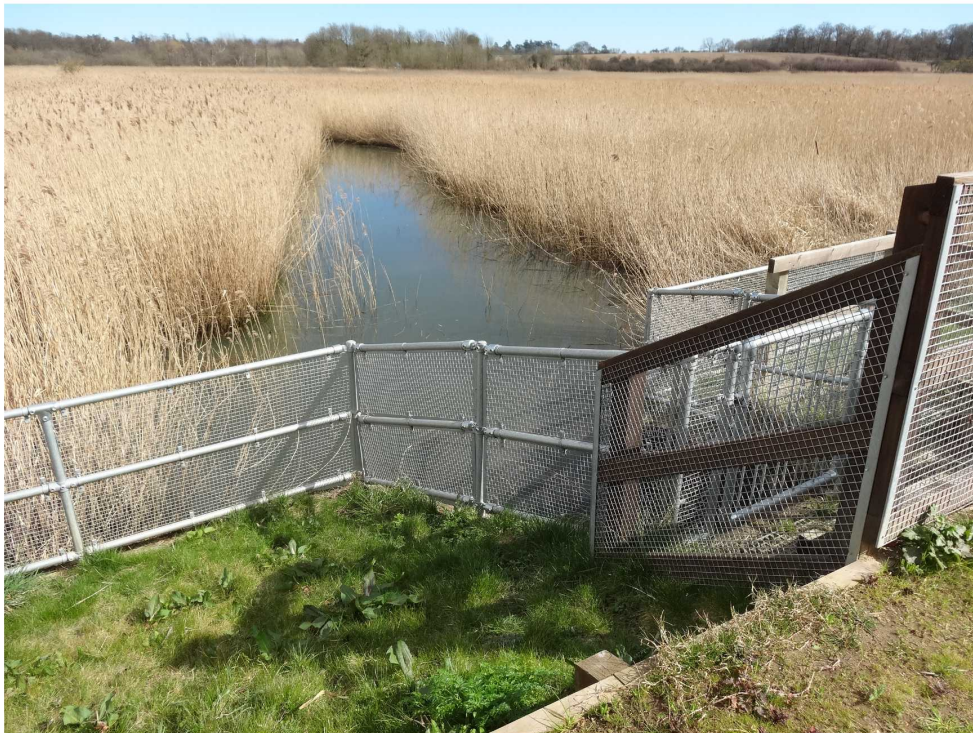
One of two sluices. Deep reed beds TM386519

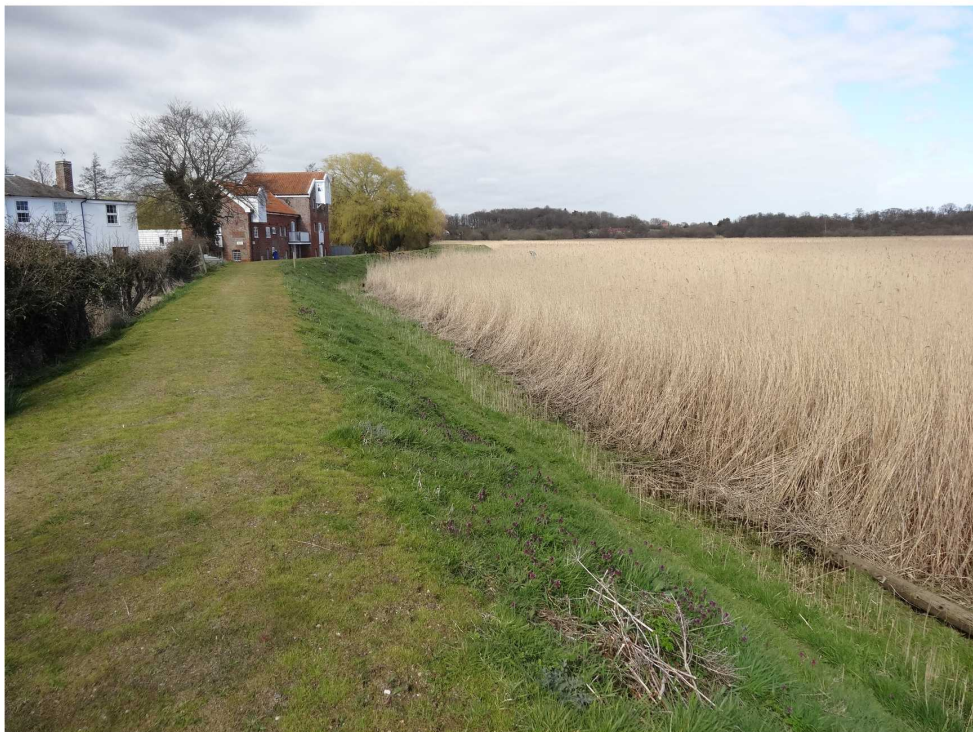
Mills on other side of the lane. TM386519 looking North
