ALDE AND ORE ESTUARY RIVER ASSESSMENT APRIL 2014

NAME: Amanda Bettinson	DATE OF INSPECTION
LOCATION: Flood Cell 3	10 th April 2014
FROM: Top of Chillesford wall travelling south

River wall inspected

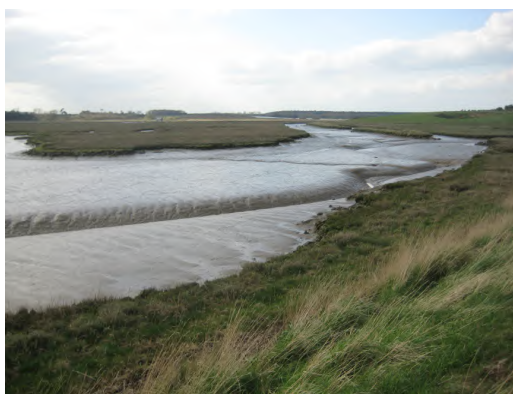
1. 394505 About 200 m from the start of the wall looking north. Saltings about 2m in width. Landward wall steep. Debris 1' below crest.

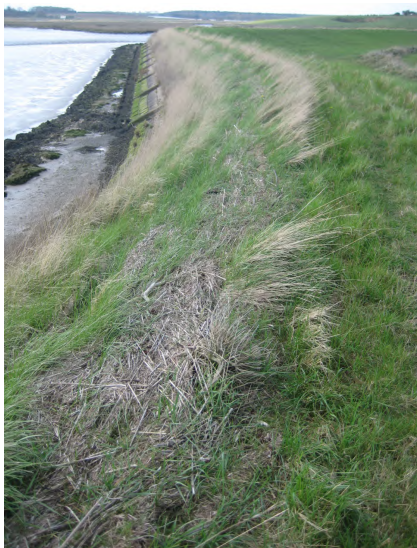
2. 395506 (By Electricity Pump station) Debris level with crest.

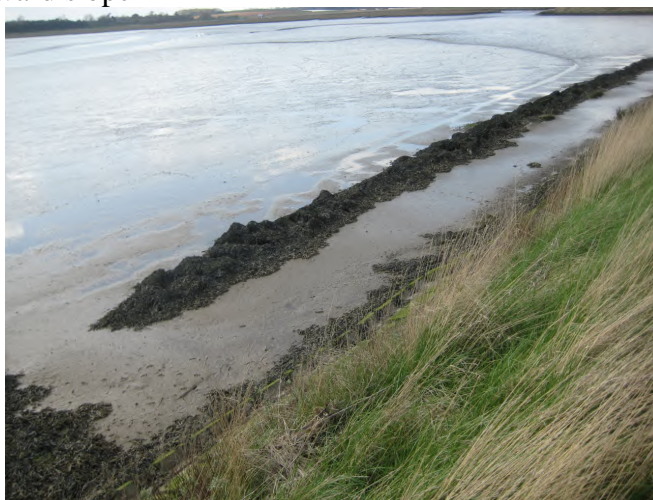
3. 3955025 1 m of mud before hardcore defence covered in seaweed – no sign of any plants establishing. Good landward slope

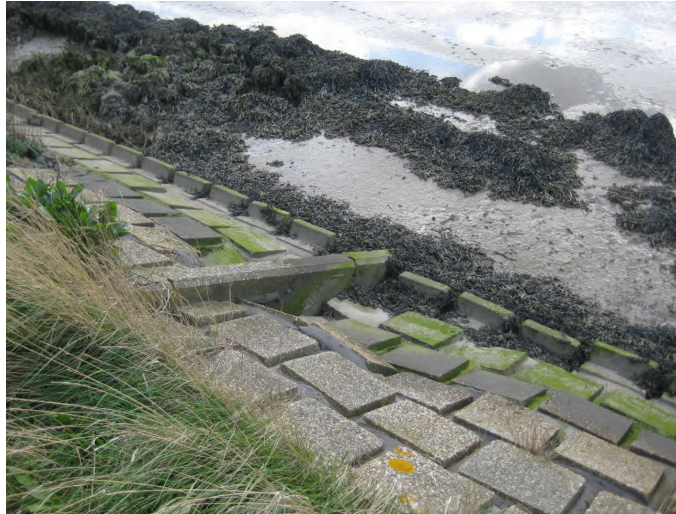
4. 396502 Revetments collapse either side of bay buttress. About 3x3 metres

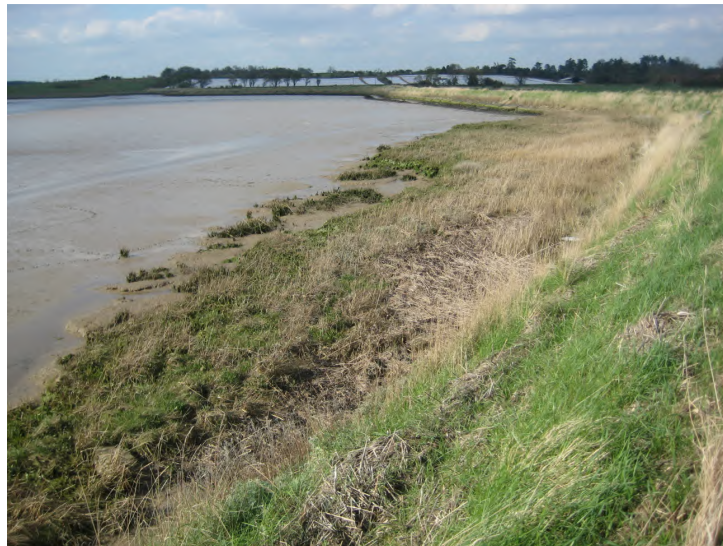
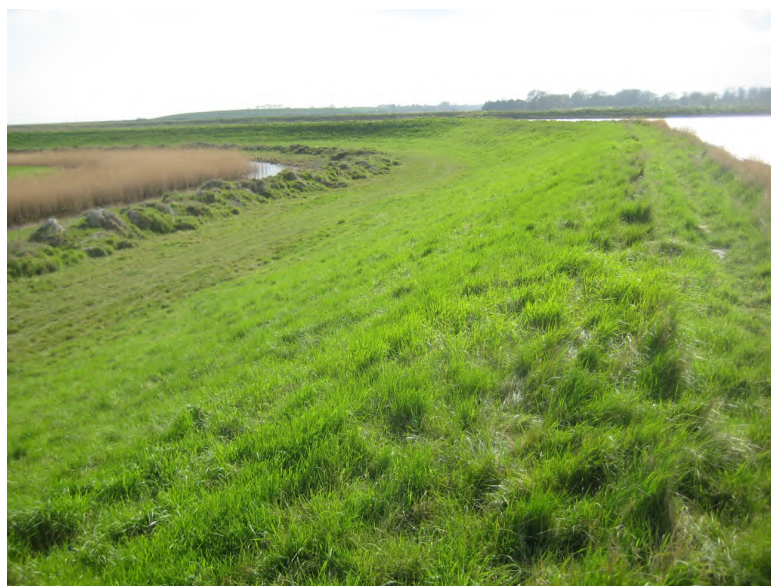
5. 396501 – 3955035 Marker on wall to show area of over topping. Small area of saltings with slight erosion. High tide debris on crest. Slightly steep landward slope.

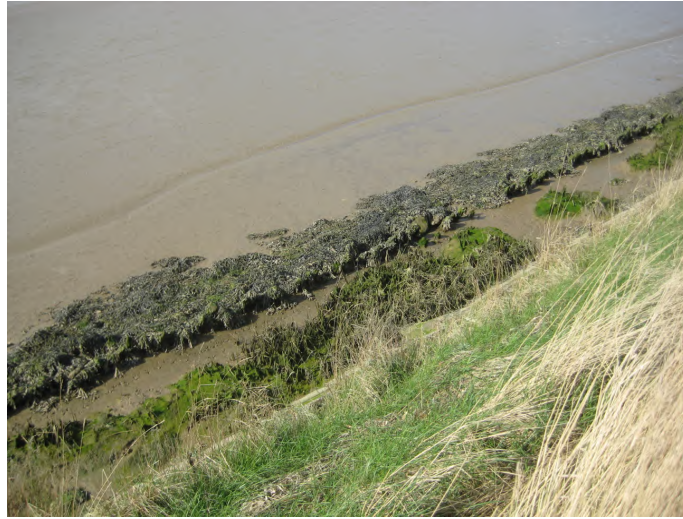
6. 3965505 slope Old NRA defences still apparent – 1m mud with some marram grass. Good landward

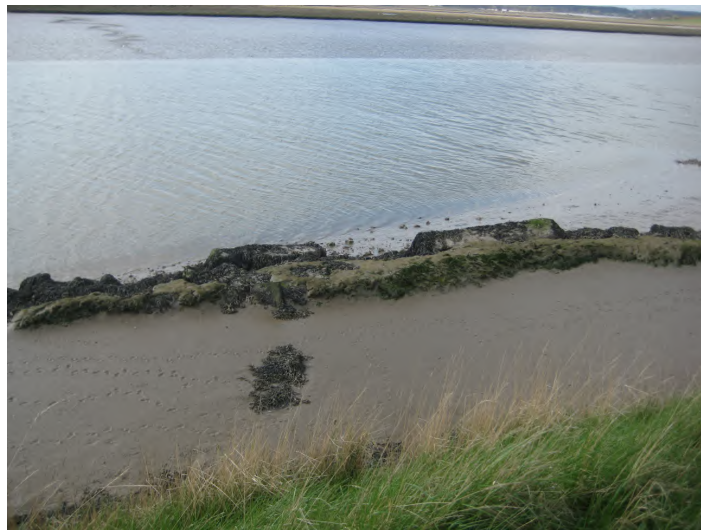
7. 394499 (Just round the bend) 2m mud at toe. Barrier significant height above low tide level. High tide line on crest, steep landward slope.

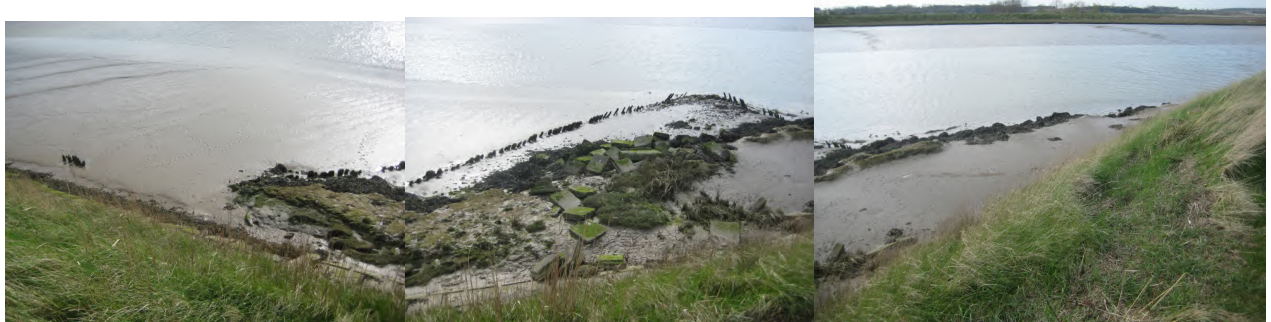
8. 3954995 One or two minor areas of revetment collapse. (photo stitching needs refinement!)

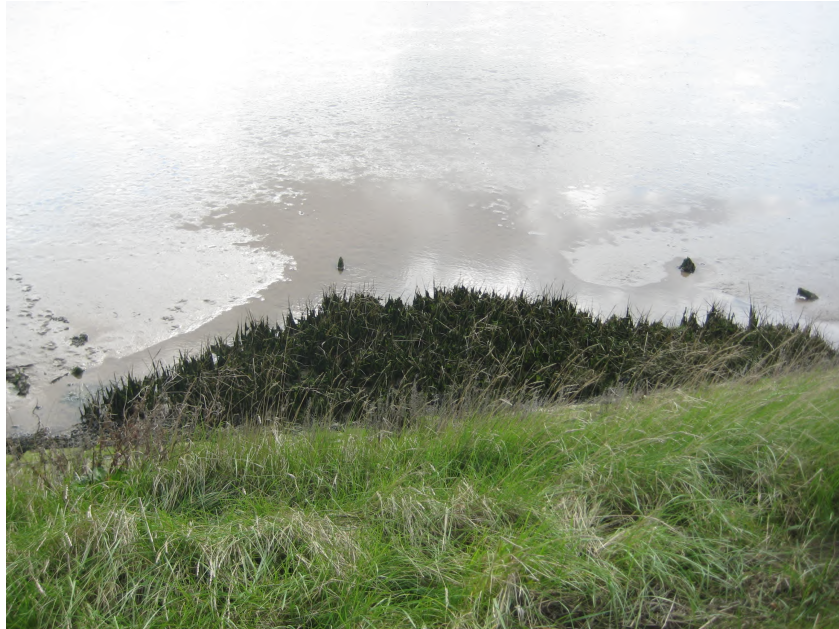
9. 395498 Outcrop of marram grass – no hardcore barrier. No saltings. Landward slope steep.

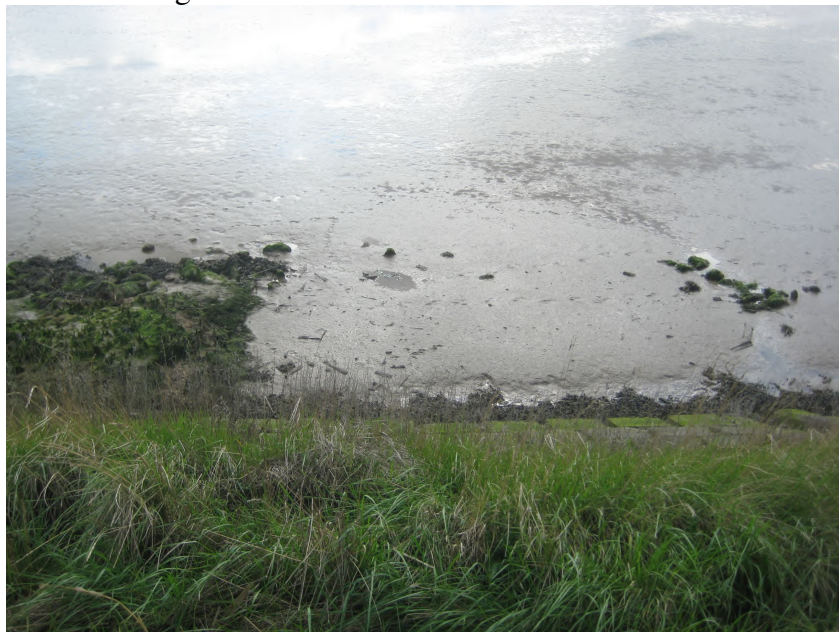
10. 395497 Start of marram grass no hardcore

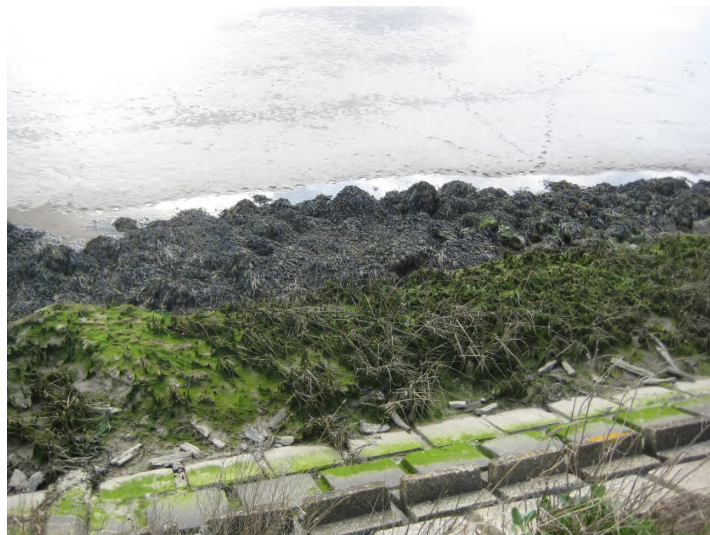
11. 396496 Marram Grass at toe difficult to establish whether this is alive hardcore baffle behind.

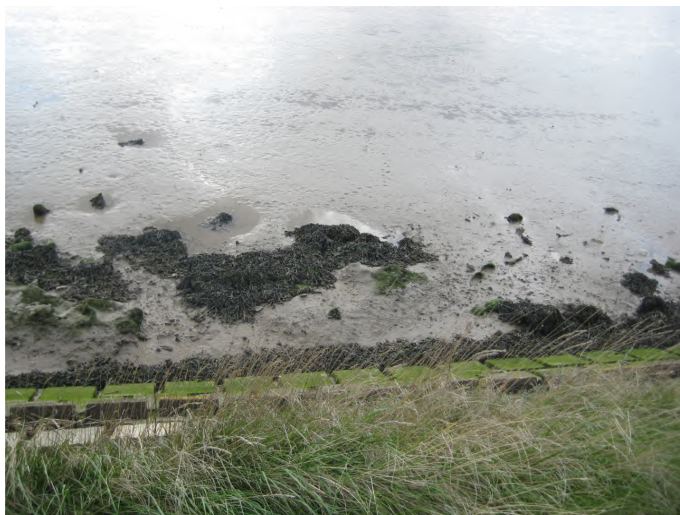
12. 3964955 By Sluice. Area with no hardcore defence.

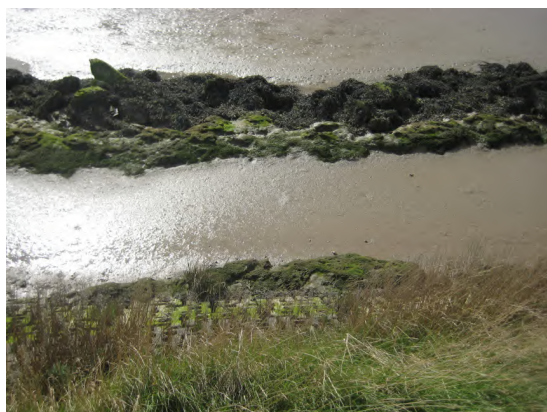
13. 397495 Close to Boundary with Greenwell estate. About 1m mud by toe in front of hardcore gathering seaweed. No saltings. Crest cut, wall side not mown. Landward slope good angle.
