# THE ALDE & ORE ASSOCIATION

## ALDE AND ORE ESTAURY RIVER ASSESSMENT 2015

<b>NAME: Amanda Bettinson/ Sally Walton</b>	<b>DATE OF INSPECTION</b>
<b>LOCATION: Flood Cell 3</b>	<b>17th APRIL 2015</b>
<b>FROM: Ferry Cottage to Chillesford Lodge travelling North</b>

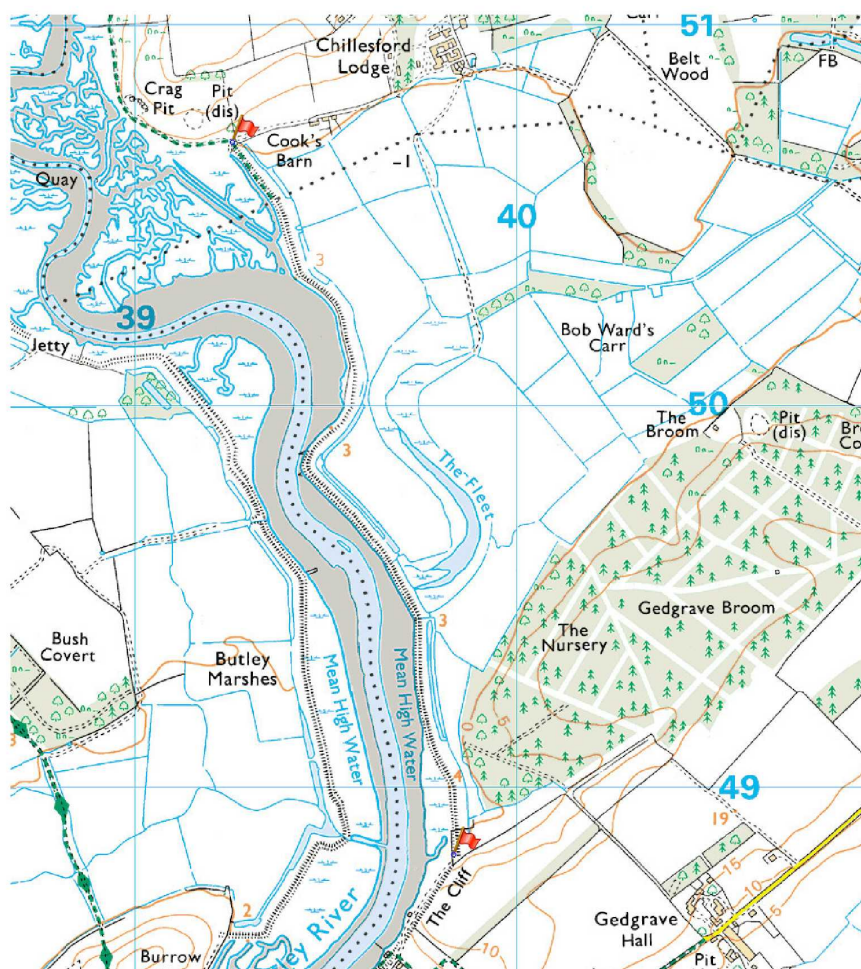
1. Because of the wire fence the river armour can only be seen from above.

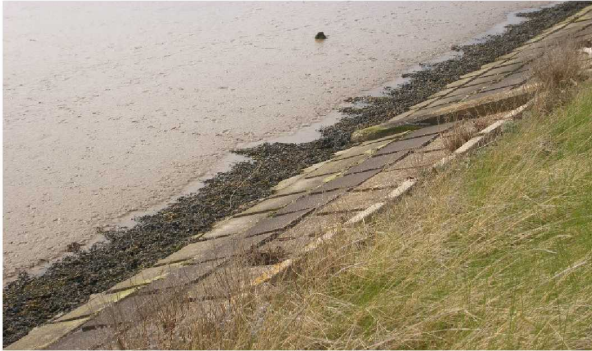
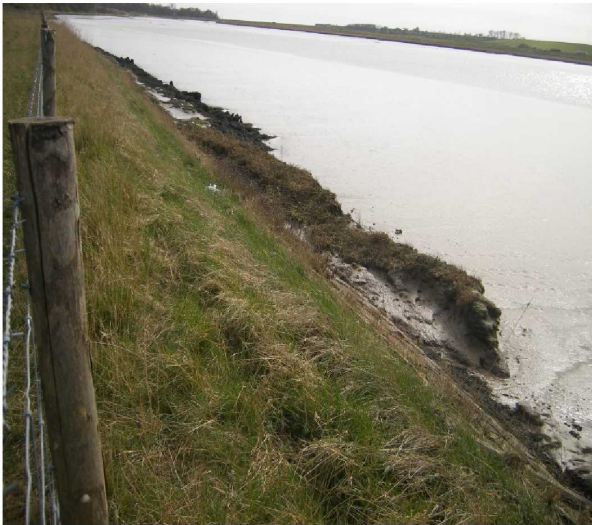
2. 396 498

Three metres of sunken Essex block

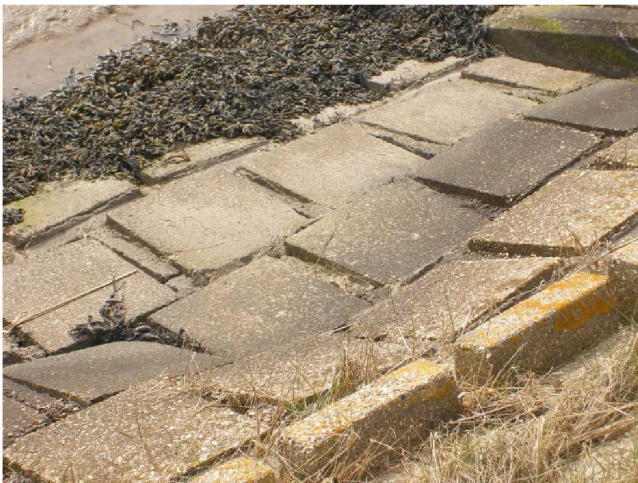
3. At 395 498

Three metres of sunken Essex block

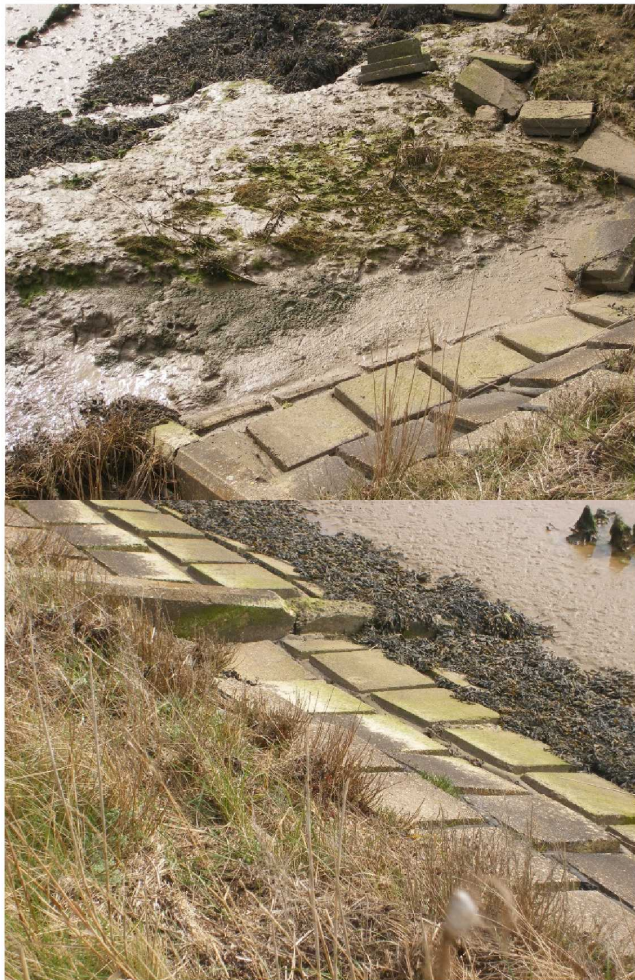
4. At 396 499

Grass growing up by old alder posts.

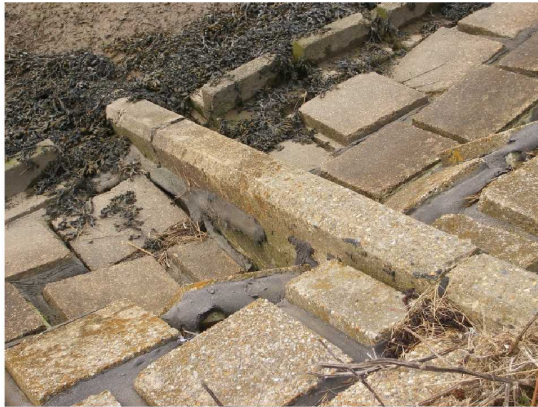
6. 394 502/3

Two metres of sunken interlocking blocks followed by sunken Essex block

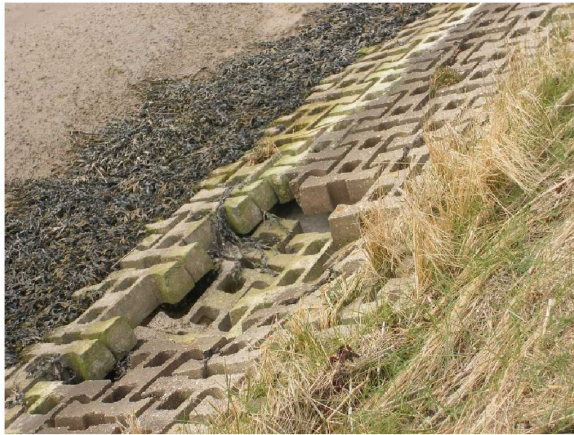
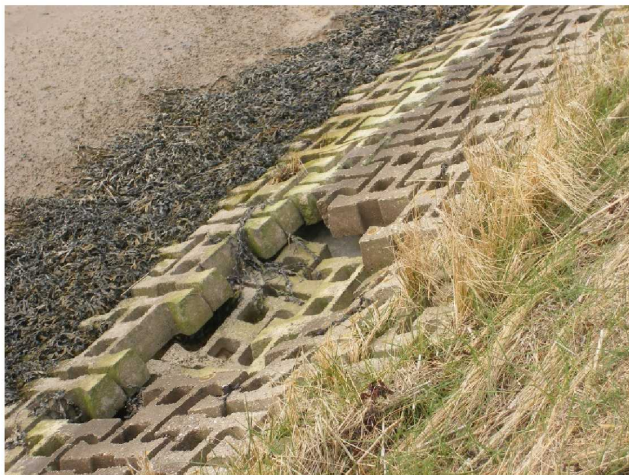
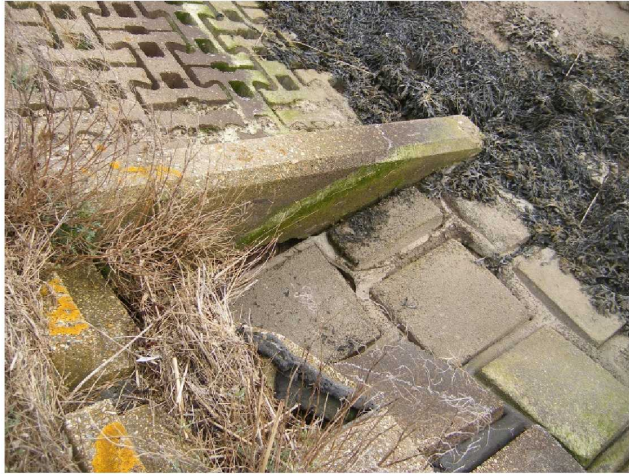
7. 393 503 (just before Saltings)

One Essex block worn away, and another 3 yards further along.

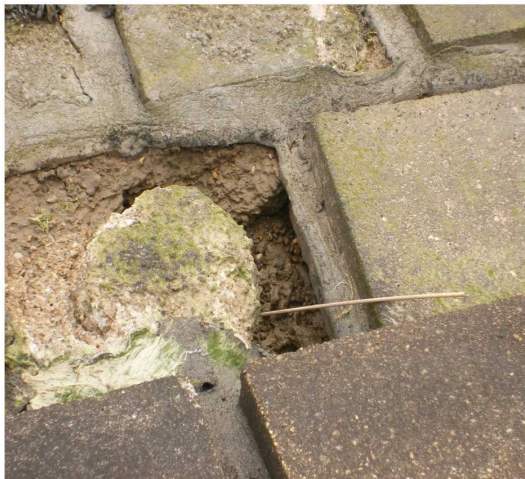
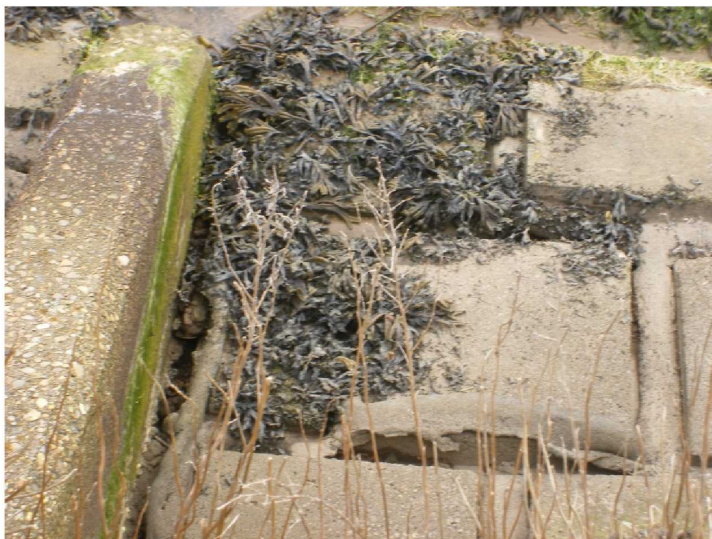
The tide line is 2/3 way up the wall.

Landward slope in the main is good, with some areas rather too steep. Potential areas for saltings should be assessed.
