# RDC survey 2013

## Flood Cell 4 – Orford Quay to Chantry Point

Section inspected by Frances Barnwell and Diana Paterson 3 May 2013

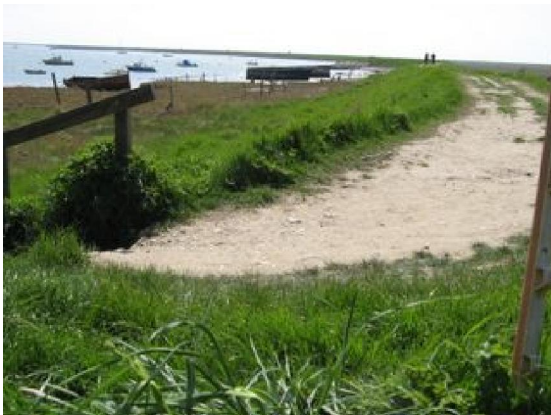
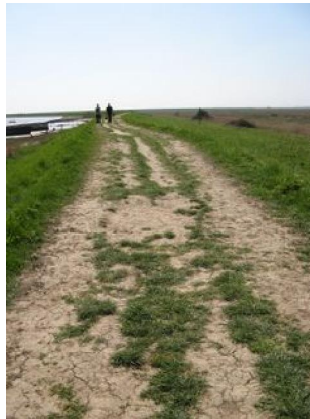
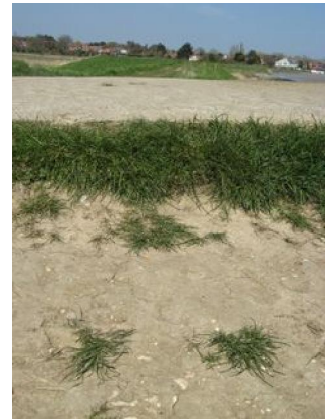
1. Although dry and hard when inspected, the path gets very muddy and slippery in wet weather. It has become eroded in areas of high usage between Orford Quay and the pillbox, especially by the steps near the quay (TM 4243 4950), the manhole cover (TM 4233 4912) and the first stile (TM 4241 4873).

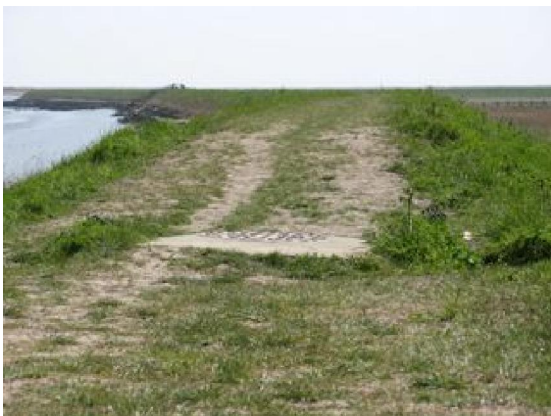
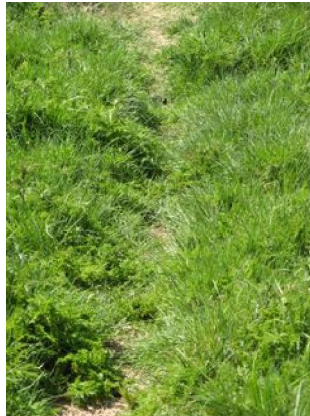
2. There is a significant dip either side of the manhole cover (TM 4233 4912) and where a path has formed down the inland bank

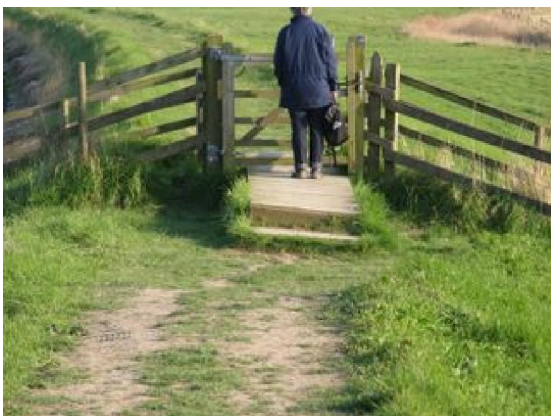
3. There is a significant dip by the stile (TM 4241 4873).

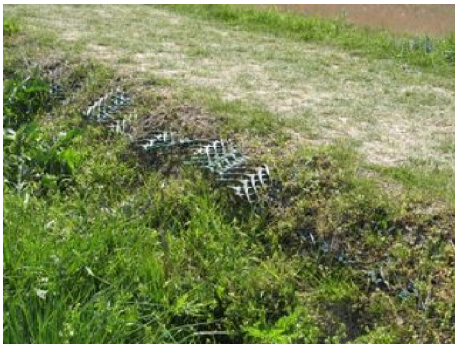
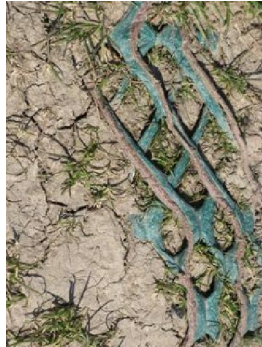
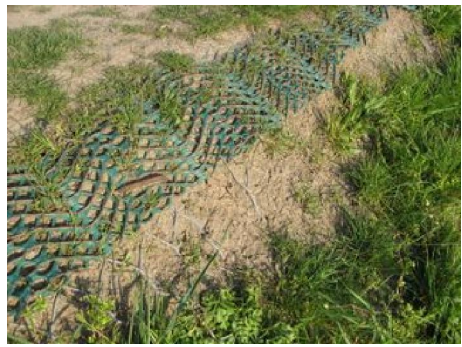
4. The plastic reinforcement has become exposed in a number of places, e.g. at TM 4237 4891

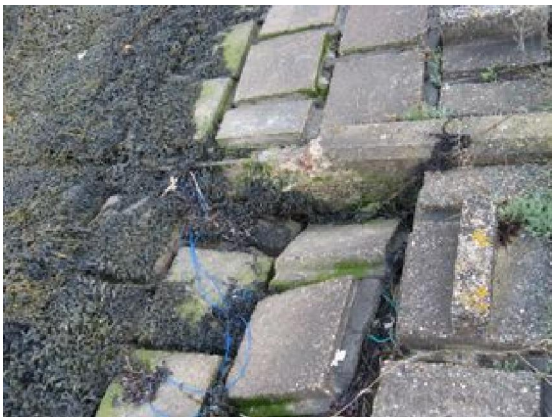
5. Small revetment collapse and an exposed steel reinforcing bar at the stile (TM 4241 4873). This was reported in 2012.

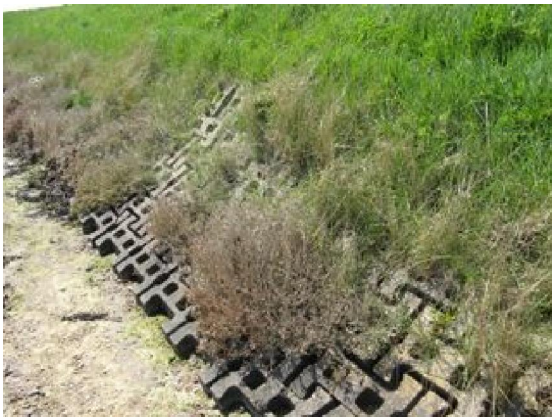
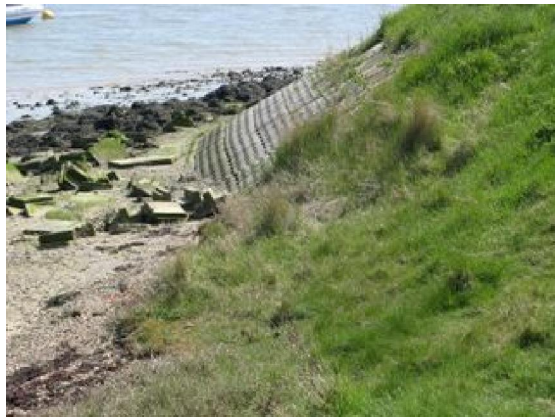
6. Otherwise, the armour appears to be in reasonable condition.
