THE ALDE & ORE ASSOCIATION

ALDE AND ORE ESTUARY ASSESSORS' REPORT

NAME: Andrew & Sue McDonald	DATE OF INSPECTION 3 rd April 2014
LOCATION: Flood Cell 4.1	MARCH equinox
Area of Assessment Butley River and Gedgrave Marsh TM 39677 48583 to 41591 48472 OS Explorer 212

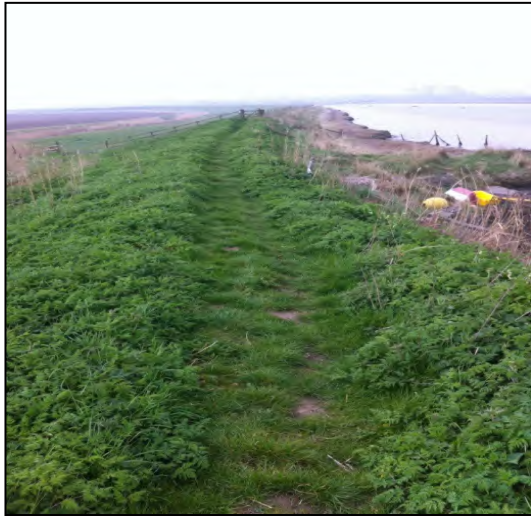
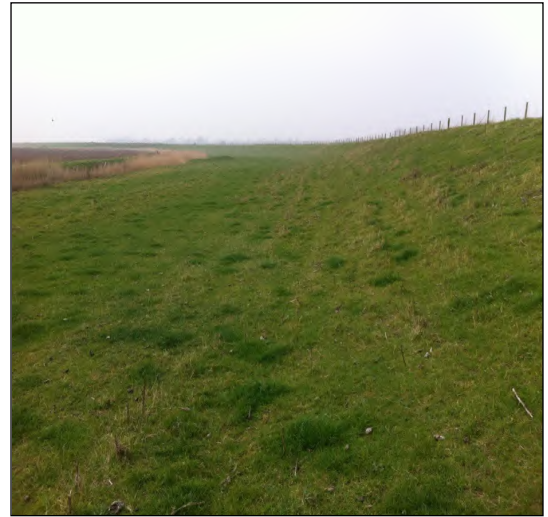
General view of pathway at 397486, start of inspection by Ferry Cottage. Some slightly bare patches, evidence of past slippage here and there, but generally well grassed and no signs of any major damage over the winter; general view of landward wall at same location (397486) looking SSE); good grassing, low slope, some cracks evident but all grassed over.

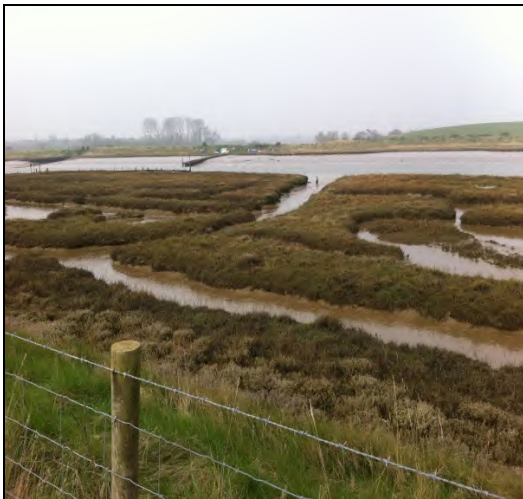
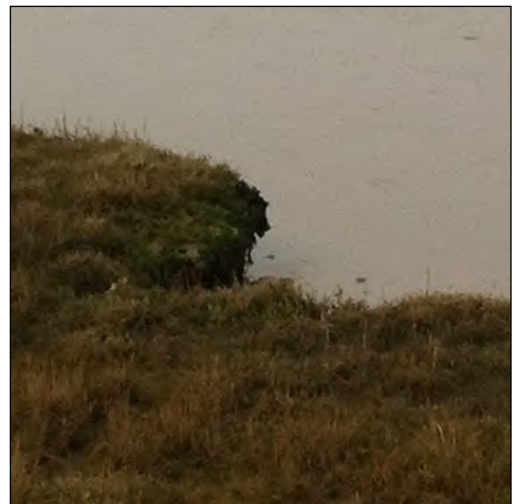
Saltings opposite Butley Ferry jetty (395484), general view and detail showing some overhang and undercutting.

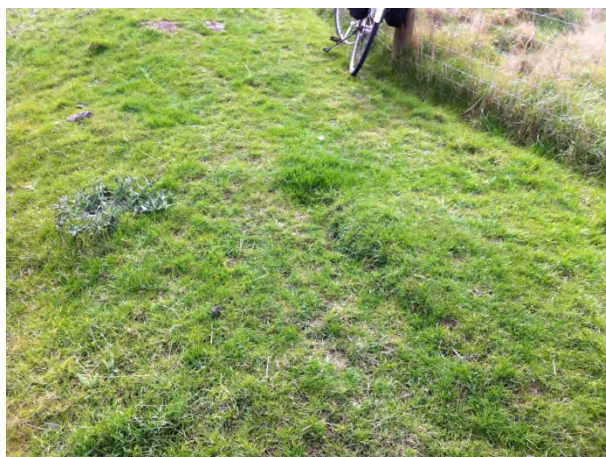
394482 – old cracks on pathway now grassed over but showing some signs of wear

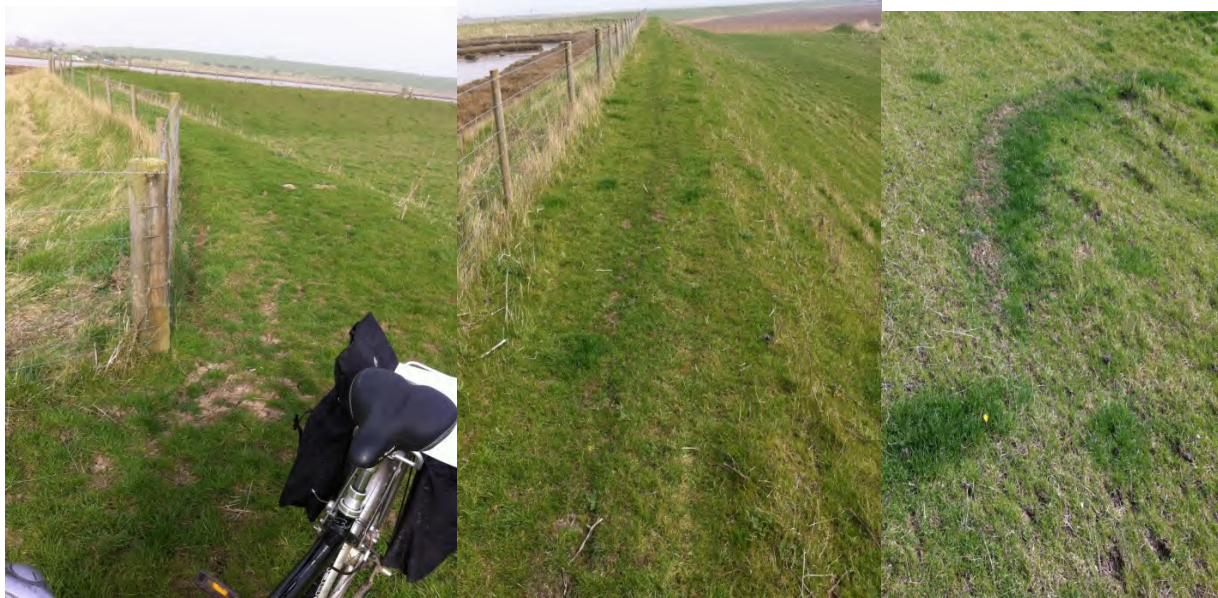
Cracking on path and under fence at corner just past ferry (394481); worn pathway at same point, and horseshoe shaped slippage on landward side at 394479; the pathway along here shows considerable signs of wear, but no recent slippage.

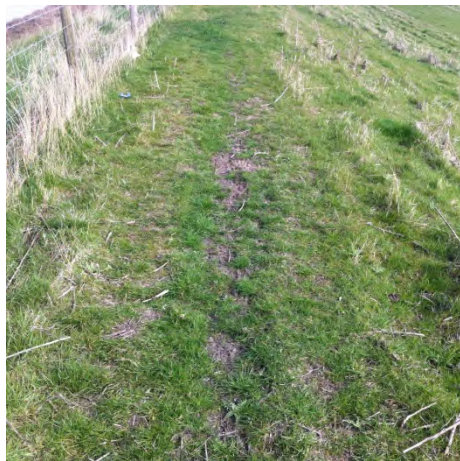
More cracks and evidence of past slippage along the pathway – these are at 394478 and 393476 respectively.

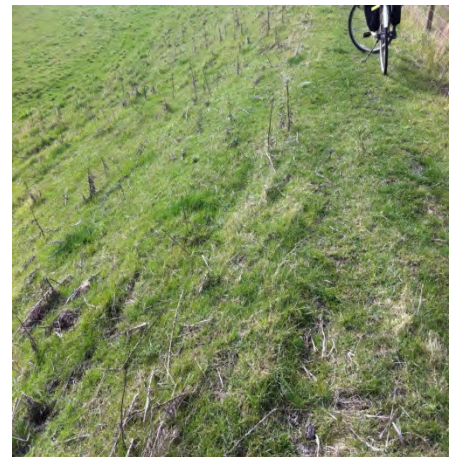
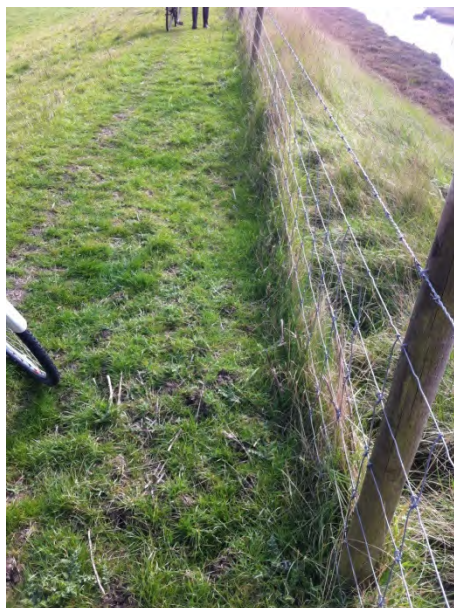
Gulleying underneath the fencing along this section (397473), and about 14 fenceposts now loose and vulnerable (see detail below at 399473 – holes and cracks appearing under fence line)

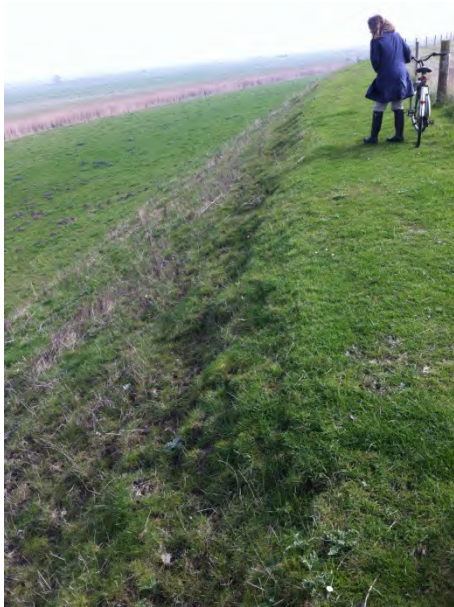
About 25m of slippage at 400474, grassed over and presumably a previously repaired section

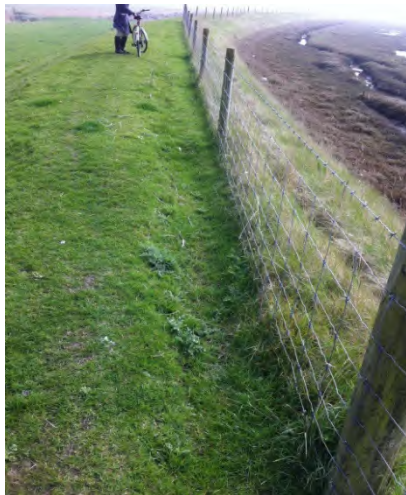
On the other side of the track, extensive and quite deep gulleying under the line of fencing has loosened many of these posts.

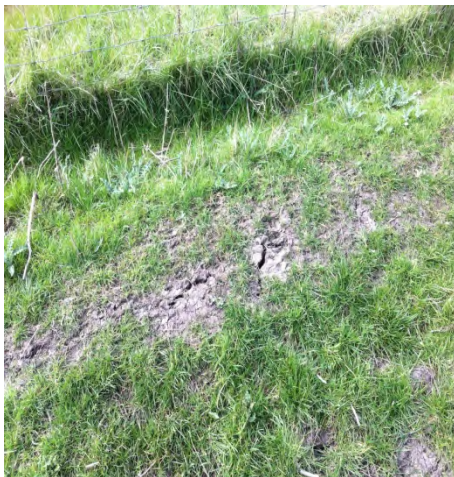
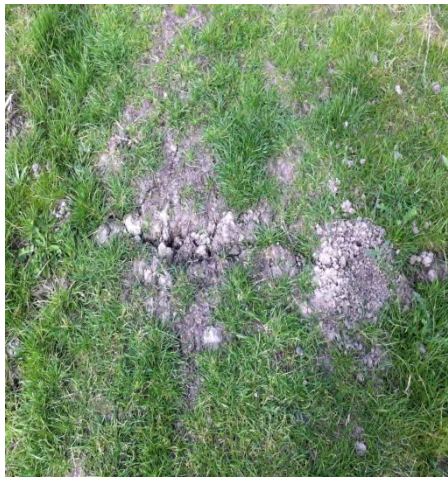
At 402473, bare earth and worn pathway, with some transverse as well as longitudinal cracks. Given the amount of rain over the winter this has dried out very quickly – the cracks are deep in places. This was the area repaired in ? 2012.

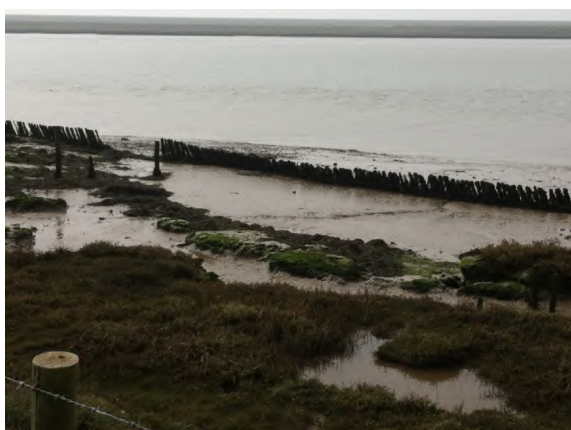
Saltings at Inset Point, for comparison with 2013 photographs – note debris carried above 2ft line

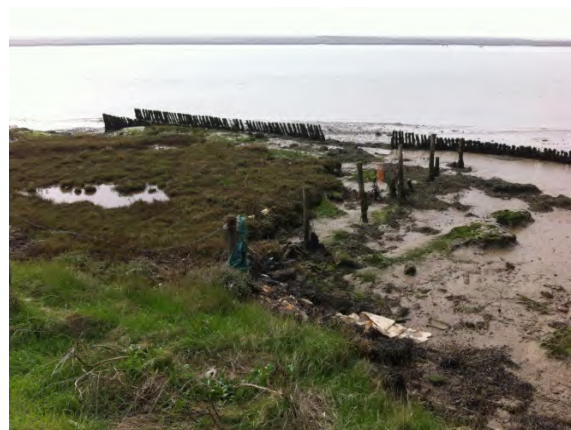
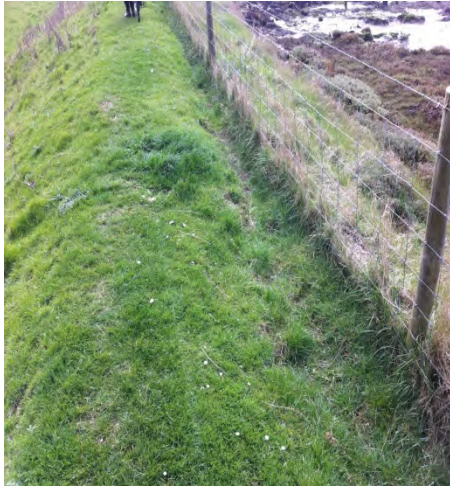
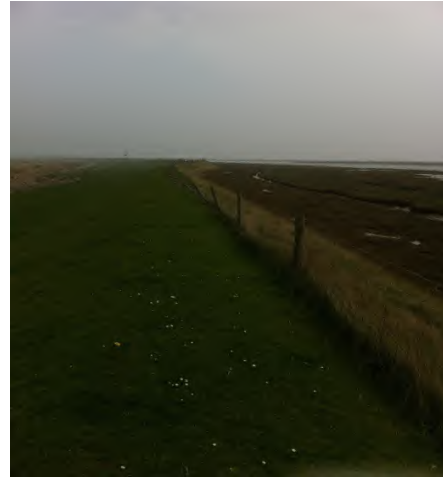
More gulleying under line of fenceposts, 406471. Further along this section (at 407471), the fence has collapsed and is lying down – see rather poor photo above right

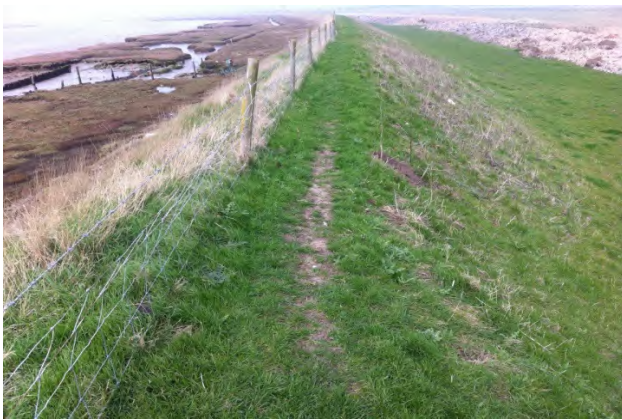
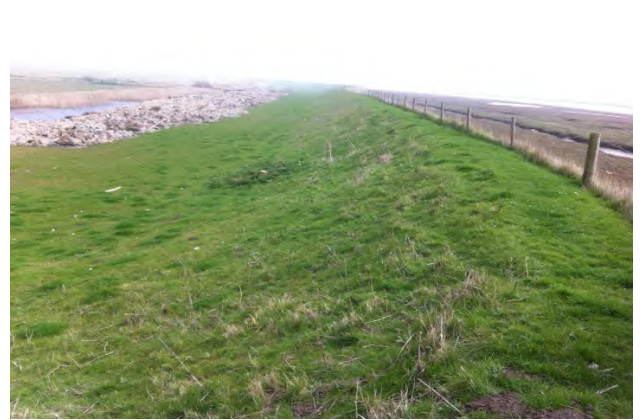
More worn pathway and bare earth at 406471, looking back along the pathway, and a general view along this section showing the dredged clay/spoil, looking NE

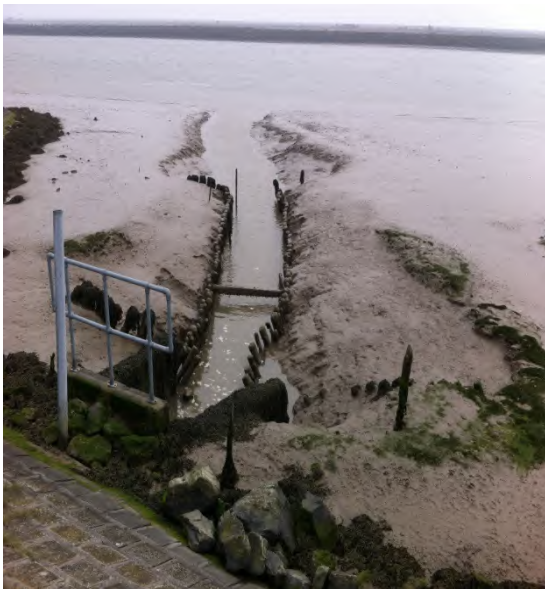
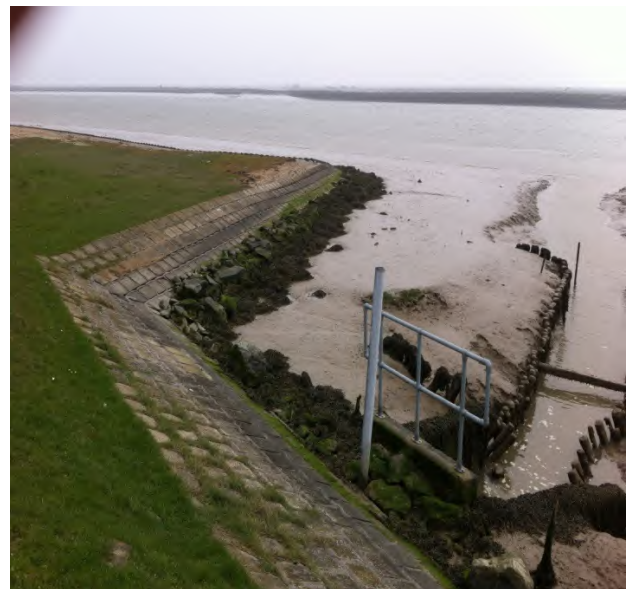
Line of stakes collapsing in drain channel; revetment in fair condition at 410474

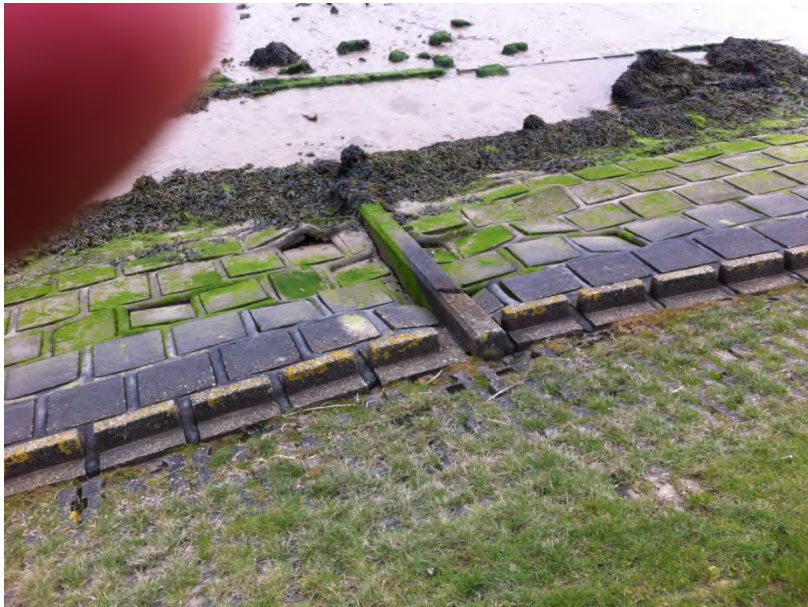
Revetment buckled and collapsing at 411476

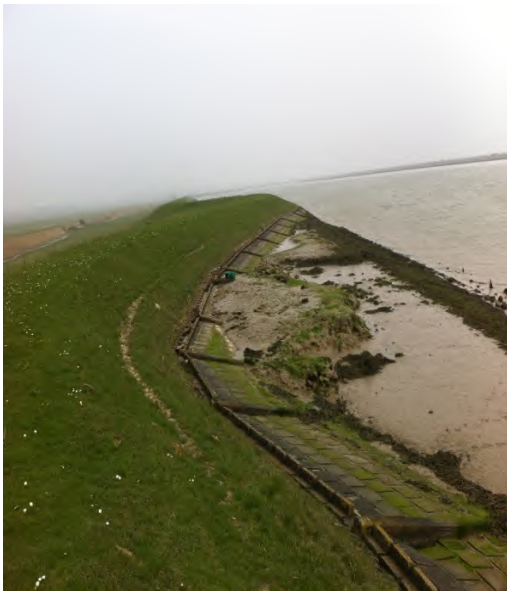
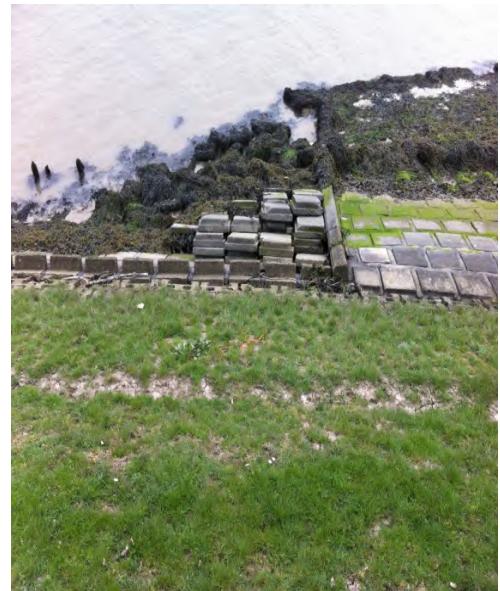
Line of bare earth above revetment at 411476; the same 'pathway' just above revetment slabs piled up at the same spot.

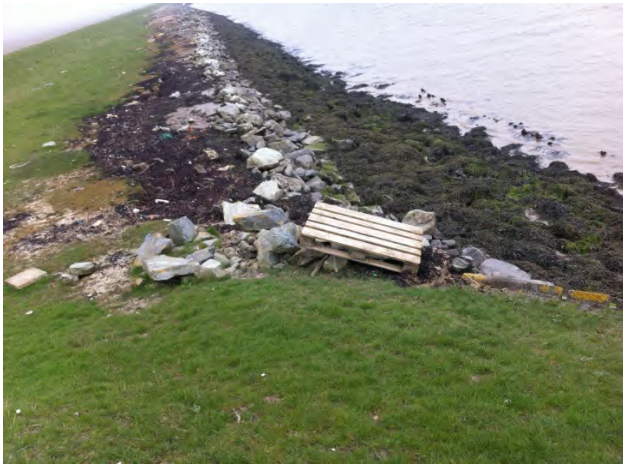
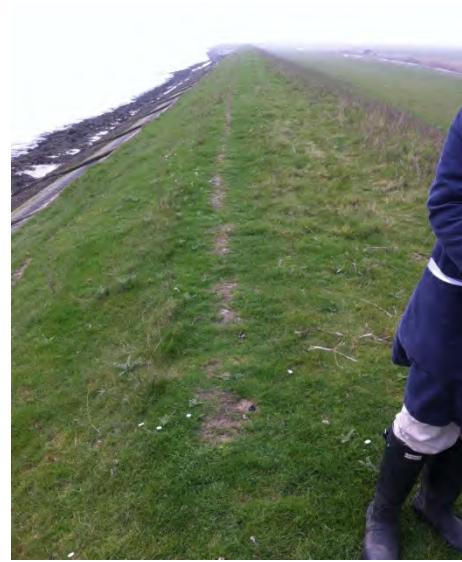
Debris piled up above tideline on the turn towards Chantry Point (411476); and narrowed and worn pathway just beyond at 413480, looking back down the path.

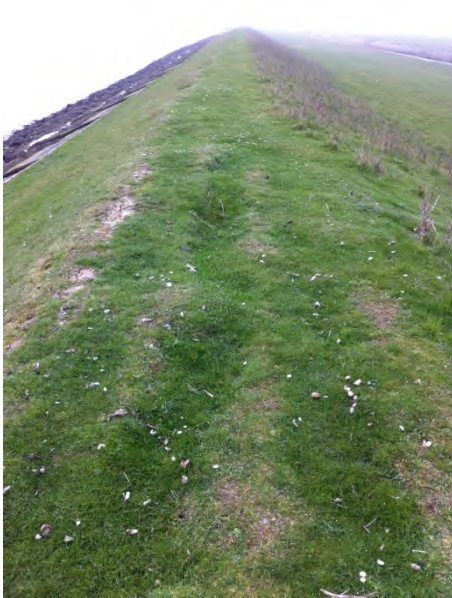
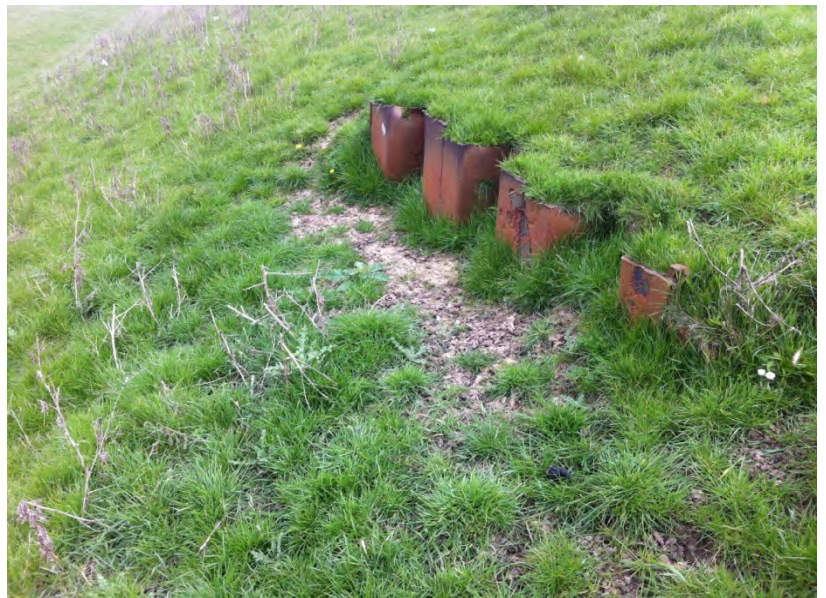
More cracked and slipped pathway at 414482; and detail of repair on seaward side at 414483.

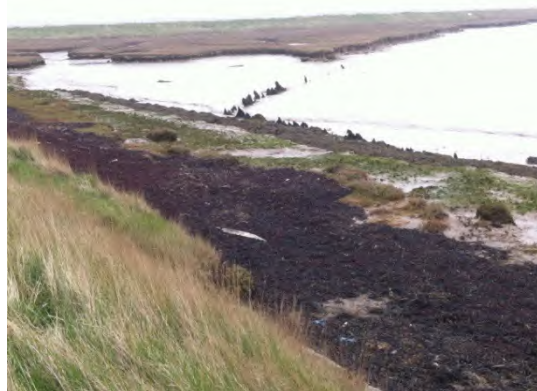
Saltings general view at Chantry Point, 416484
