THE ALDE & ORE ASSOCIATION

ALDE AND ORE ESTUARY ASSESSORS' REPORT

NAME: Andrew & Sue McDonald	DATE OF INSPECTION 5th April 2015
LOCATION: Flood Cell 4.1	MARCH equinox
Area of Assessment Butley River and Gedgrave Marsh TM 39677 48583 to 41591 48472 OS Explorer 212

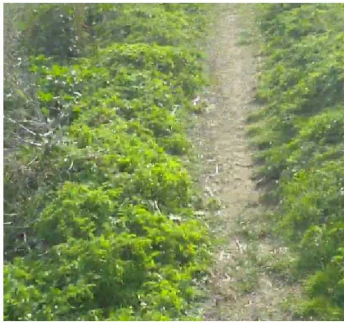
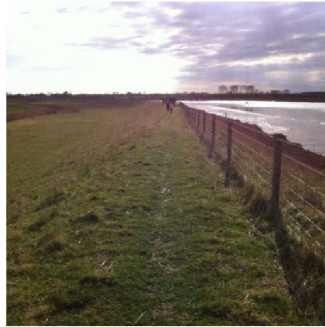
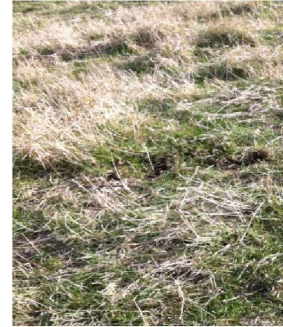
General view of pathway at 397486, start of inspection by Ferry Cottage. Bare and pitted here and there (0.5" rain since March 1st!), some evidence of past slippage and a few cracks on inward side, but no signs of major damage since last inspection; landward wall in good order with good grassing, low slope, some cracks evident but all grassed over.

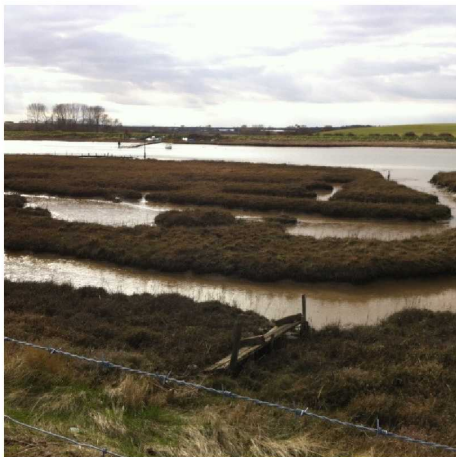
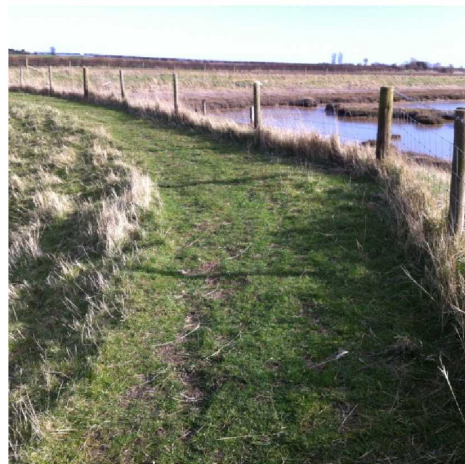
Saltings opposite Butley Ferry jetty (395484), general view – no changes since last year; worn pathway (396485) a little further along.

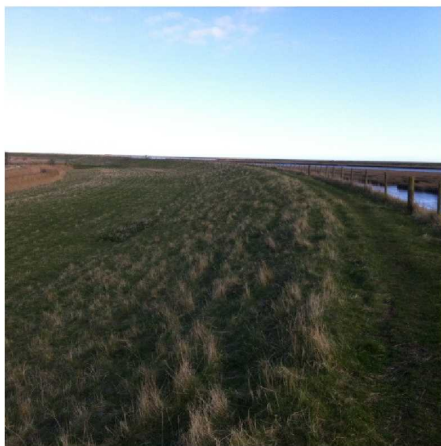
(394474) – Landward side of wall opposite Butley Ferry, all in good order. Some gulleying underneath the line of the fenceposts at this point, but no worse than last year. Pathway worn in places but no concern.

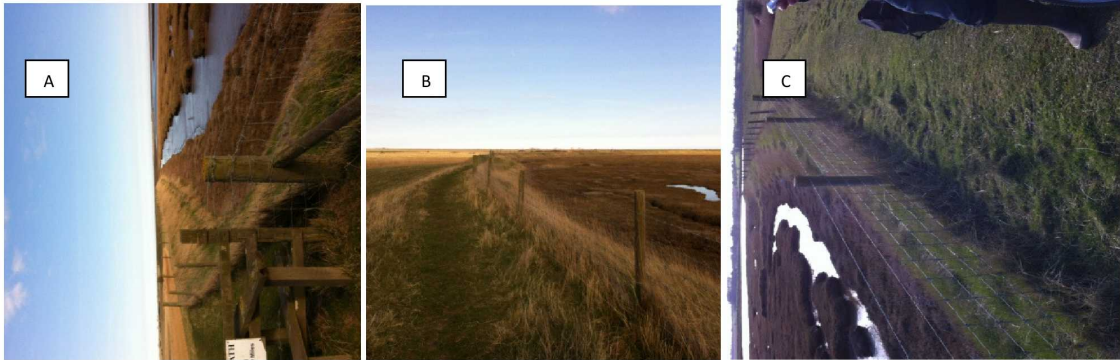
(A) River wall at 394474; no damage or debris visible; (B) Path well worn in this area (398473), but no great change from last year's photos (see below). The fenceposts that were loose and lying over in 2014 have been re-secured (C) path at 400473 – continued slumping by posts, and some evidence of slippage on wall facing river.

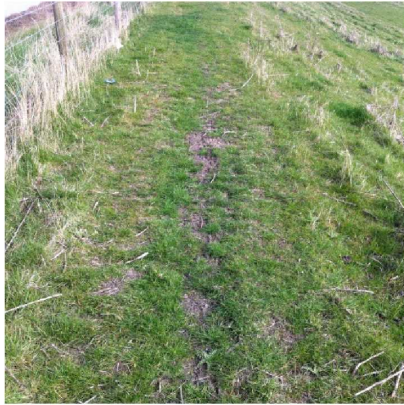
[2014]
More cracks and evidence of past slippage along the pathway – these are at 394478 and 393476 respectively.

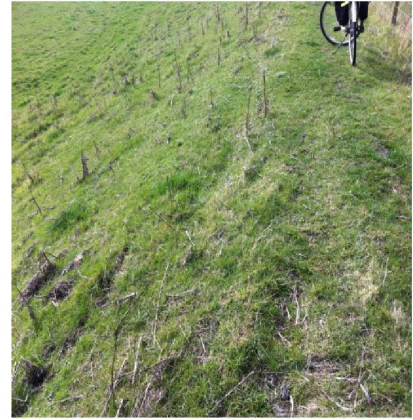
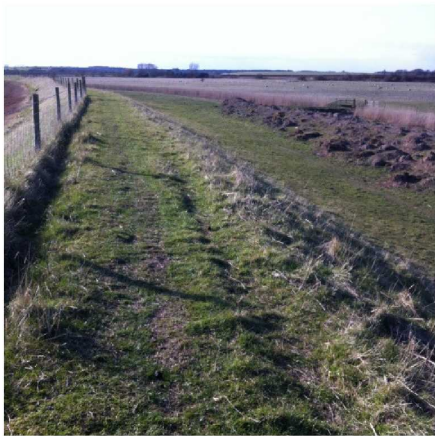
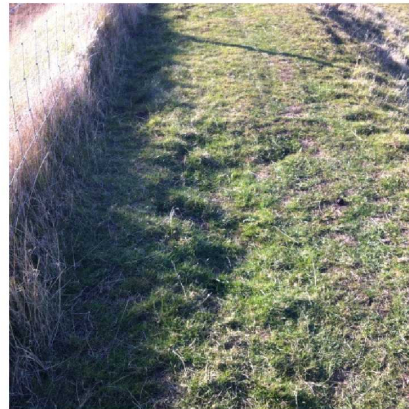
Looking back along the same section this year. Incidentally, the grass along this section is very noticeably close-cropped this year.

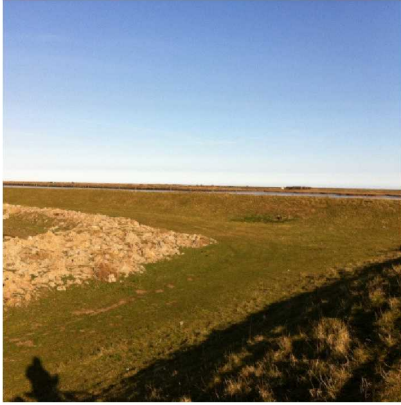
Looking along the landward wall at 405471;

..and at the saltings and stakes at Inset Point on the outside of the river bend – no real change visible since 2013 photos.

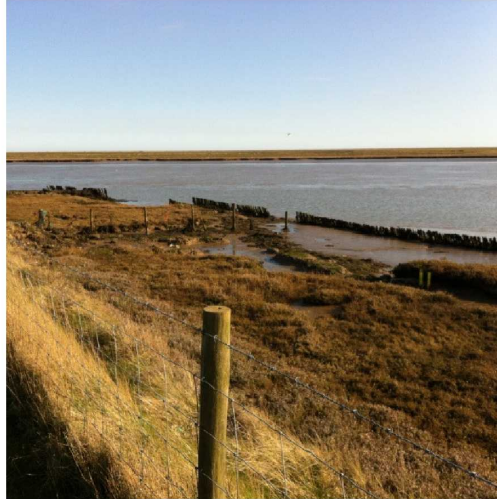
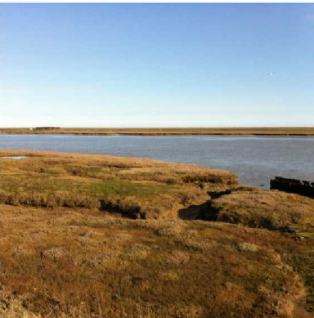
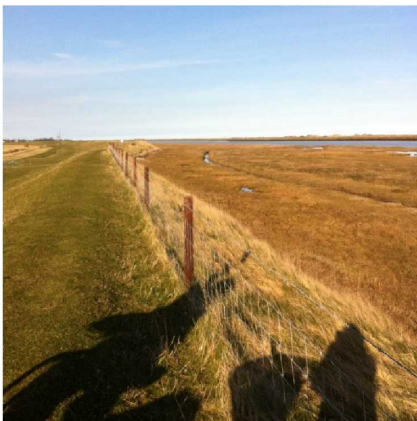
Pathway at 407472, and -

slightly along line of fenceposts (which have been repaired and maintained since last year) but no major damage evident over last winter.

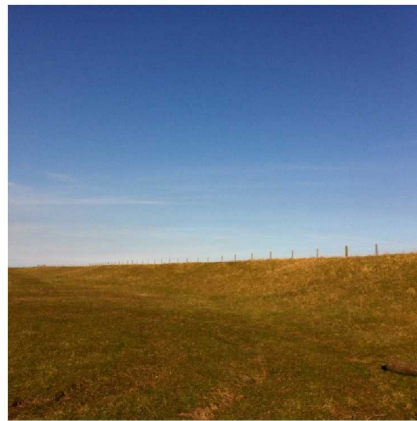
Landward wall at same point – pathway is slipped

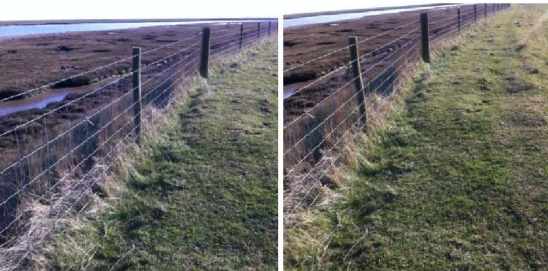
Pathway condition – two more photos at 407 472/ 409 474, looking back down the track. Wear and tear (mainly animal?) and gulleying under the line of posts. No serious damage apparent.

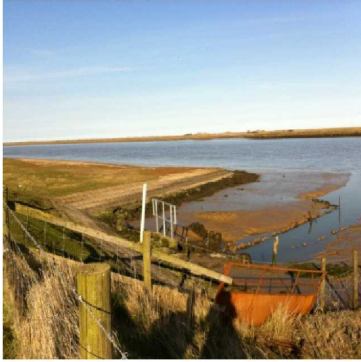
Drain channel condition largely unchanged since last year (stakes have almost disappeared though). Revetment in place at this point and no signs of damage – fair condition.

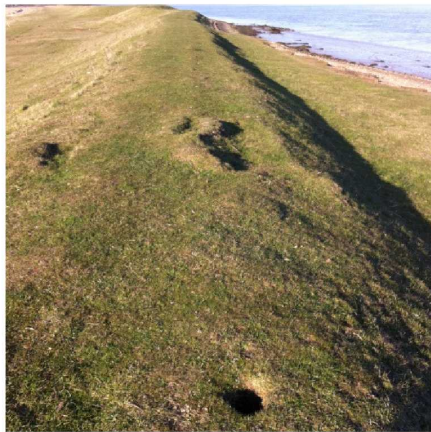
Damage to pathway a little further along - animal tracks, damage and slippage (?)

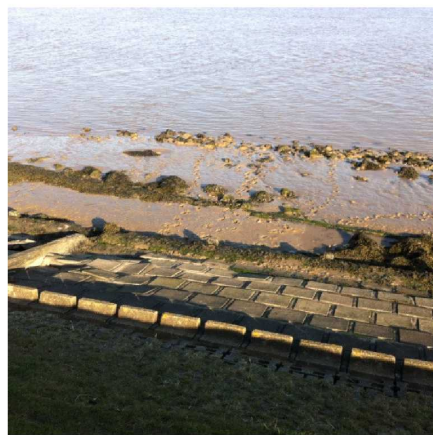
Close-up showing buckling and damage – but not much worse than in 2014

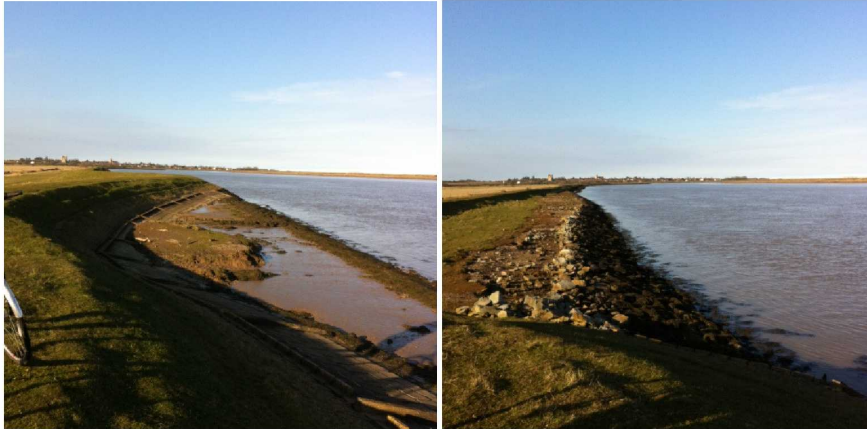
Condition of revetment and river wall at 411 476, looking north towards Chantry Point. Fair condition and no obvious changes since 2014. The path is better grassed here this year.

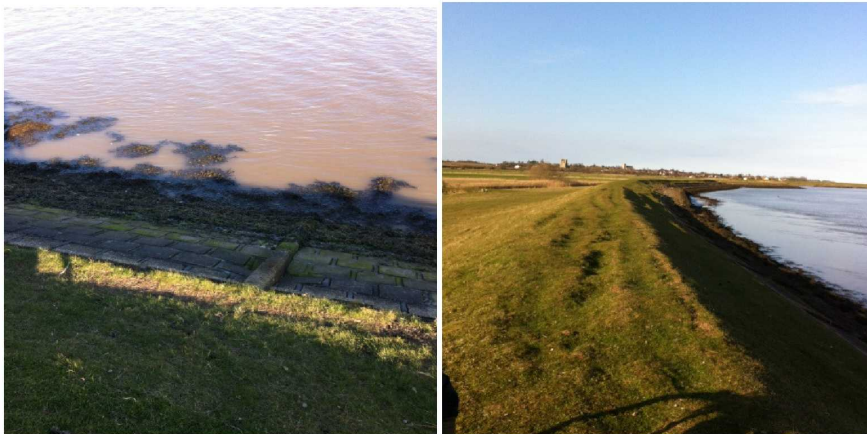
Revetment at 413 479, slight buckling, otherwise in fair condition along this section of wall. The pathway is lumpier than in 2014, and the usable path has narrowed considerably, although well grassed all over, including landward side.

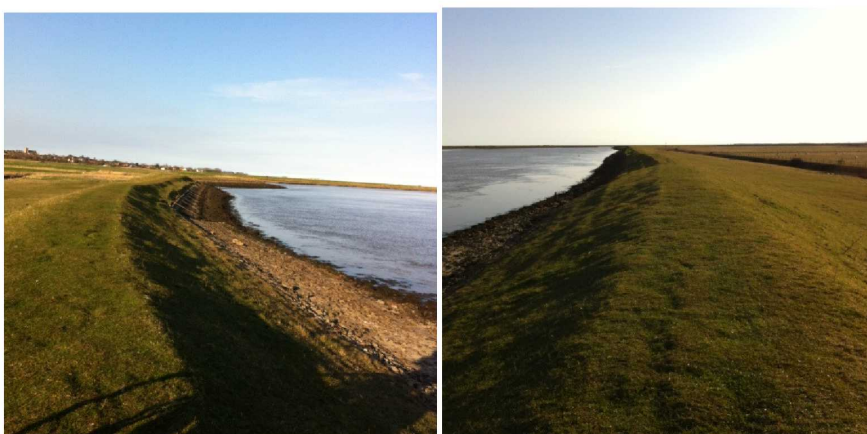
Final section of revetment, covered with sand and shingle but in good condition where visible. The path is a little better in this area (414 483), and well grassed; landward slope is in good order.

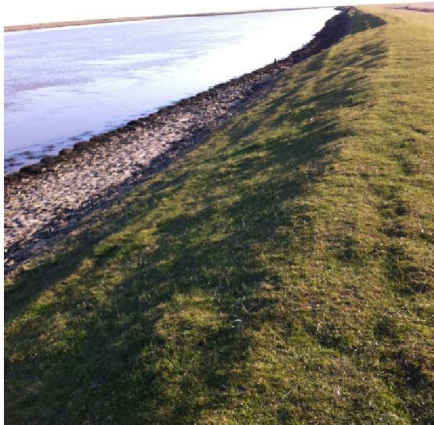
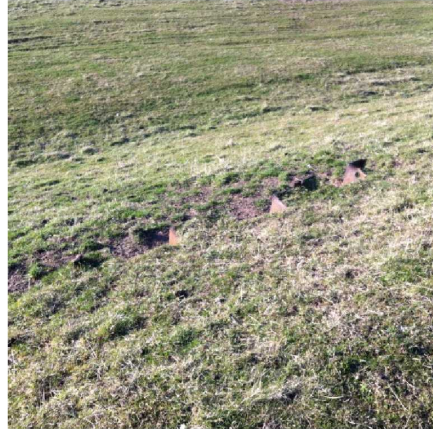
Slight slippage on river wall slope, and detail of previous repair on landward slope. No changes in this section (415 483) since last year, unless there have been minor repairs to revetment??

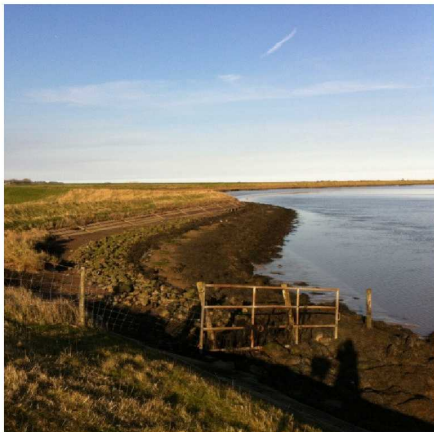
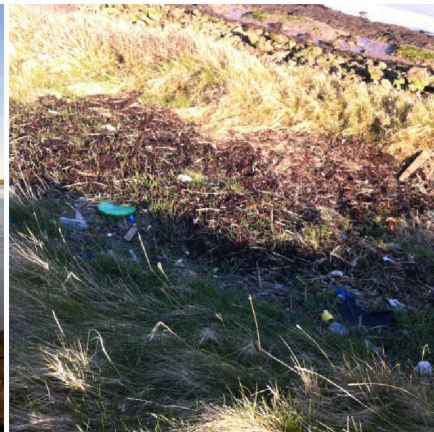
River wall and revetment at 415484

Debris above 2ft line at 416 485
