ALDE AND ORE ESTUARY ASSESSORS' REPORT

NAME: Frances Barnwell and Diana Paterson	DATE OF INSPECTION 3 rd April 2014
LOCATION: Flood Cell 4.2	MARCH/SEPTEMBER/TIDAL EVENT
Area of Assessment: Orford Sailing Club to Chantry Point	Send to

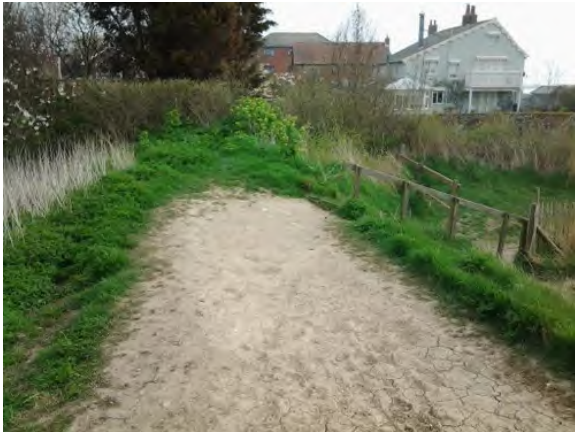
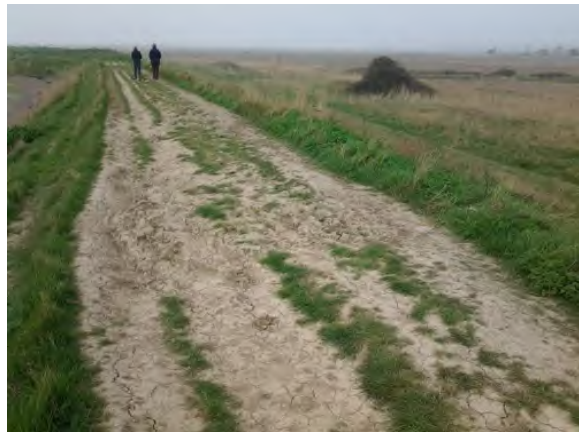
1. Although dry and hard when inspected, the path gets very muddy and slippery in wet weather. It has become eroded in areas of high usage between Orford Quay and the pillbox, especially by the steps near the quay (TM 4243 4950), the manhole cover (TM 4233 4912) and the first stile (TM 4241 4873).

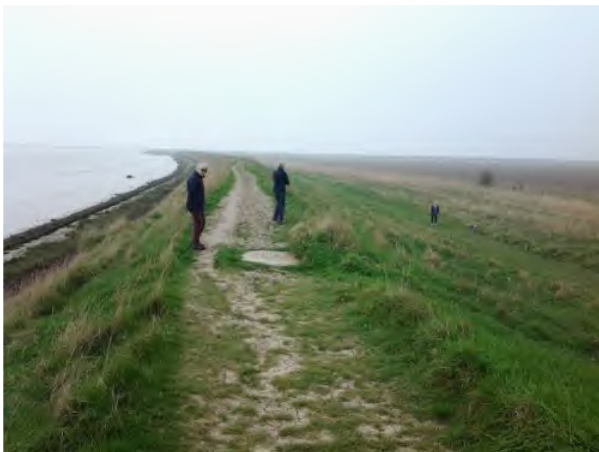
2. There is a significant dip either side of the manhole cover (TM 4233 4912) and where a path has formed down the inland bank

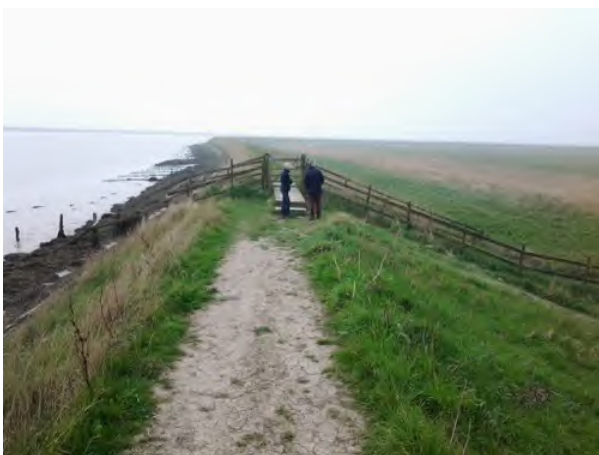
3. There is a significant dip by the stile (TM 4241 4873).

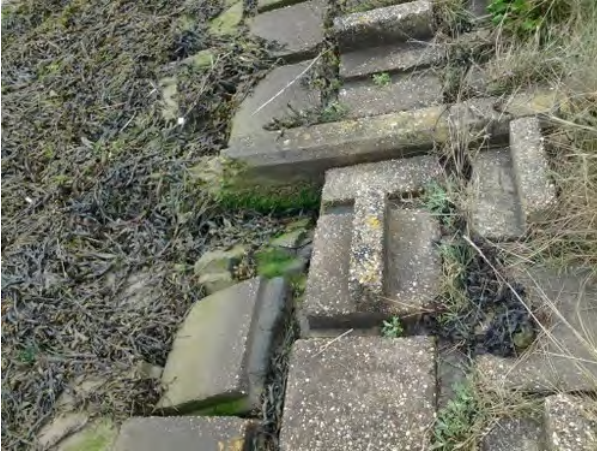
- 4 Small revetment collapse at the stile (TM 4241 4873). This was reported in 2013.

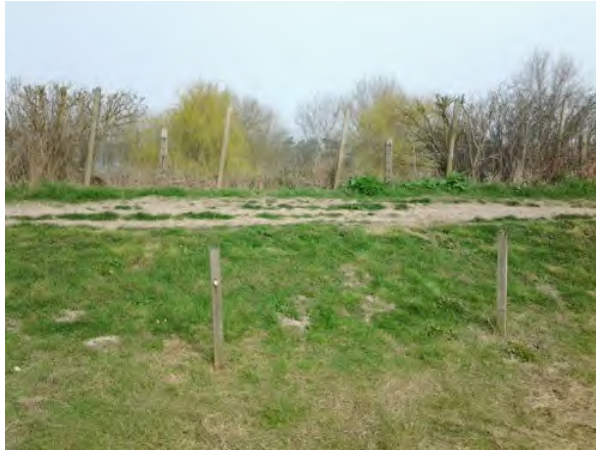
5. We were also asked to inspect the river wall between Orford Quay and Orford Sailing Club. There is evidence of slump to seaward by the Sailing Club dinghy park (TM 4266 4963).

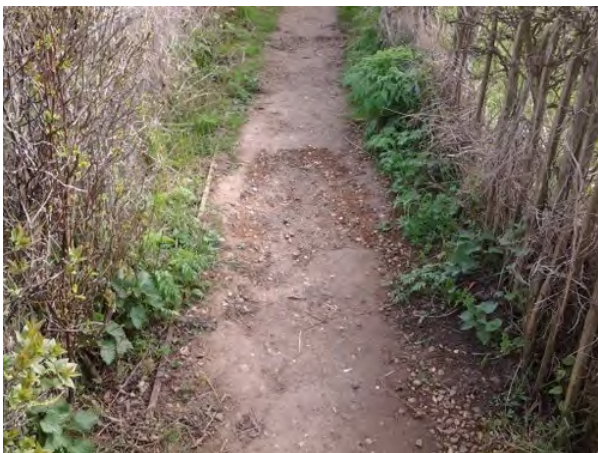
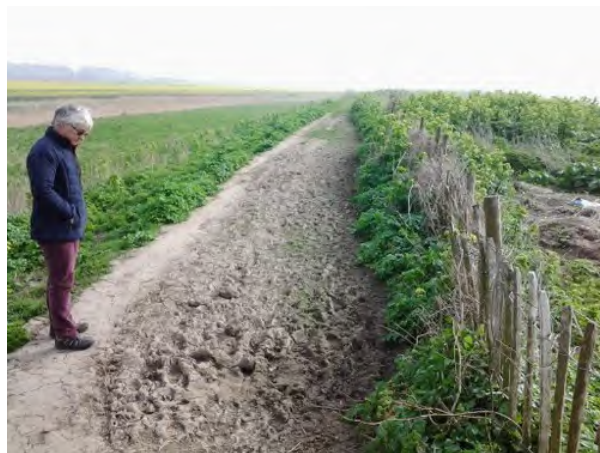
6. The path east of Orford Sailing Club (by The Pavilion) shows damage to the hoggin surface and gets very muddy when wet (TM 4266 4963).
