ALDE AND ORE ESTUARY ASSESSORS' REPORT

NAME: David and Frances Barnwell	DATE OF INSPECTION 7 th April 2015
LOCATION: Flood Cell 4.2	March Equinox
Area of Assessment: Orford Sailing Club to Chantry Point	Send to

River wall inspected

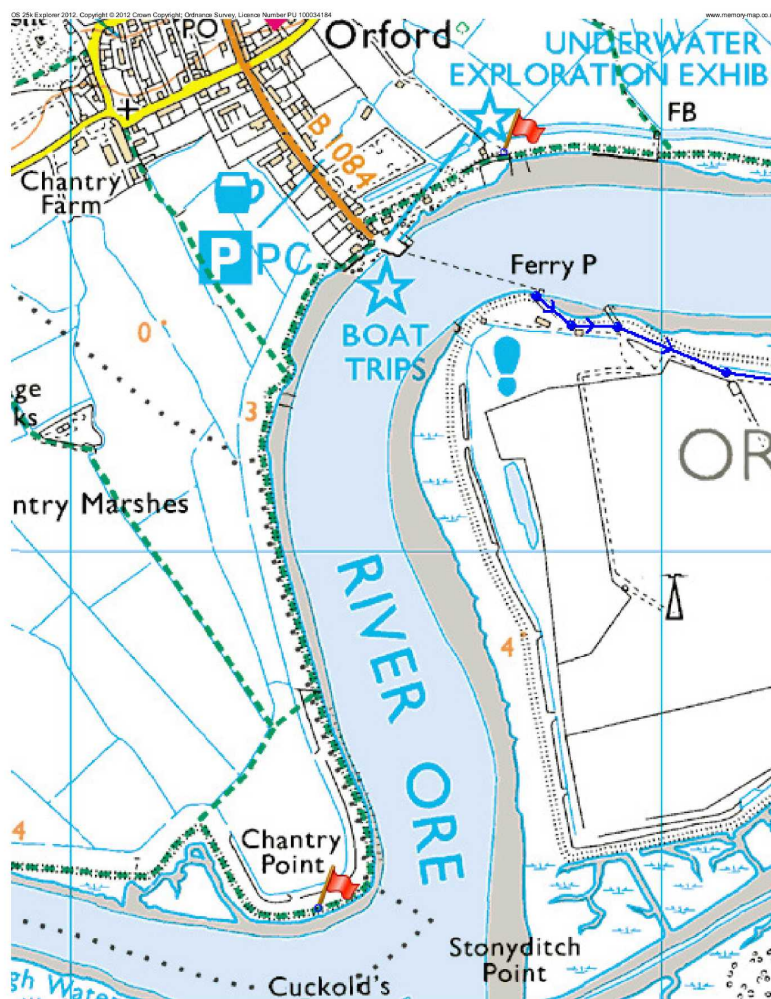
1. The path east of Orford Sailing Club (by The Pavilion) gets very muddy when wet and shows damage to the hoggin surface (TM 4266 4963).

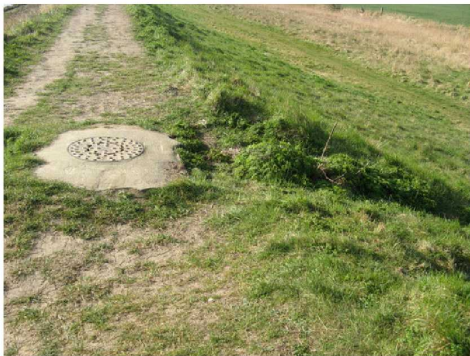
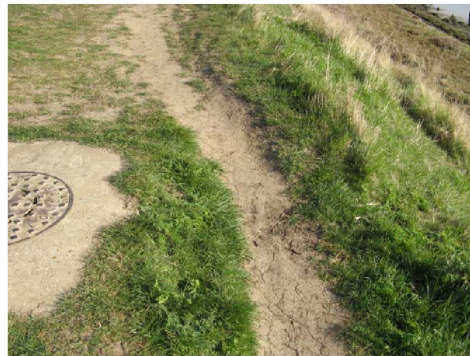
5. This year we stretched a taut string across in order to measure this dip. This shows that dip is 30cm lower than the adjacent river wall. The path to seaward is 45 cm lower.

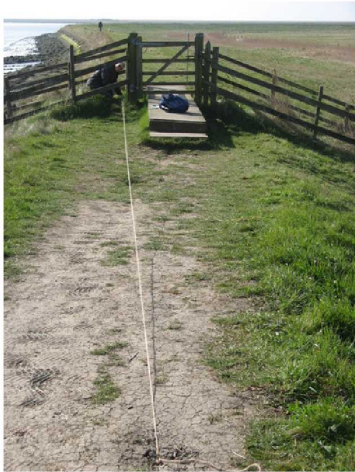
8. Small revetment collapse at the stile (TM 4241 4873). This was reported in 2013 and 2014 but has not changed since then (this is the April 2014 photo).
