ALDE AND ORE ESTUARY ASSESSORS' REPORT

NAME: Simon Reid Roger Baxter Rufus Gilday	DATE OF INSPECTION: April 2015
LOCATION: Flood Cell 4.3	March Equinox
AREA OF ASSESSMENT: Pump House on West Bank to Orford Town

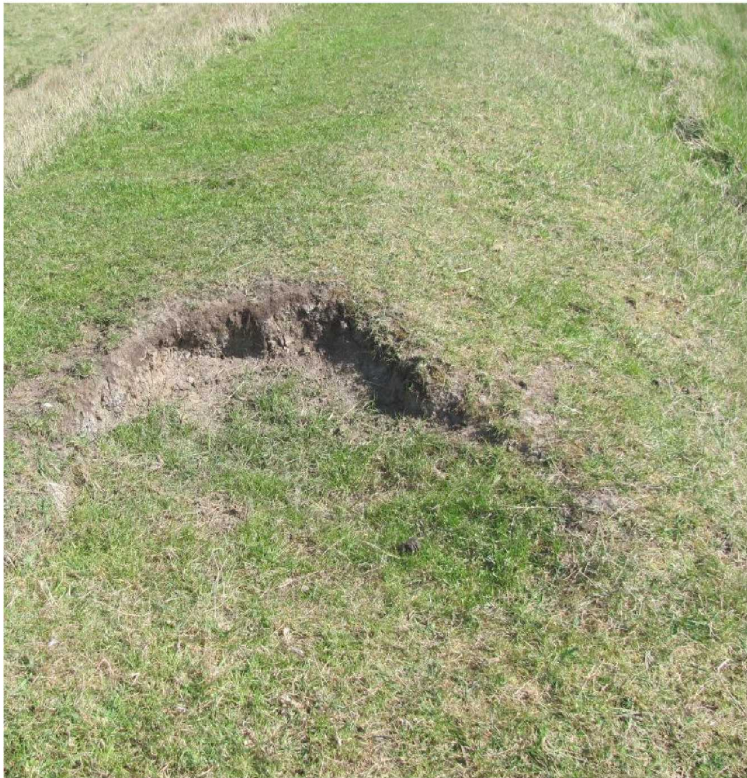
Hole on wall top at 449 524. No change since last year

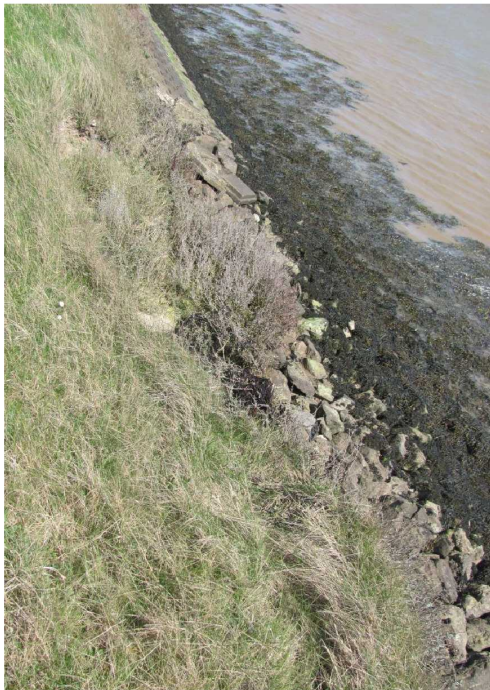
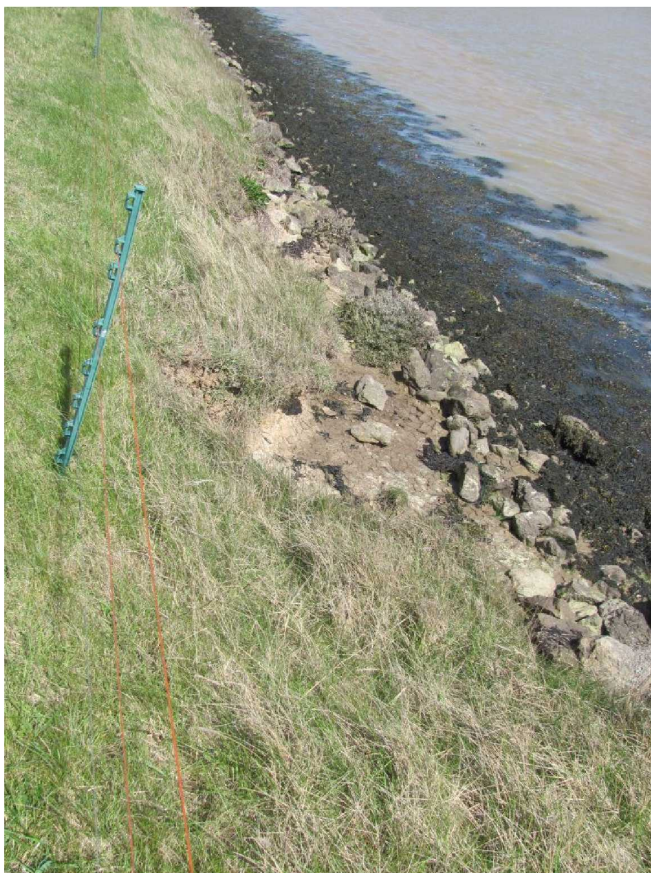
Revetment erosion at 443 518
