THE ALDE & ORE ASSOCIATION

ALDE AND ORE ESTUARY ASSESSORS' REPORT

NAME: Roger Baxter, Sally Jones, Mike Steen	DATE OF INSPECTION: 31 March 2014
LOCATION: Flood Cell 4.4	MARCH EQUINOX
AREA OF ASSESSMENT: Pump House to Chapmans Creek 453536-451552

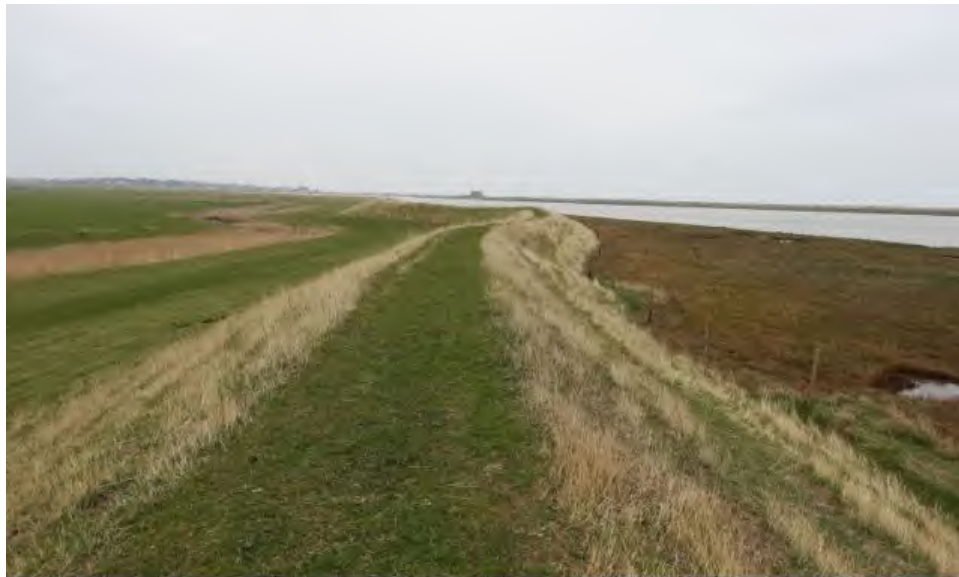
A typical view of the terrain at 456537 looking towards the Martello Tower.

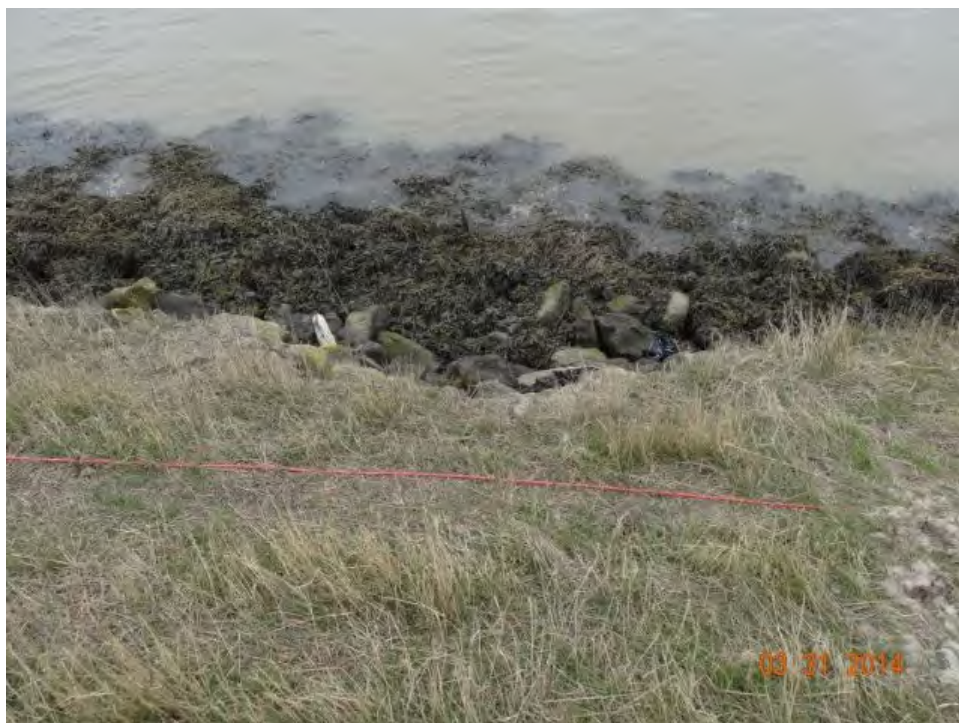
Exceptions are an area of erosion (revetment break up), shallow saltings, and low points at Westrow Reach with debris evidence (not overtopping).

Revetment breakdown (erosion) at 457543

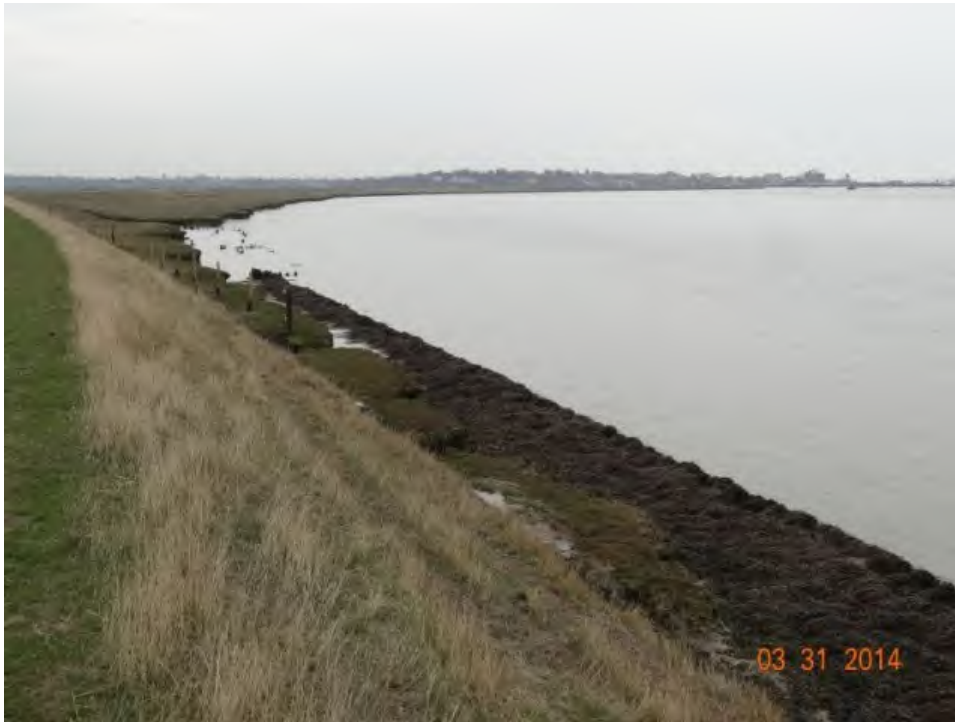
Lack of saltings in this area. Substantial post and electric fencing here, where sheep have been grazing on the wall (457545).

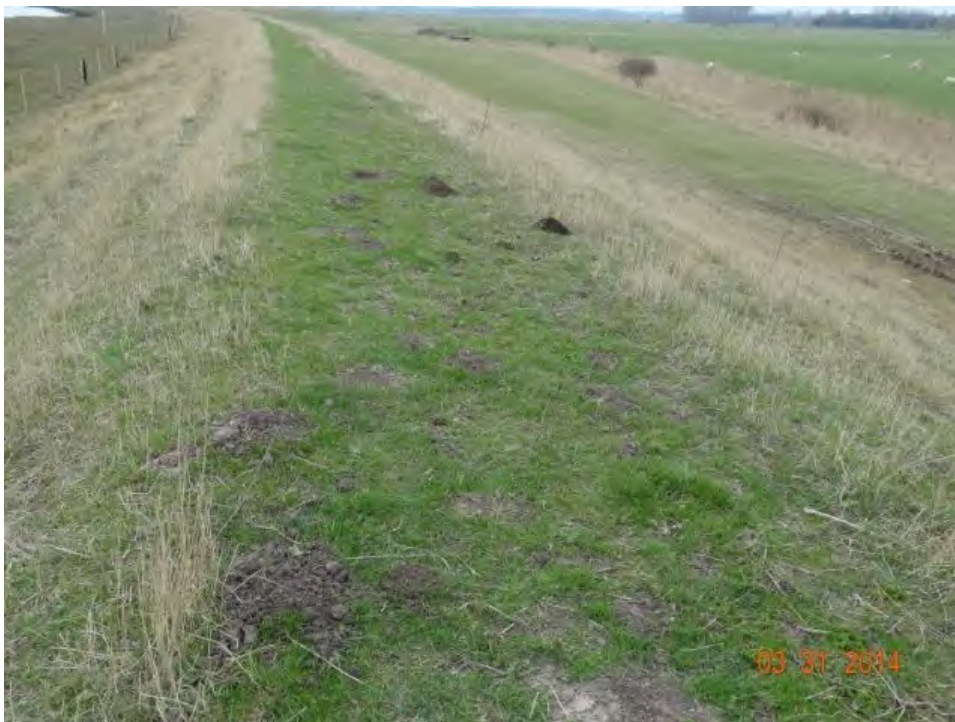
Evidence of mole activity here, and other areas.

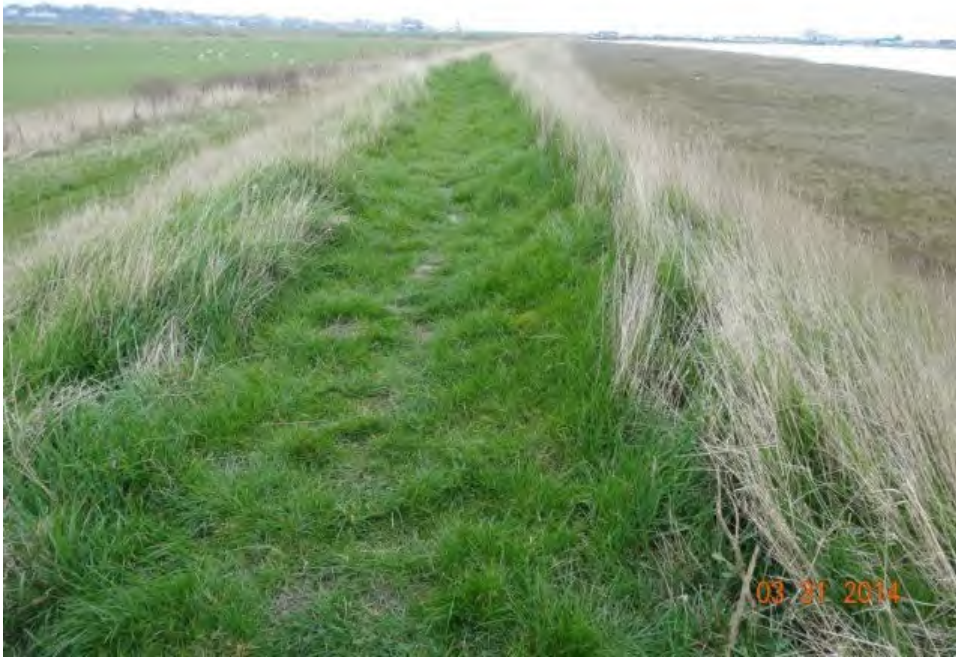
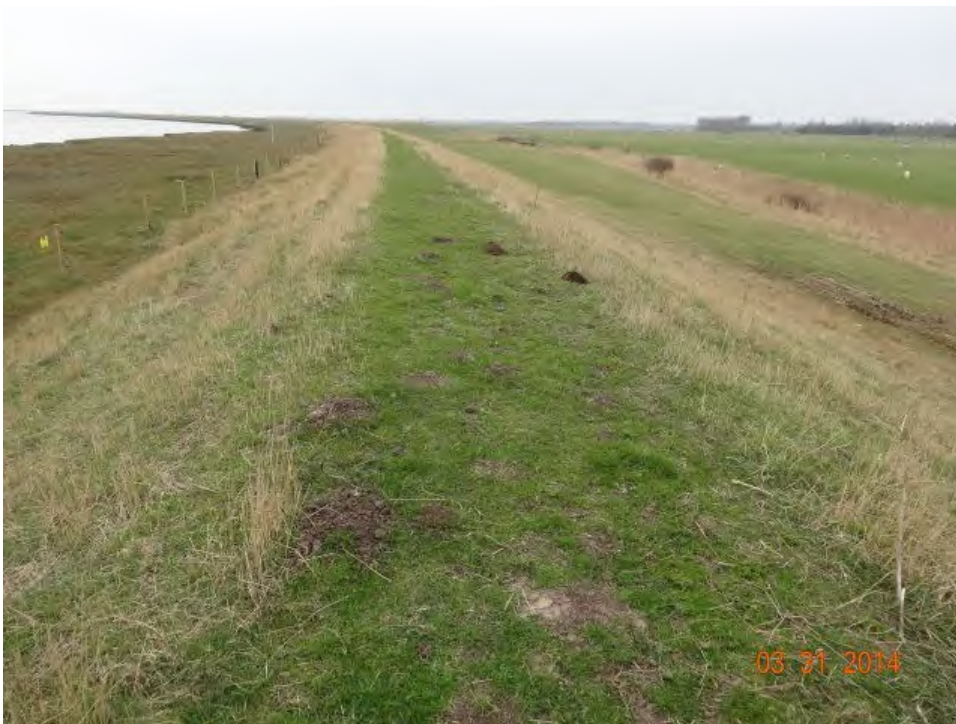
Photos taken in each direction at 458549 demonstrating the difference between where sheep have and have not been grazing.

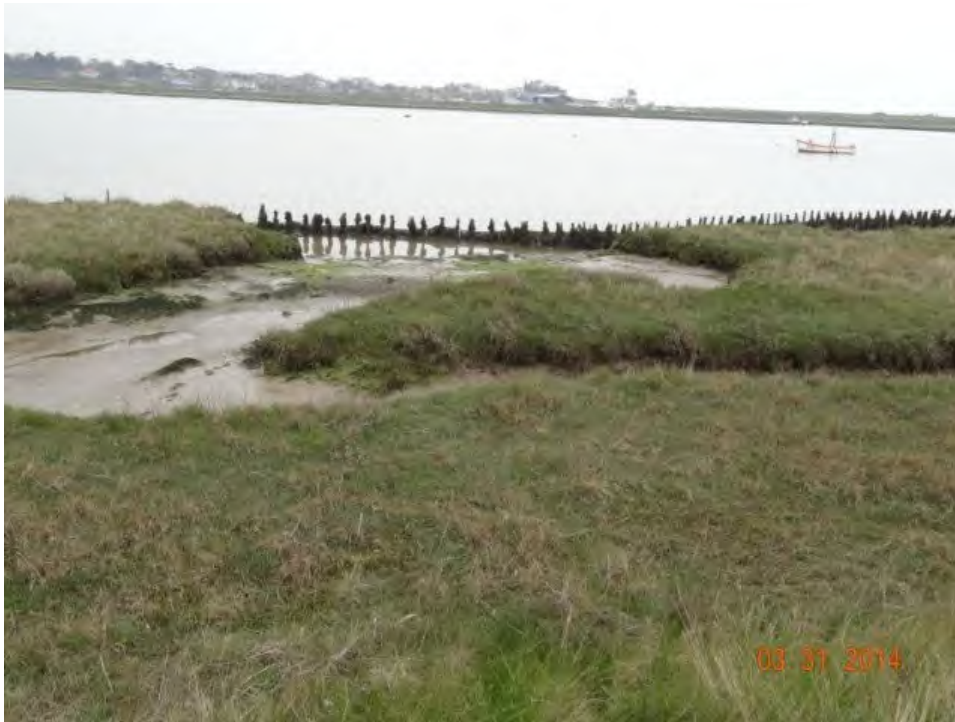
The original attenuation system in place at Ferry Point, which has now been extended upstream by the Skepper Family.

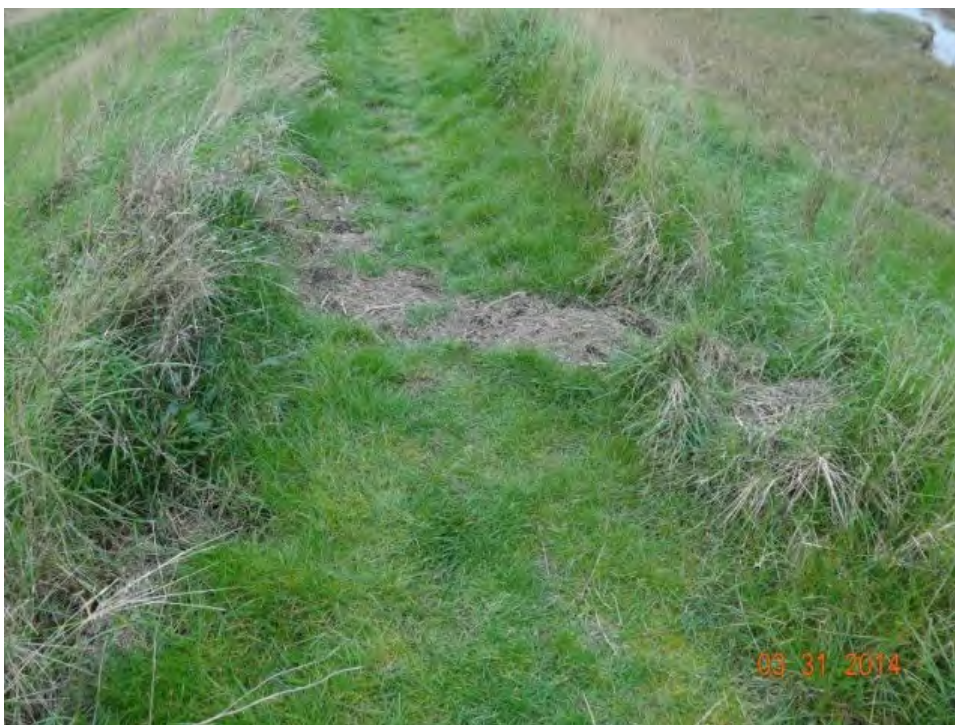
Low points on the wall at Westrow Reach with debris in places but not overtopping.
