# THE ALDE & ORE ASSOCIATION

## ALDE AND ORE ESTUARY ASSESSORS' REPORT

<b>NAME:</b>	<b>Roger Baxter Rufus Gilday Simon Reid</b>	<b>DATE OF INSPECTION:</b>	<b>April 2015</b>
<b>LOCATION:</b>	<b>Flood Cell 4.4</b>	<b>March Equinox</b>	
<b>AREA OF ASSESSMENT:</b>	<b>Chapmans Creek to Pump House</b>

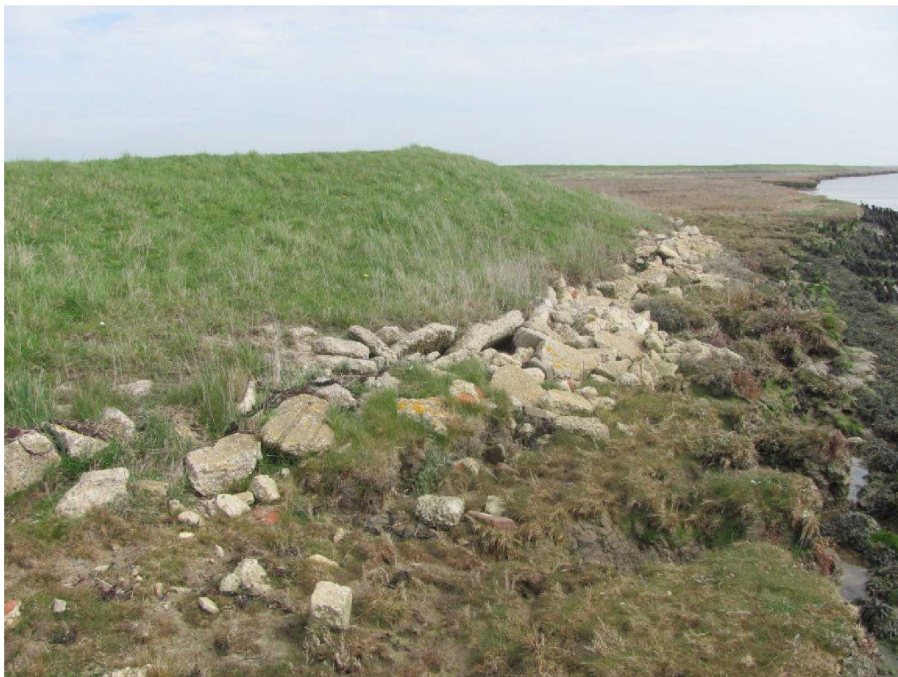
Typical front slope with good vegetation

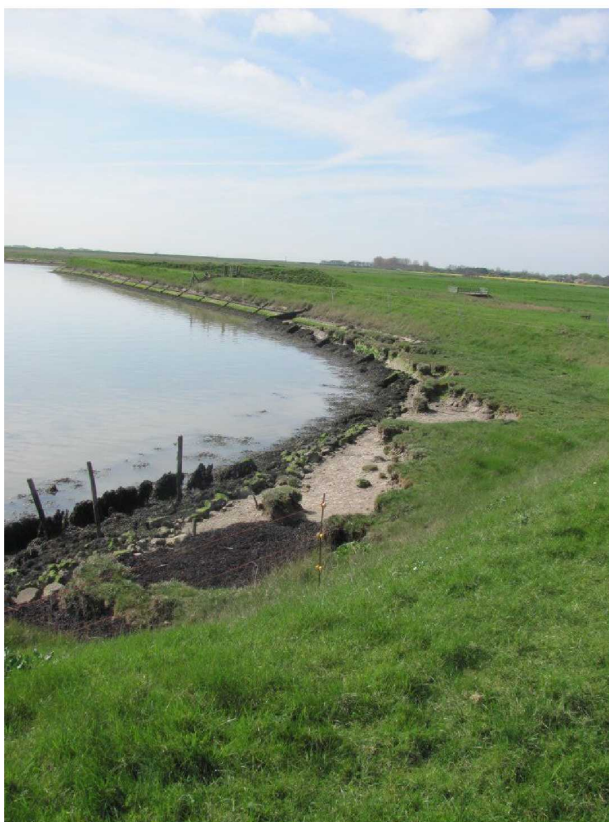
Lack of saltings in some areas.
