ALDE AND ORE ESTUARY ASSESSORS' REPORT

NAME:	DATE OF INSPECTION
David and Caroline Martin	27 th April 2014
LOCATION: Flood Cell 5	MARCH equinox
	-
Area of Assessment	
Chapman's Creek to The Anchorage, Iken

Flood Cell 5 – Chapmans Creek to the Anchorage, Iken by Keith & Caroline Martin Sunday 27 April 2013 – part accompanied by Paul Cooke

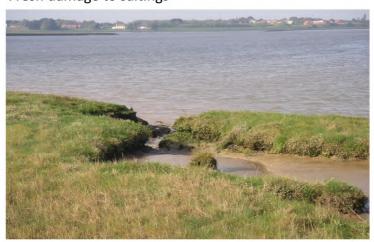
558438 Fresh damage to saltings

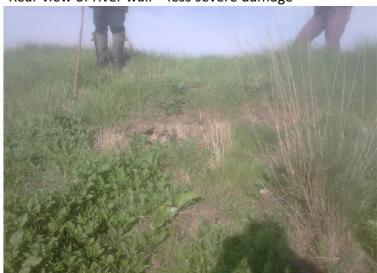
Sear view of river wall – less severe damage

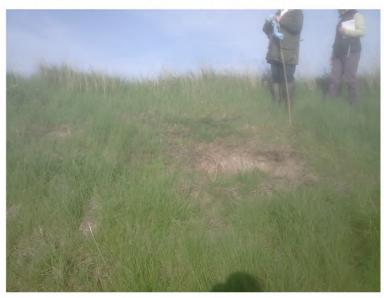
Near to previous shot
10m stretch of damage to rear of river wall

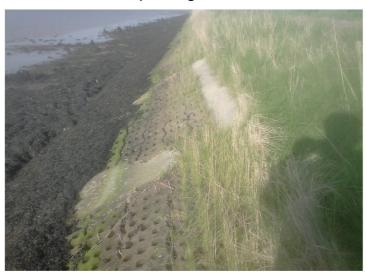
Evidence of concrete patching to concrete mattress

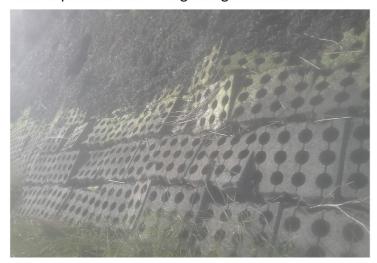
Near to previous shot – degrading concrete mattress

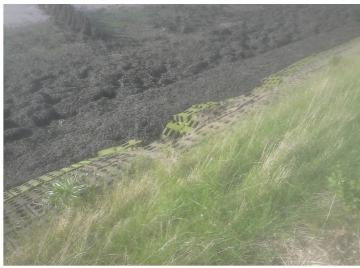
Further damage/degraded concrete mattress – plenty more of this here

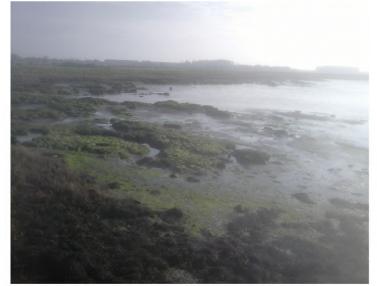
565443 Salting accumulating – good

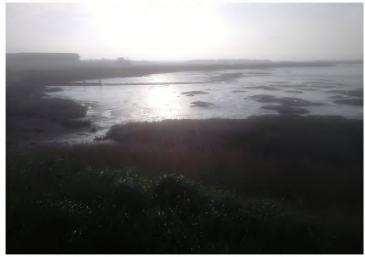
Near pump house – degrading saltings

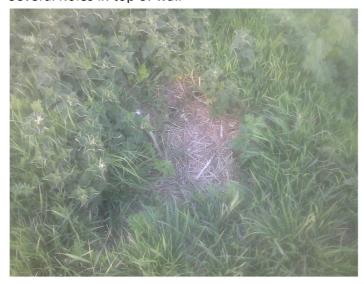
566456 Several holes in top of wall

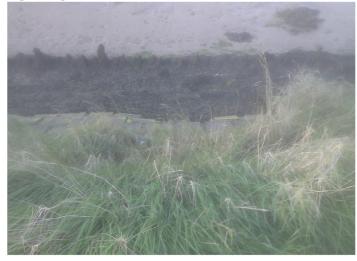
567457 Degrading Essex Blocks
