River Defence Committee, Alde & Ore Association.

Flood Cell 10 – Chapmans Creek to the Anchorage, Iken by Simon Barrow and Keith Martin Sunday 14th April 2013

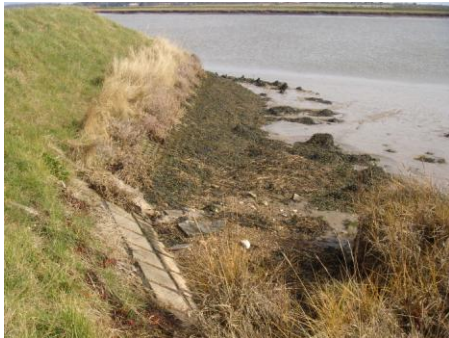
554445 Gap at the end of one type of armour as it links with another

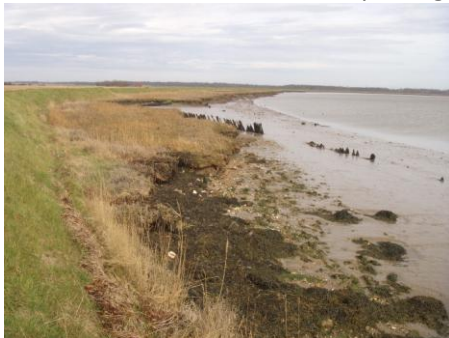
552440 Old stakes in the mud need replacing (widespread issue throughout)

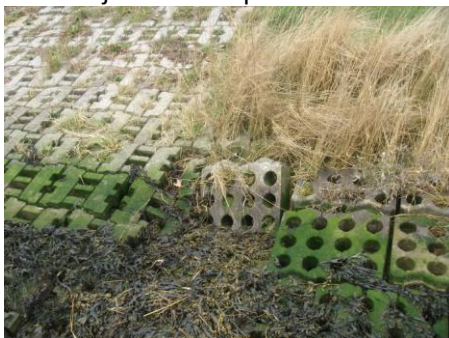
560440 Armour joins out of place

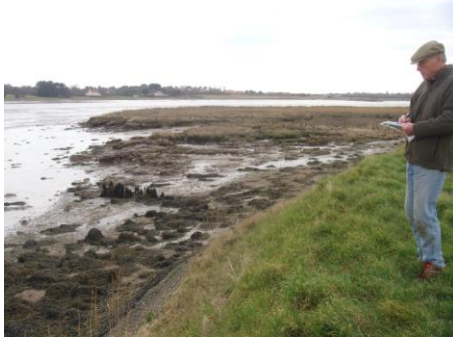
567441 Saltings severely damaged and close to being mud

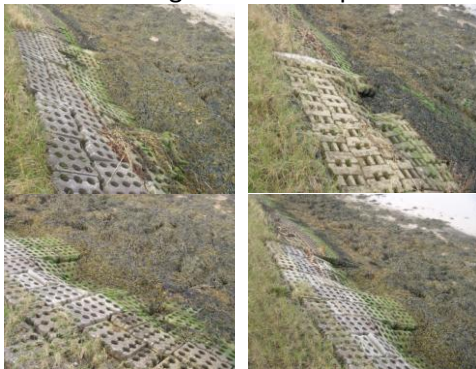
564435 Armour damaged in several places

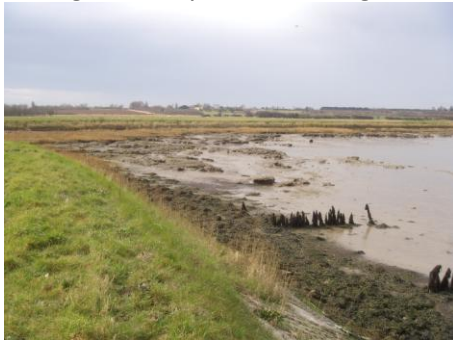
563434 Saltings severely reduced. Height of wall seems low judging by high tide debris

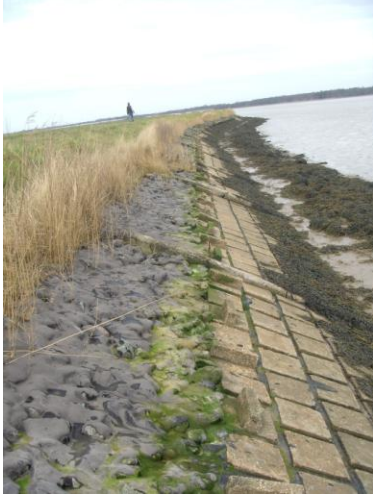
562430 Extensive new armour with bitumen topping over stones. New technique?

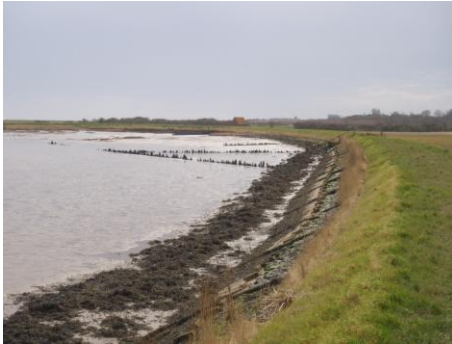
554427 Bay with not saltings. Needs stakes

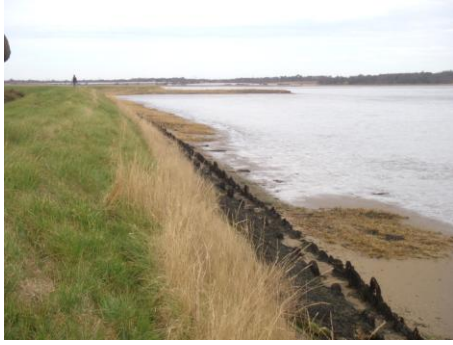
568421 Armour ok but no saltings

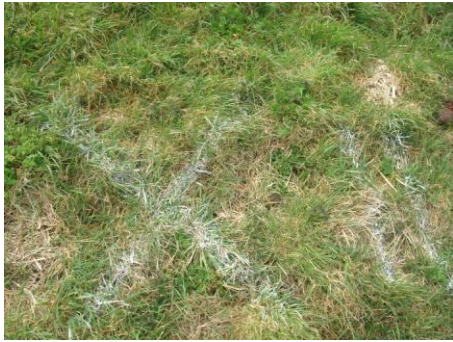
568416 Just curious – white marking on top of wall at intervals X11, X10, X9?
