ALDE AND ORE ESTUARY ASSESSORS' REPORT

| LOCATION: Flood Cell 6 | MARCH/SEPTEMBER/TIDAL EVENT |
| Area of Assessment: South bank from Snape sluice to Iken Church. | Send to |

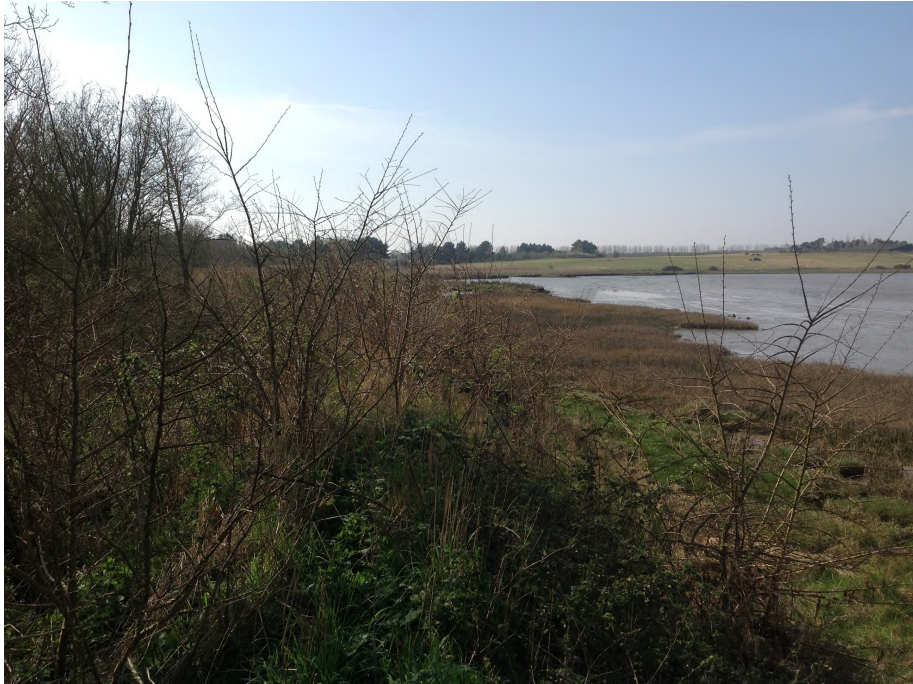
Picture 1: TM4121 5647 looking South

Bank well covered with grass and protected by saltings but sapling growth starting.

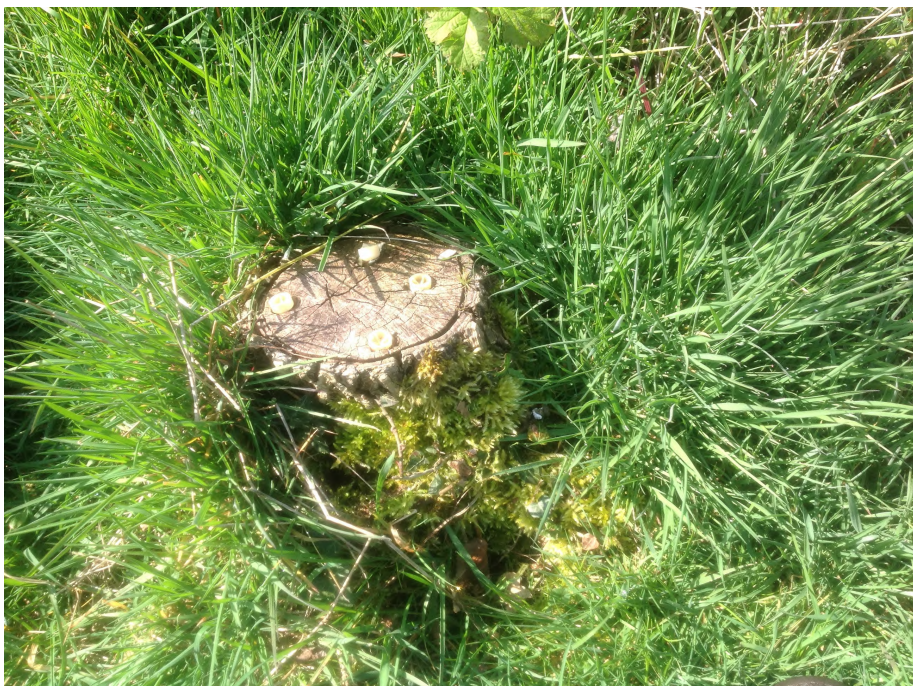
Picture 2: TM4121 5644

Old trees-stumps drilled and filled

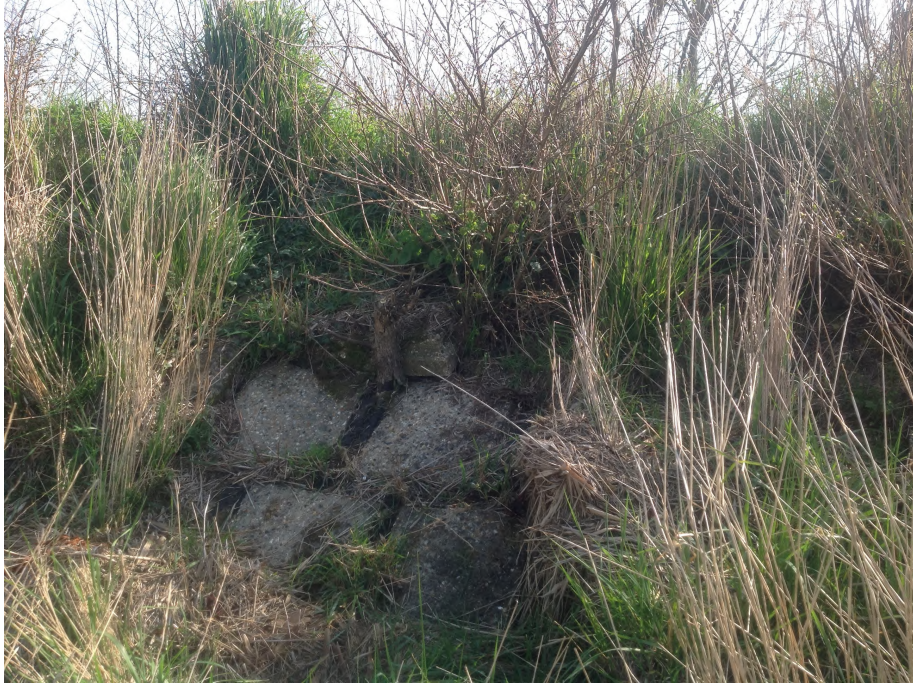
Picture 3: TM4213 5632 looking East
Old concrete armour showing through vegetation on river side of bank.

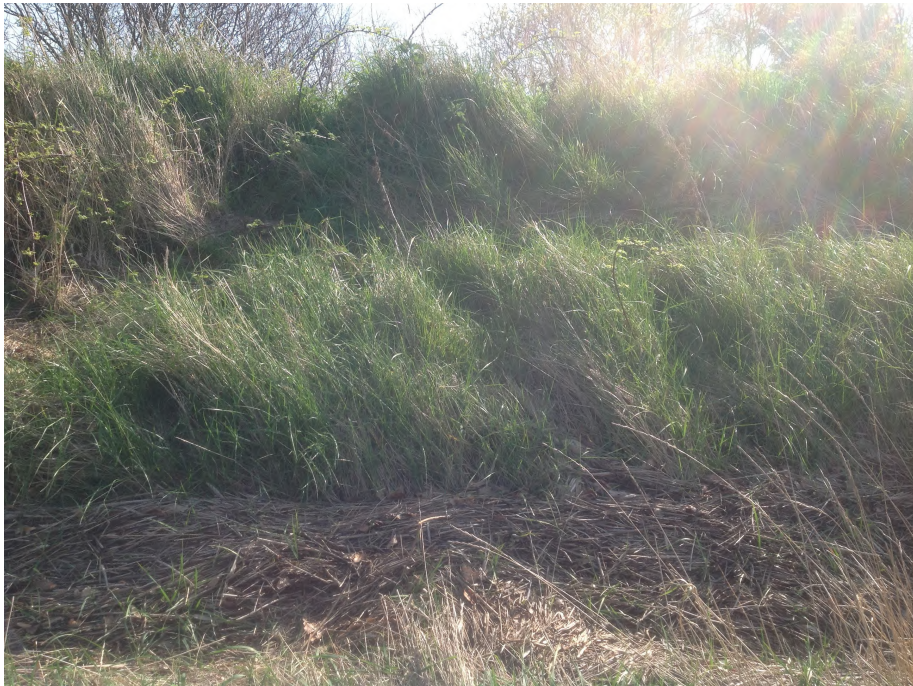
Picture 4: TM4121 5625 looking ESE
Surge debris some 600mm below wall crest
