## THE ALDE & ORE ASSOCIATION

### ALDE AND ORE ESTUARY ASSESSOR'S REPORT

<b>NAME:</b> John Grayburn	<b>DATE OF INSPECTION</b> Spring 2015
<b>LOCATION:</b> Flood Cells 6 and 7	<b>SPRING 2015</b>
<b>Area of Assessment:</b> FC6 South bank from tidal sluice to end of Maltings defences at TM393 573 FC7 North bank from tidal sluice to rising ground at TM401 576	Send to

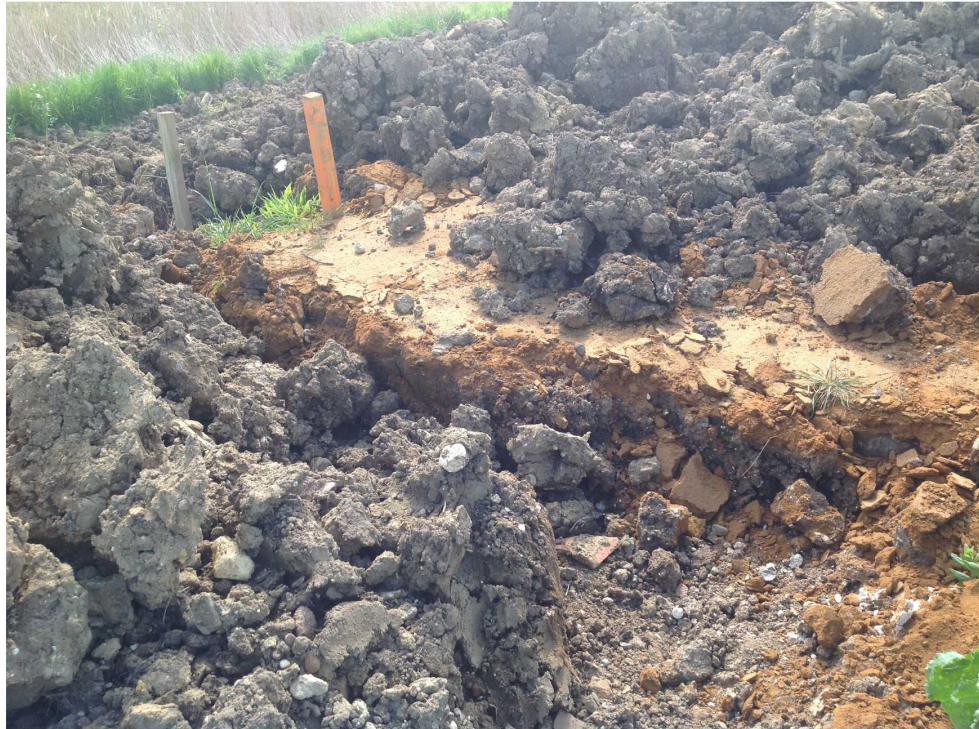
Picture 1: TM397 576 looking Southeast

The new clay repairs are replacing/covering over the previous sand/hoggin footpath

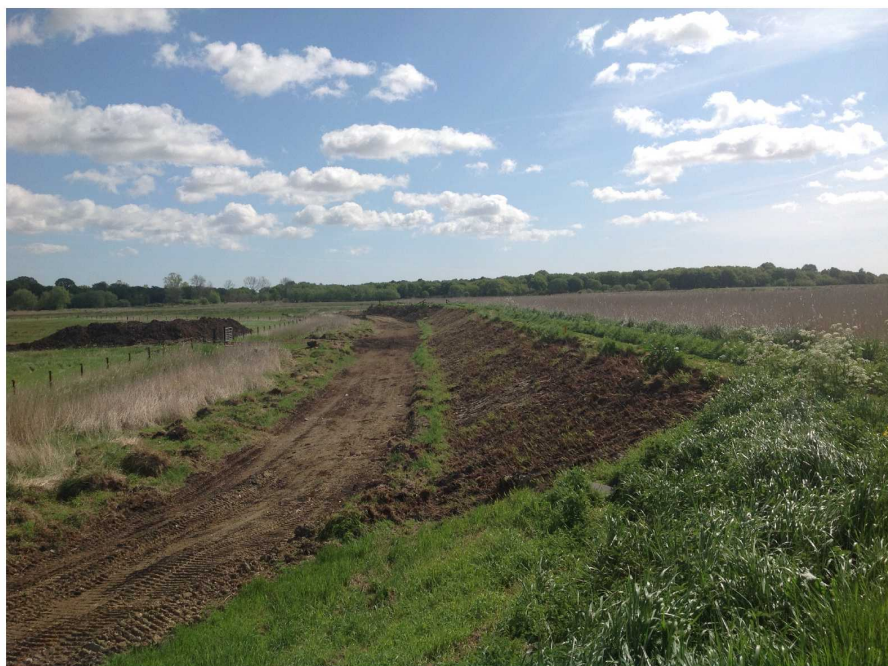
Picture 2: TM394 579 looking East

Work in progress: regrading the rear of the bank west of Blackheath sluice

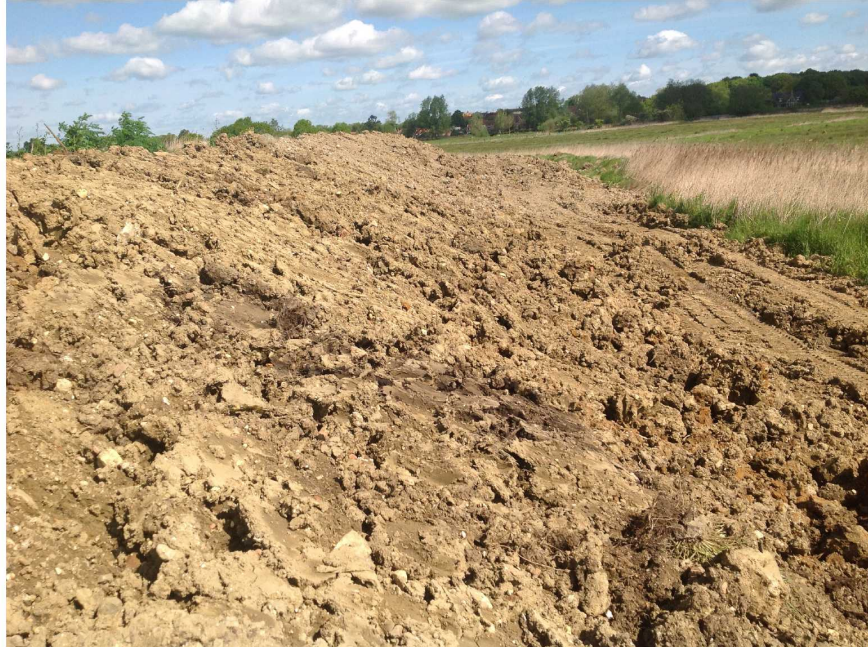
Picture 3: TM397 576 looking North

The previously oversteep rear face is being regraded

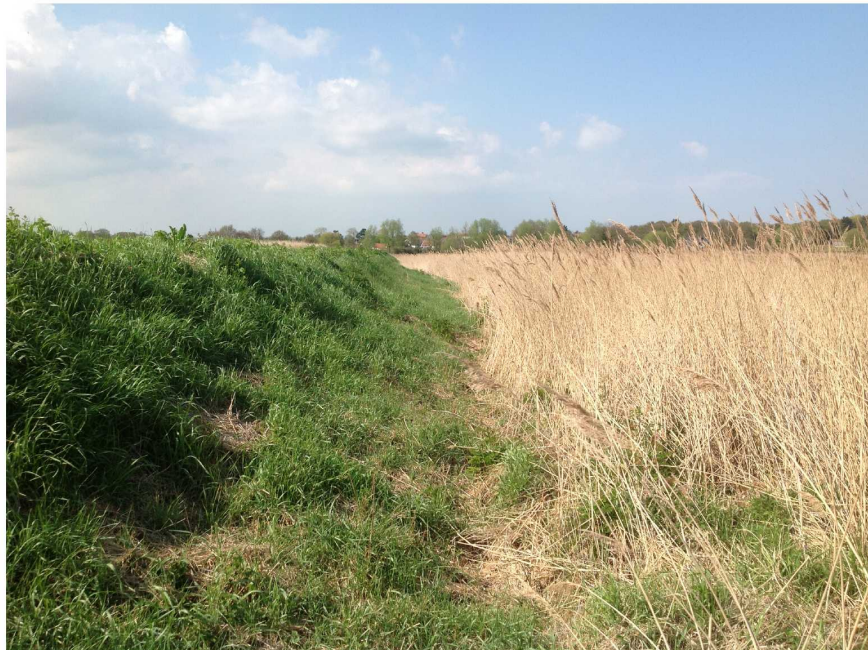
Picture 4: TM397 575 looking North in 2013

The same point in 2013 showing the oversteep rear face before the surge

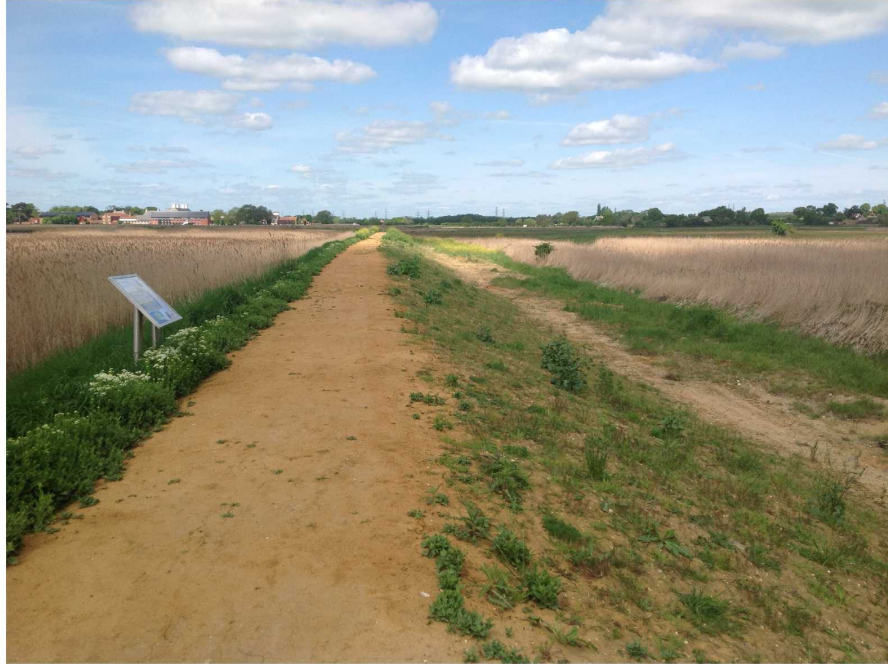
Picture 5: TM400 576 looking West.

Showing part of the wall which was repaired in autumn 2014. The rear slope has been regarded with a smooth curve from the flat top. The footpath along the top has stood up well to walkers' traffic over the winter.

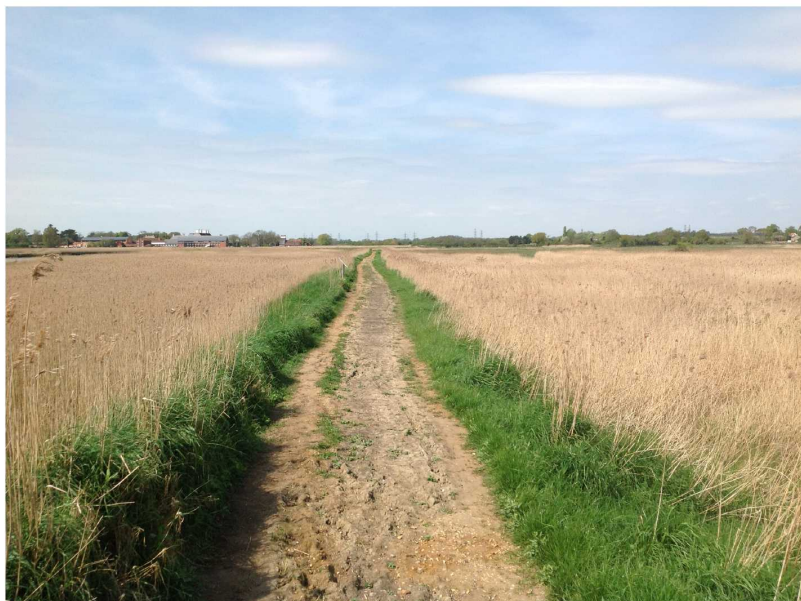
Picture 6: TM400 576 looking West

The same section in spring 2014 showing the damage caused by overtopping in December 2013
