# THE ALDE & ORE ASSOCIATION

## ALDE AND ORE ESTUARY ASSESSORS' REPORT

<b>NAME:</b> Robin and D Alderson, John Grayburn	<b>DATE OF INSPECTION</b> Spring 2013
<b>LOCATION:</b> Flood Cell 6 & 7	<b>MARCH/SEPTEMBER/TIDAL EVENT</b>
<b>Area of Assessment:</b> South bank from Snape sluice to Iken Church. North bank from Snape sluice to the point opposite Iken Cliff.	Send to

## South bank, Snape sluice to Iken Church and North bank, Snape sluice to higher ground at TM39174 57523

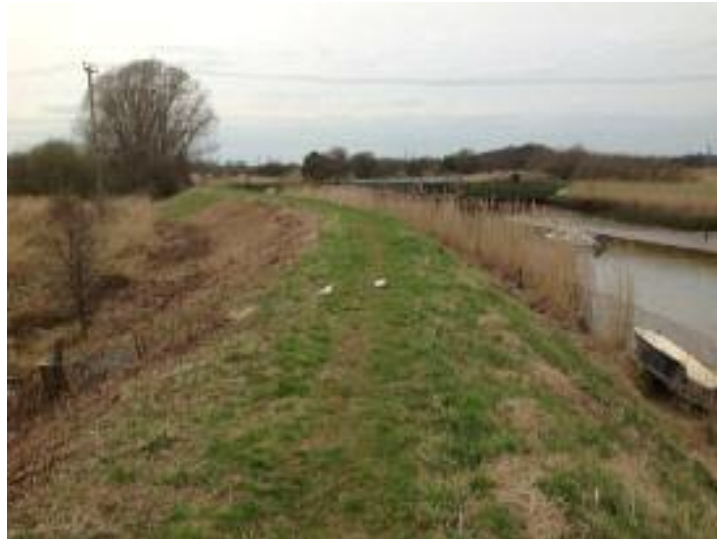
Picture 1: grid TM39174 57523 direction WNW 288°

River walls are mown regularly. Some vestiges of old armour at base on river side plus reed protection.

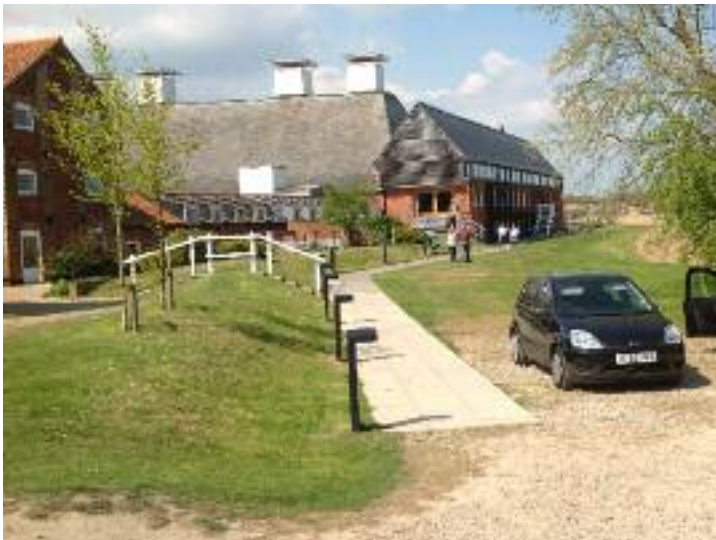
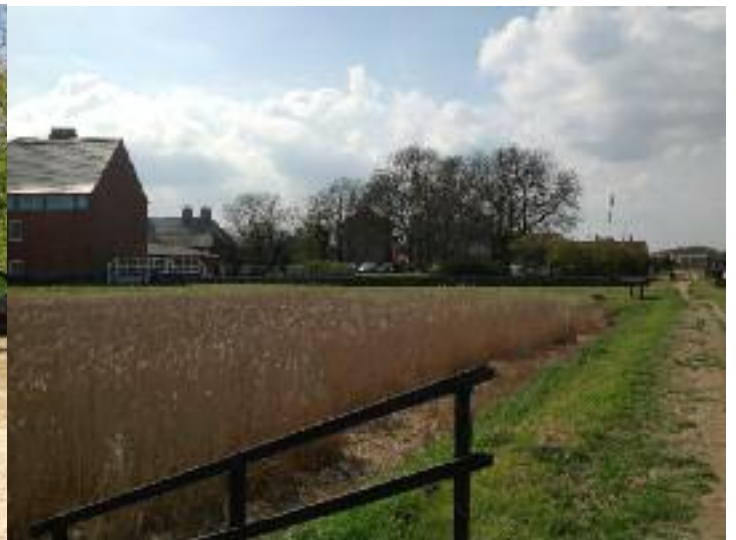
Picture 2: grid TM39339 57390 direction N 4°

Concrete wharf edge at Maltings followed by short length of bank returning to concrete wall to building followed by bank to higher ground at car park. Bank is grass covered and regularly maintained.

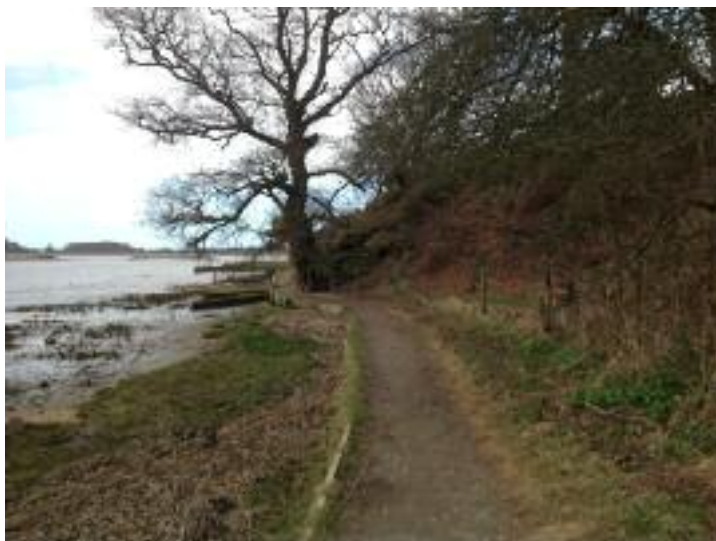
Picture 3: grid TM40277 56106 direction E 105°

Steep natural bank up to 5 metre contour running along river. Timber boarding protection to footpath along the riverside with mudflats and reedbed.

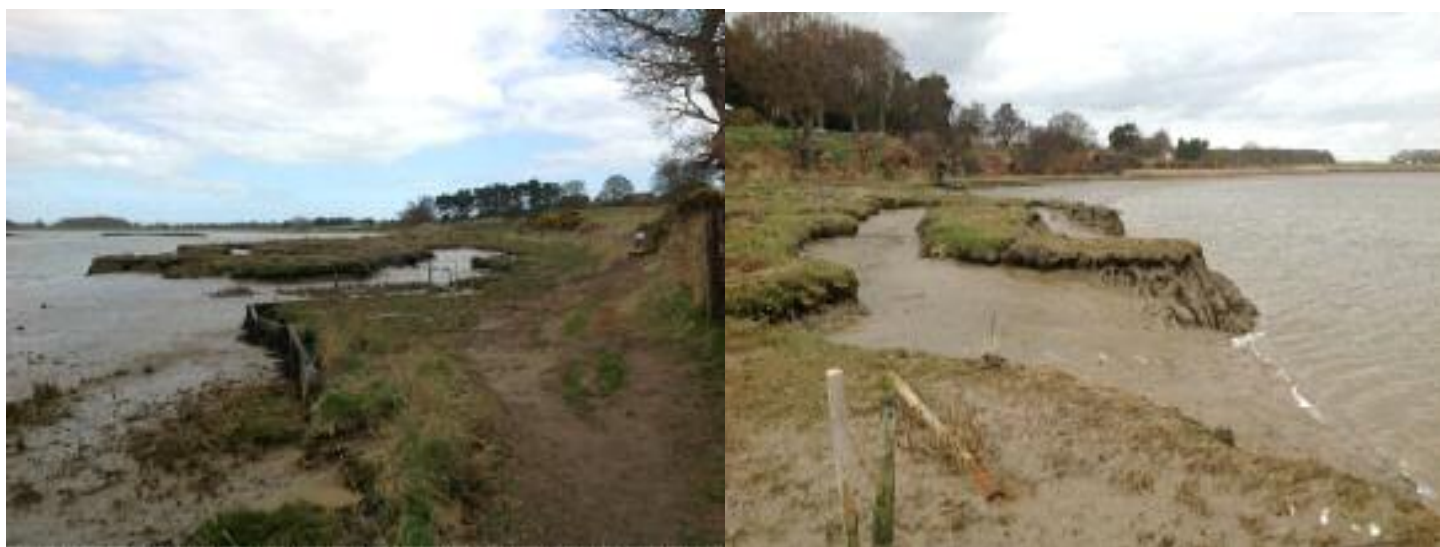
Picture 4: grid TM40330 56105 direction E 96°

followed by length of saltmarsh to Iken Cliff. Some of the marsh at the west end is eroding with creeks and islands. Details logged to keep an eye on rate of erosion although from historical data, erosion appears to be slow.

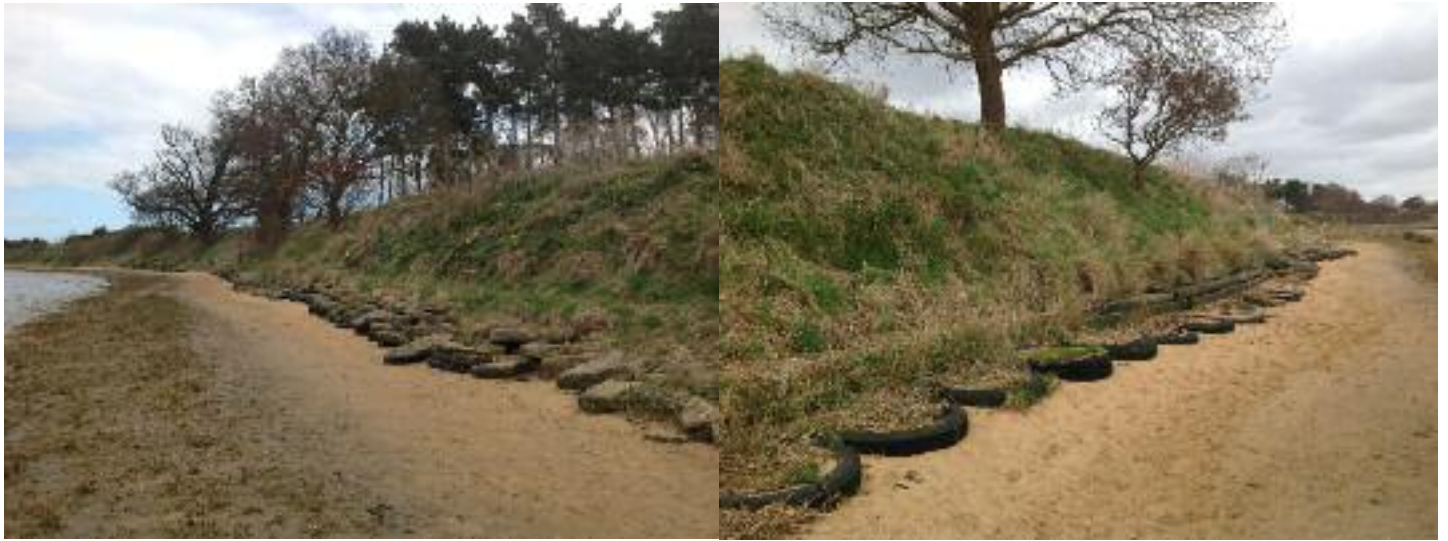
Picture 6: grid TM40618 56044 direction SE 135°

Mud and sand at base of the cliff. Concrete and tyres as unofficial protection to the base of the cliff.

From historical data, it would appear that the area of sand at the bottom of the cliff is unchanged from 1945.

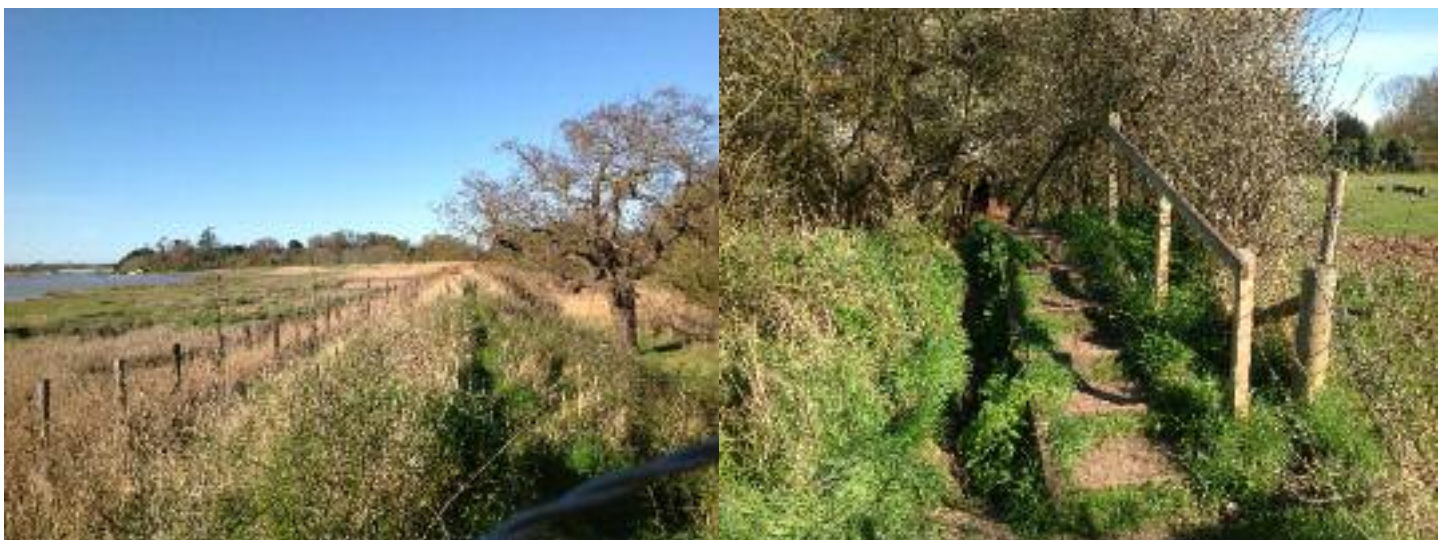
Picture 8: grid TM41148 56073 direction E 76°

The river wall runs from the rising ground at TM41144 56022 eastwards to Iken Church. It is well protected by saltings. It was not possible to walk the wall but from the west end at the footpath it appears to be covered in saplings for most of its length. In addition there is some erosion where the footpath crosses the wall.

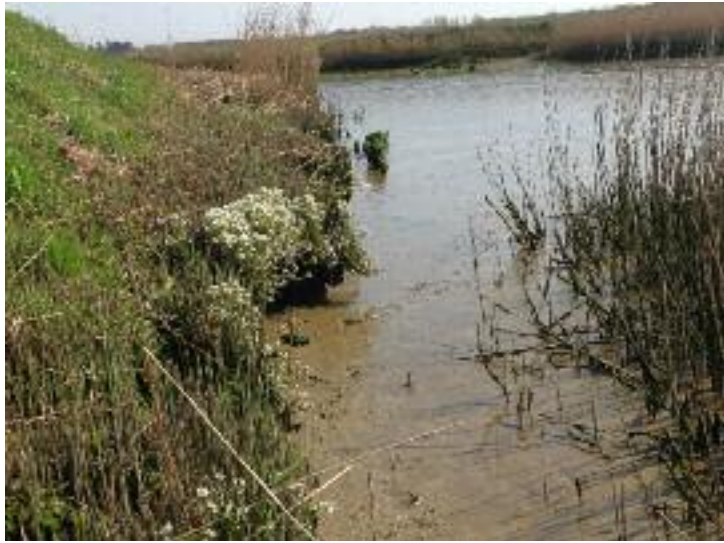
Picture 10: grid TM39662 57527 direction SE 156°

There are areas of erosion through the old armour both upriver (picture 10) and downriver (picture 11) from the point at TM39688 57523.

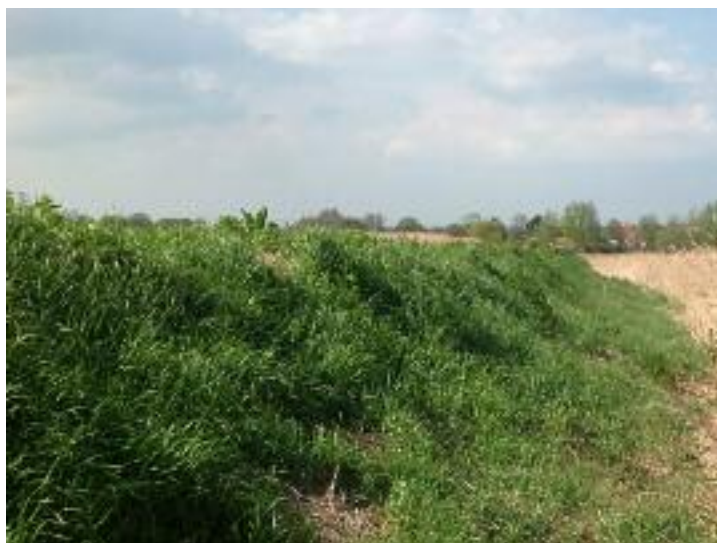
Picture 12: grid TM39671 57521 direction N

On the inside of the bank between Blackheath Sluice and the point at TM39688 57523 there is considerable steepening of the upper slope, up to 45°. (This may be a product of the recent levelling work as the top of the bank was narrow and sloping before the levelling).

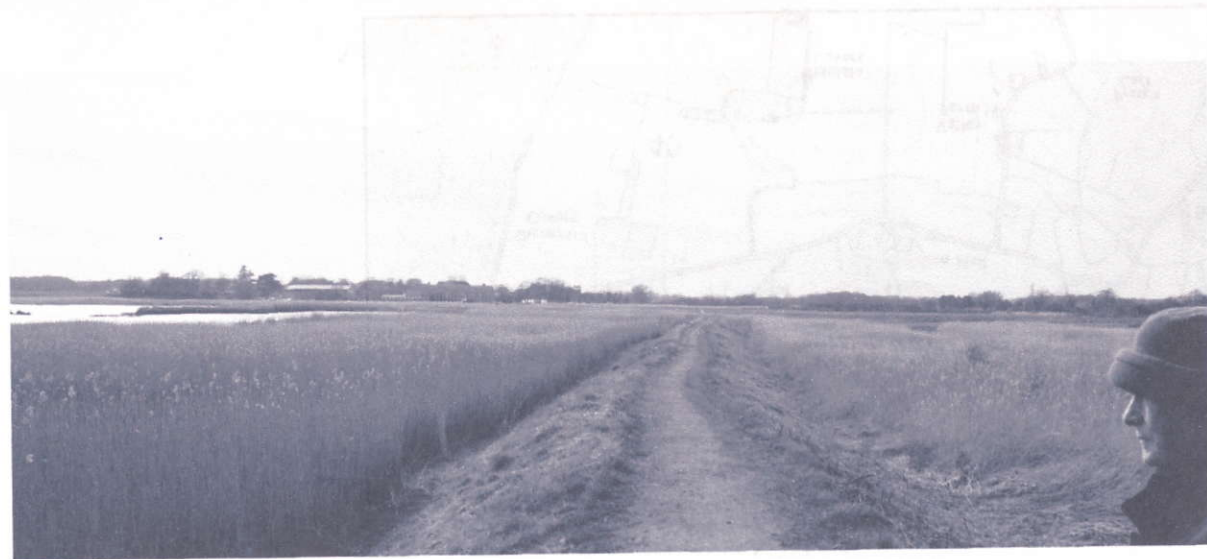
Photograph A1:

View looking West looking towards Snape Maltings, showing the recently surfaced foot path along the top of the river wall.
