THE ALDE & ORE ASSOCIATION

ALDE AND ORE ESTUARY ASSESSORS' REPORT

NAME: Robin and D Alderson, John Grayburn	DATE OF INSPECTION Spring 2014
LOCATION: Flood Cell 7	MARCH/SEPTEMBER/TIDAL EVENT
Area of Assessment: North bank from Snape sluice to the point opposite Iken Cliff.	Send to

1. North bank.

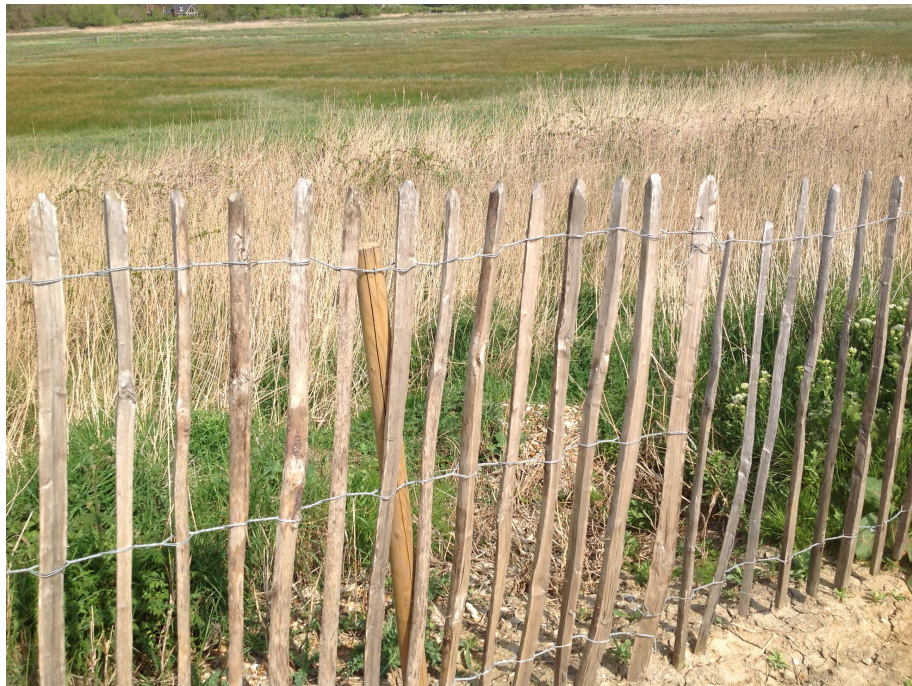
Picture 1: TM3976 5757 looking North

In many places, the hoggin has been washed off the top of the bank by the December surge. Collapsed bank top protected by temporary chestnut paling.

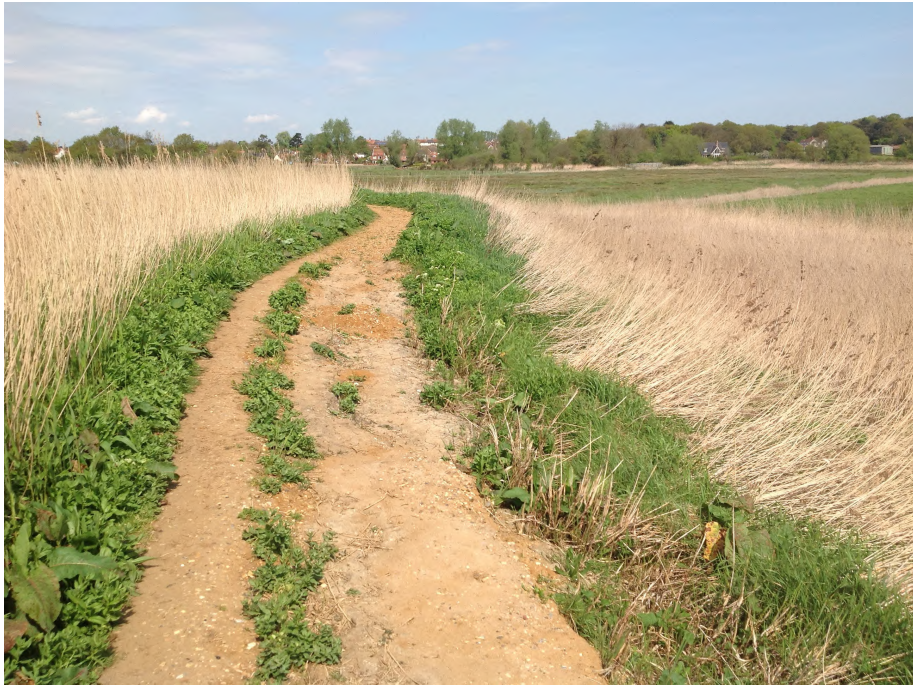
Picture 2: TM3964 5759 looking North

The north end of the long stretch where the inner side of the crest has collapsed.

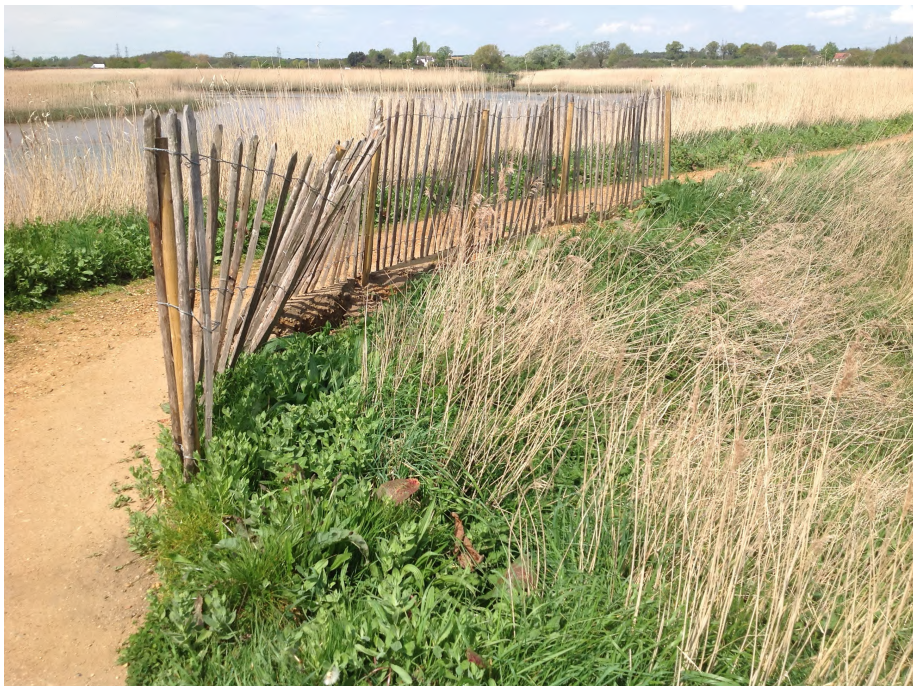
Picture 3: TM3967 5752 looking NW

At the point of most serious undercutting, the temporary chestnut paling is protecting the undercut area and annual weeds are re-establishing.

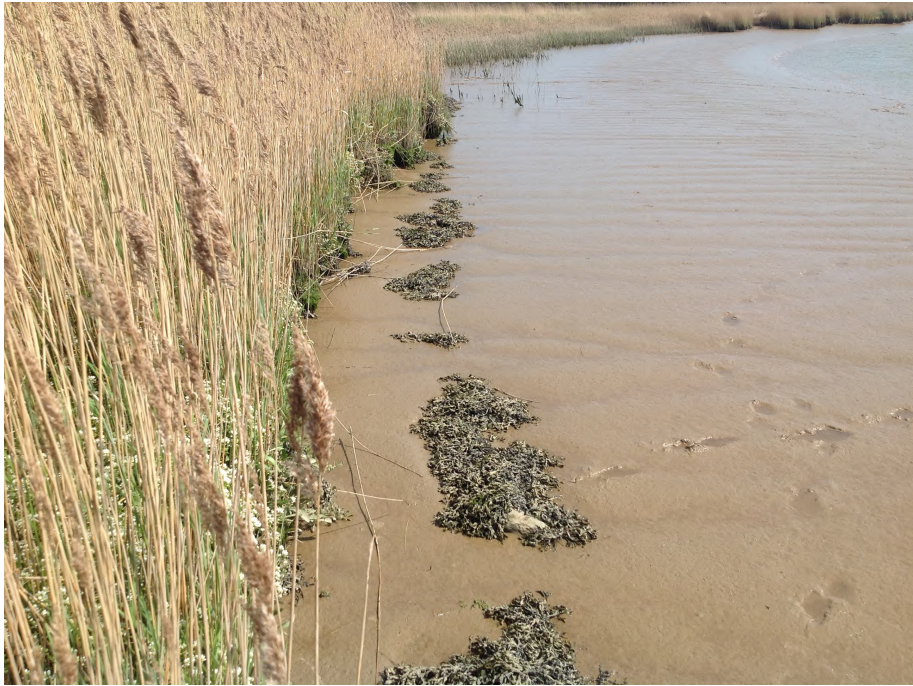
Picture 4: TM3972 5754 looking NE

From Snape Bridge to Blackheath Sluice, the bank is protected by reedbeds and from TM3980 5759 eastwards to the higher ground at the wood it is again protected by reedbeds and saltings. However, as noted last year, there is erosion on the river side both downriver and upriver of the point at TM3969 5752.

Erosion from old stone armour line downriver from the point at TM3969 5762

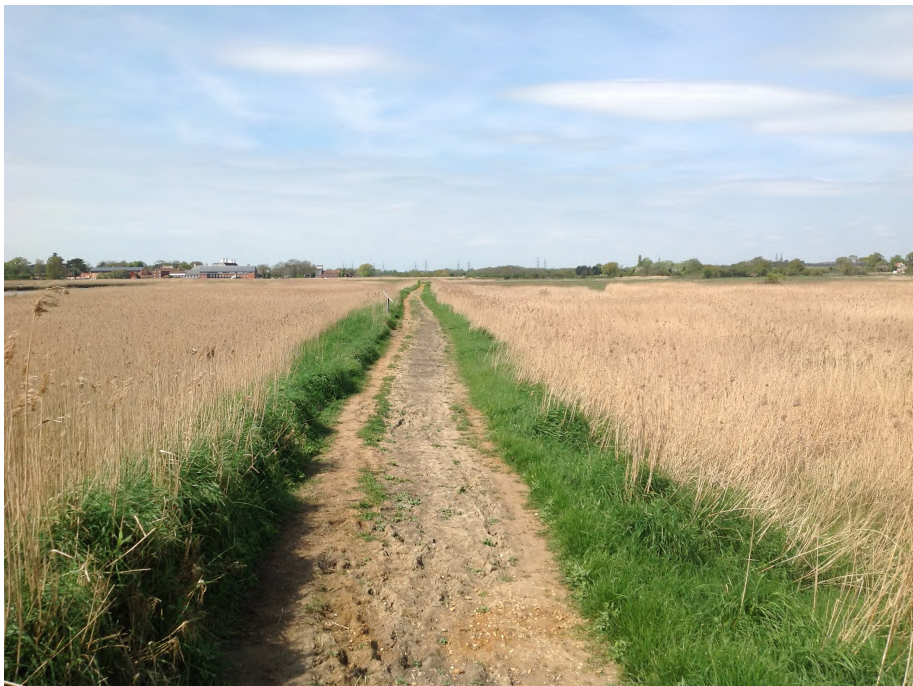
Picture 5: TM4004 5759 looking West

Footpath traffic wear where hoggin path has been washed away in the December surge exposing the underlying clay which was scalped to level when the hoggin footpath was installed.
