ALDE AND ORE ESTUARY ASSESSORS' REPORT

NAME:	Tim Dudgeon John Grayburn Roger Baxter	DATE OF INSPECTION: May 2015
LOCATION:	Flood Cell 8	March Equinox
AREA OF ASSESSMENT:	Blackheath Estate, Ham Creek

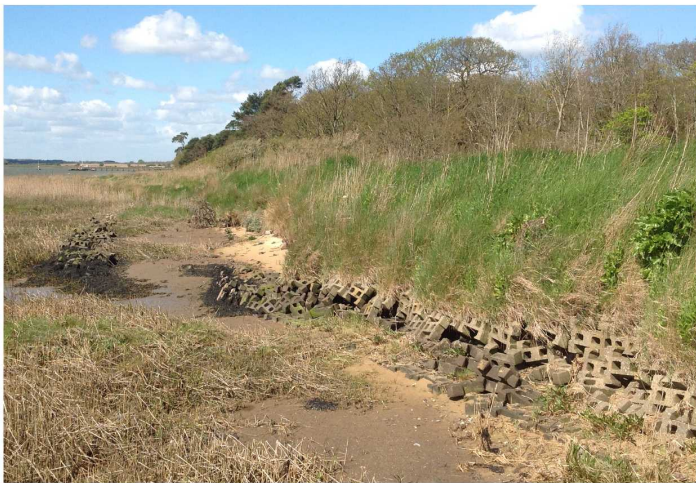
TM 5287 5780 Looking North: old collapsed armour

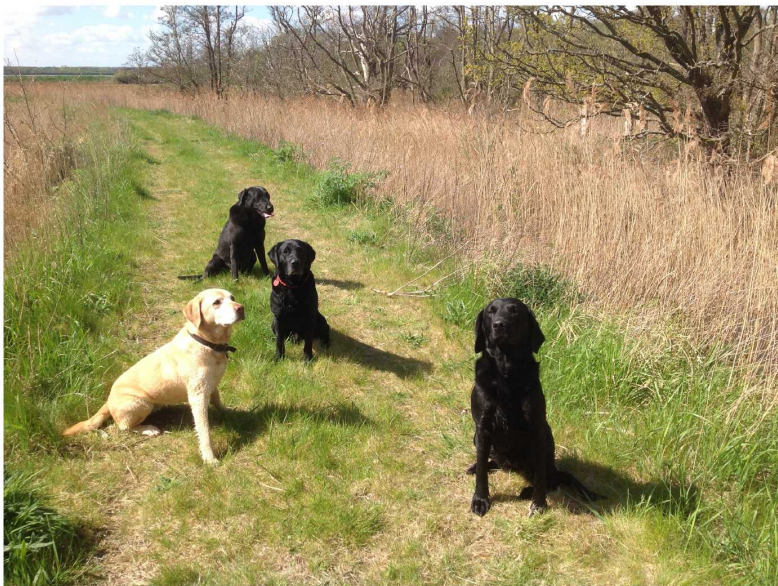
TM 4298 5798 Looking Southwest over repaired breach. Vegetation establishing well.
