# RDC survey 2013

## Flood Cell 2 – Butley Mills

Section inspected by Frances and David Barnwell 5 May 2013

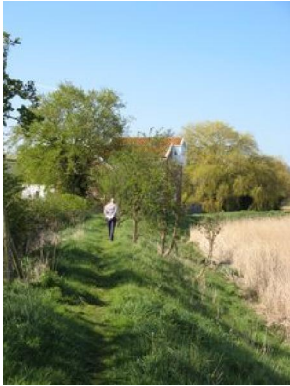
1. Walking north from Butley Mills, the first section by the barns at TM 3858 5159 is in reasonable condition with some small trees

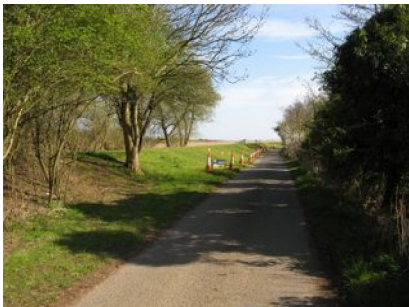
2. The new work at TM 3858 5194 is mown and in good condition

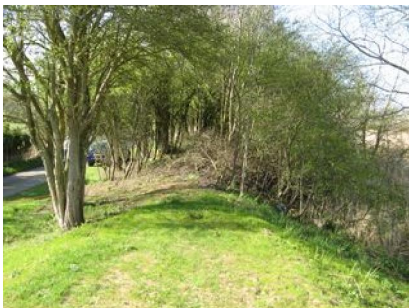
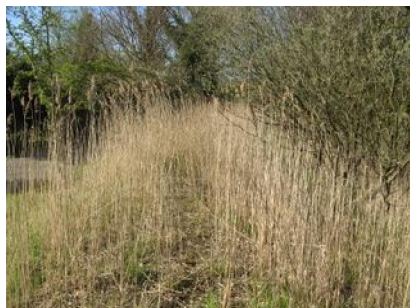
3. This is followed by heavily wooded and overgrown sections at TM 3858 5194

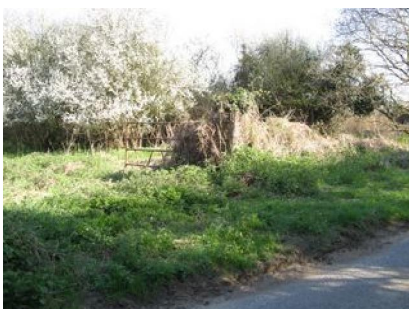
4. The final section by Chillesford at TM 3861 5211 is overgrown
