# THE ALDE & ORE ASSOCIATION

## RDC BULLETIN NO. 4 December 2007

### THE SURGE

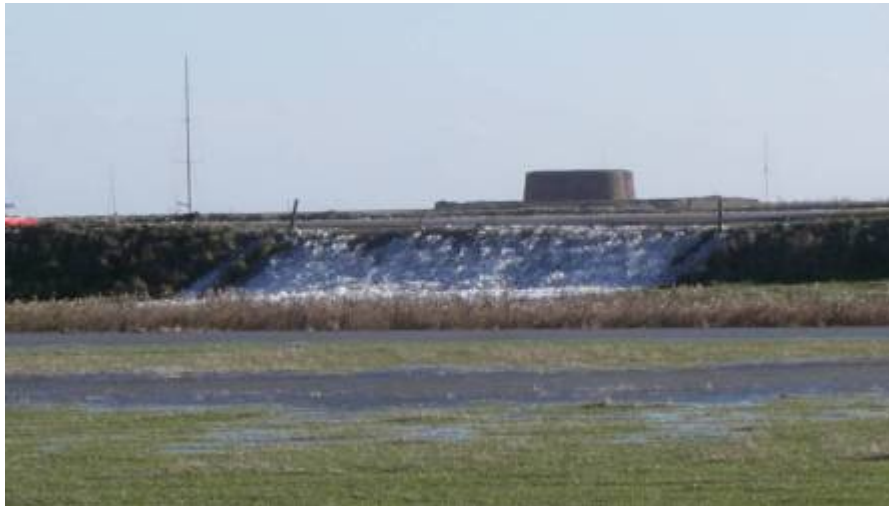
**Overtopping on Aldeburgh River Wall – photo courtesy of Andrew Hawes November 2007**

- **Aldeburgh Sluice:** bank still in poor condition. To north side of sluice two of the undercut parts of the bank where the armour has gone and an earth cave is being carved out, now have each a single long crack going up to 1-2 feet into the bank, from a few inches wide at the outside to a finger inside. One of the fingers is in line with the edge of the path if projected vertically, indicating the start of undermining the path. The EA agreed that this might require work now.
- In the slumped area between West Row and Chapmans the water over topped. A 15-20 metre wide area of the bank away from the river had the grass lying flattened where

the water had rushed over (see Andrew Hawes' photo) Work has started to raise the wall height by a modest 100mm

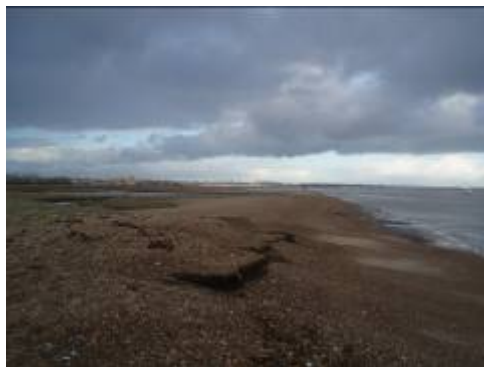
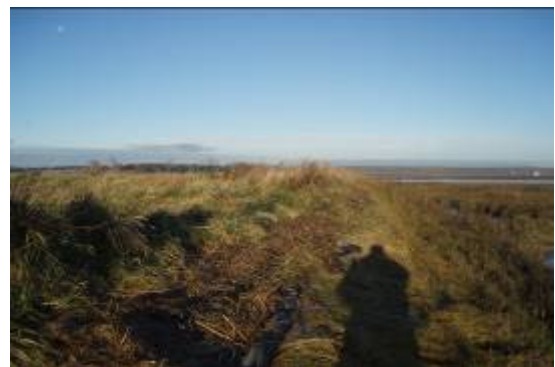
#### 5. Shingle Street to Butley West Bank

- North of the beacon there was some over topping with shingle thrown back over vegetated areas resulting in a narrowing of the shingle bank. There was also over topping at 391492(Greenwell land). Additionally the beach profile at the mouth of the river was considerably altered.

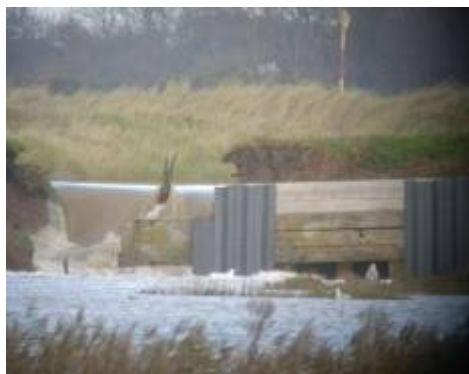
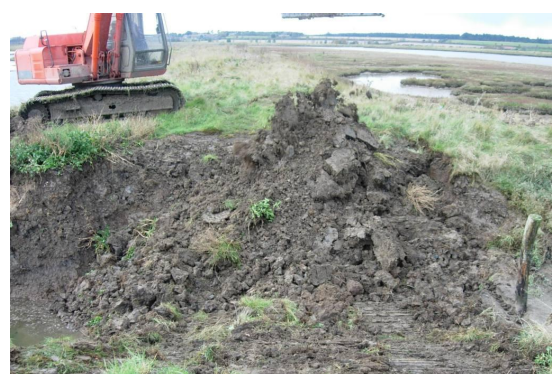
#### 6. Havergate Island (RSPB)

- The breach on Havergate Island was adjacent to the northern inlet sluice that feeds the three northern lagoons. It is thought that the water overtopped at a low point here, eroding the inside of the wall and cutting back to create the breach. The breach opened up to be approximately 4 metres wide at the top, narrowing to 2 metres wide at the bottom. It was approximately half the depth of the wall, water only flowed in during the high tides of the Friday (9th November) and the weekend. By the middle of the following week tide levels had dropped so water did not come through the breach. The breach was plugged on Friday 16th, with further work in the following week. Water levels on the lagoons rose by approximately 30cm. As it was saltwater adding to saltwater it is unlikely to have caused any ecological damage. Low points on Doveys lagoon (at the south end of the island) also overtopped causing slumping to the inside of the river wall, but the wall did not breach. There was also overtopping onto the visitor reception area, causing damage to bridges, steps, etc. - this is still in the process of being repaired.

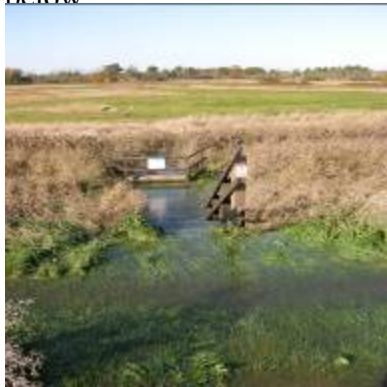
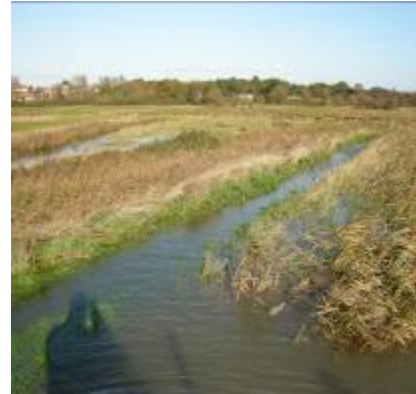
### 7. Snape Bridge to Blackheath

- No breaches occurred in the stretch but there was considerable overtopping at the Blackheath Sluice and beyond for approx 60 metres (OS212 3905 5764) – see photos below

- There was an additional small area of overtopping just before the spot where the footpath leaves the marsh (4020 5740). These over topplings into the grazing marsh are less serious than the potential for damage to the Concert Hall and shops if water came over the concrete wall from the Maltings to the river bank. The EA says that any action on the wall will have to await the strategy

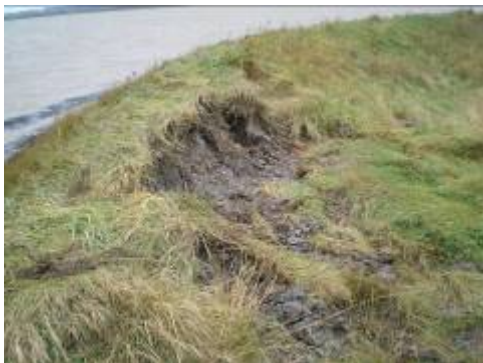
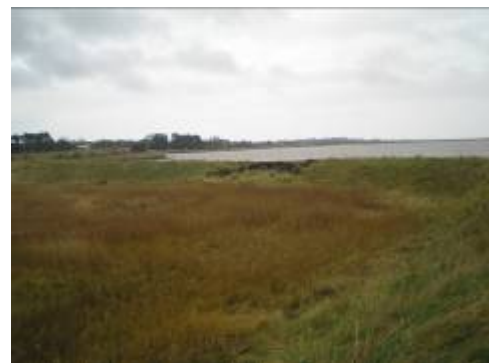
### 8. Blackheath to Barbers Point

- Some undermining of the cliff at Little Japan, but not too serious. Only in one spot has there been a minor fall of the cliff.
- The concrete revetments at the Blackheath House end of the Ham Creek wall continue to cause concern. Photos have been taken. The revetment blocks are, in many places, now next to useless and the wall behind is being eroded. The EA agreed to look at this.
- The river wall on Roundhill side of the Suffolk Wildlife marsh, an SPA, is in a poor state. The EA is planning some minor work there this year, however a complete job must await the strategy.

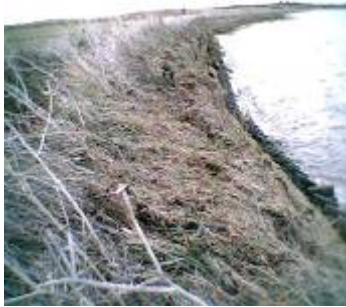
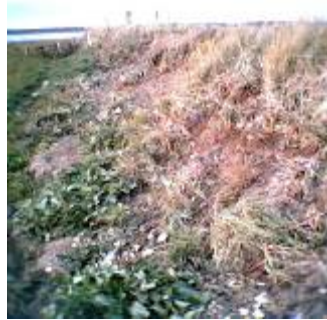
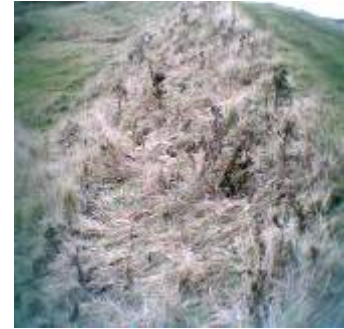
### 9. Barbers Point To Aldeburgh Martello Tower

- New development - on the corner near Stanny the river side of the bank is now sheer open earth. The seabiet roots do not hold the bank like grass and many plants are half washed out. The EA will check this where much of the damage has been caused by cattle
