## River Alde Flood Defence Committee Flood Cell 8

From New England Farm to Little Japan Inspected by Richard Newman and Roger Baxter on April 22<sup>nd</sup> 2014

### River bank surveyed

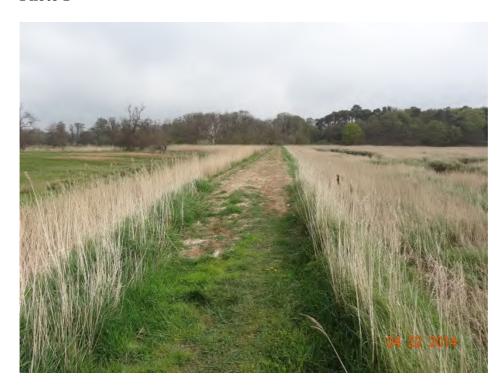
#### Photo 1

- 1. The repaired river wall
- The residue from the breached wall on the other side of the gully
  The height reached by the surge of Dec 8<sup>th</sup>, at the western end of Little Japan

The breach was rapidly repaired by the landowners involved and a superb job appears to have been carried out. As well as the breach being repaired, the wall has been heightened slightly for about 200 yards from its western end to allow for topsoil to be applied, into

which grass has been sown, which undoubtedly will help to stabilise the wall.

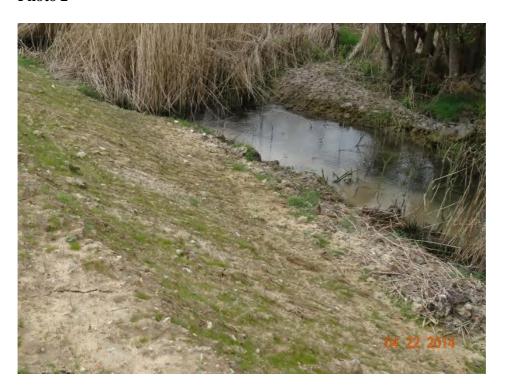
# Photo 2

At the east end of the Ham creek river wall, where there was a worry about the state of the wall as concrete blocks had been removed, no extra damage appears to have occurred as a result of the surge. Towards the west end of the wall, where overtopping occurred during the last surge five years ago, the wall was breached by the surge on December 8<sup>th</sup>, to a width of some 4 metres, causing extensive flooding over about 100 acres behind the wall, affecting an irrigation extraction point. There were also a number of back wall slips caused by overtopping.
