THE ALDE & ORE ASSOCIATION

ALDE AND ORE ESTUARY ASSESSOR'S REPORT

NAME: Alison Andrews	DATE OF INSPECTION 2 April 2014
LOCATION : Flood cell 10 Brick Dock to Martello, river side TM 450565 to 463548 All map references from OS Explorer 212	MARCH/TIDAL EVENT
CO-ORDINATOR: Amanda Bettinson	Send to email: John Grayburn

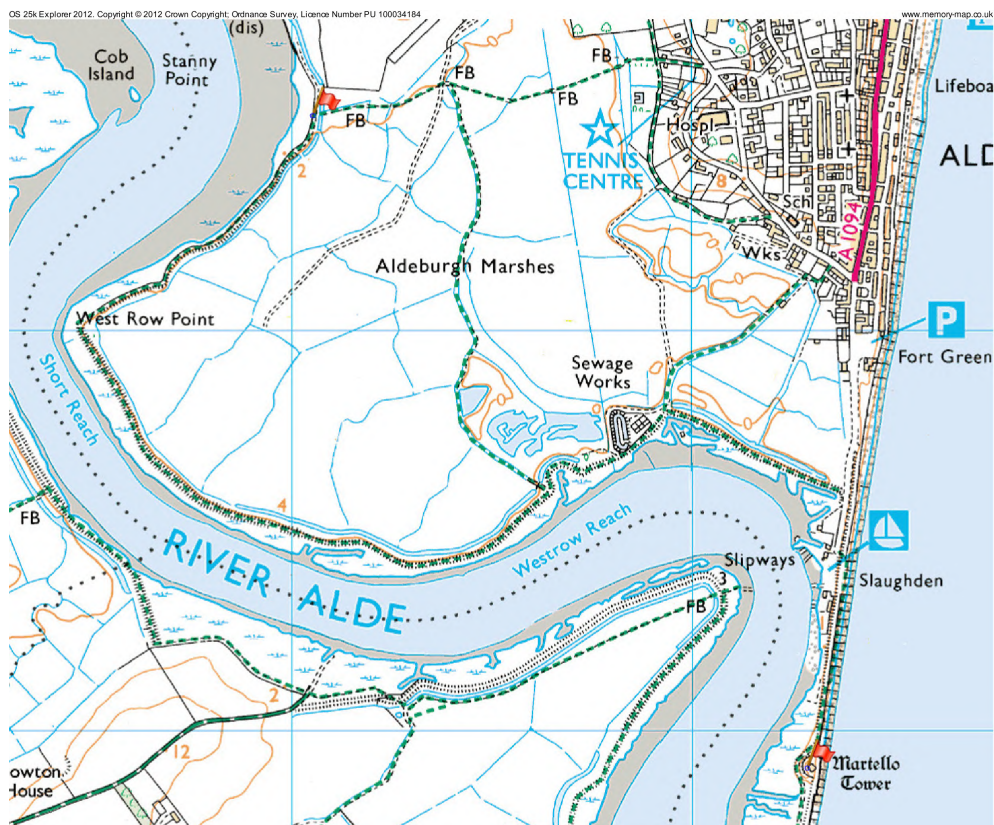
River wall inspected

CATEGORIES TO REPORT ON		
RIVER WALL /ARMOUR	SALTINGS	HIGH TIDE DEBRIS LINE
<p>Two concerns-</p> <p>1. the area reported last year below the level of the walls generally and which was overtopped in December 2013. TM460558</p> <p>2. of great concern is the long stretch of wall (TM 450564 to 459558) which was 'repaired' over 2012\13 and is showing long stretches of steep walls without vegetation, almost vertical walls. All of that has been compounded by destructive mowing undertaken in November 2013 which has not only scraped off grass in places but broken down the wooden boarding bordering the hoggin path</p>	<p>Nothing to report on saltings projects: one not yet completed and for the other, at the Iona site, it is early days except to say that loose sea weed and green algae are covering the hazel faggots.</p>	<p>Debris from the 5/6 December 2013 surge remains as it was, slightly slipped down, as in December. Around the Brick Dock curve this means close to top all along. For the rest of the wall mostly one foot below except where overtopping took place near Slaughden.</p> <p>The winter and March tides debris all lie at the base of the walls and in most areas lie quite thickly, some smothering the saltings for a 2-3 yard width</p>
