ALDE AND ORE ESTUARY RIVER ASSESSMENT APRIL 2014

NAME: Amanda Bettinson	DATE OF INSPECTION
LOCATION: Flood Cell 3	10 th April 2014
FROM: Top of Chillesford wall travelling south

River wall inspected

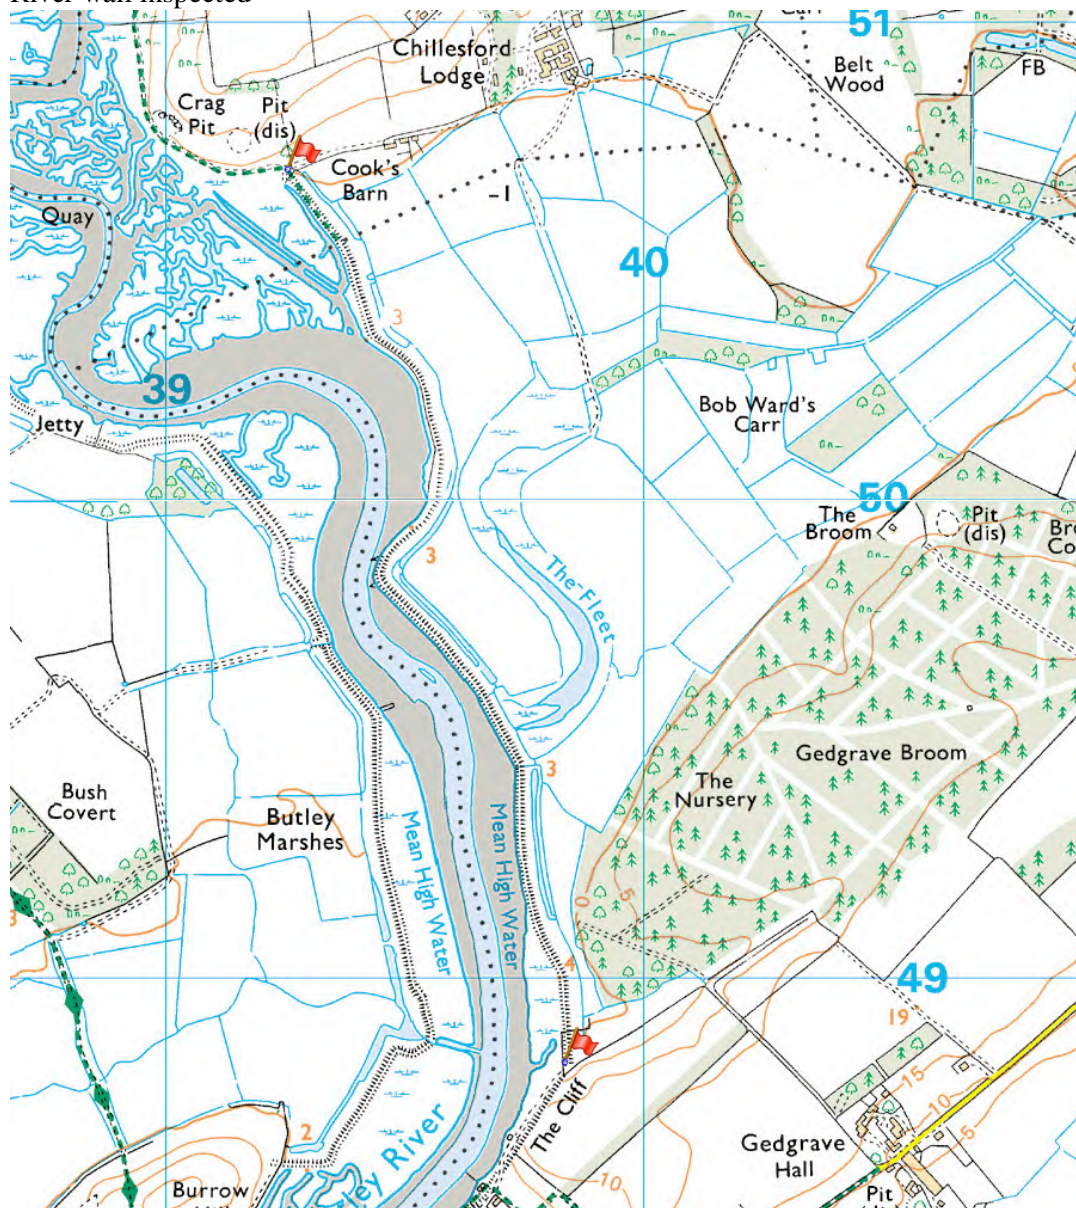
The majority of the wall length is designated 1:20 due to height. Overall, the landward slope has a good incline in most areas, not all. There was one area that overtopped during the surge. The wall appeared in reasonable condition although no account made of the height which can only be determined by LIDAR. The saltings are patchy, good at the top end of the river and areas of marram grass are establishing although at this time of year it is difficult to tell whether they are alive and growing. There are small areas of damaged Essex Block revetments that will need repair at some stage. Map references approximate.
