ALDE AND ORE ESTUARY ASSESSORS' REPORT

NAME: David and Frances Barnwell	DATE OF INSPECTION 7 th April 2015
LOCATION: Flood Cell 4.2	March Equinox
Area of Assessment: Orford Sailing Club to Chantry Point	Send to

River wall inspected

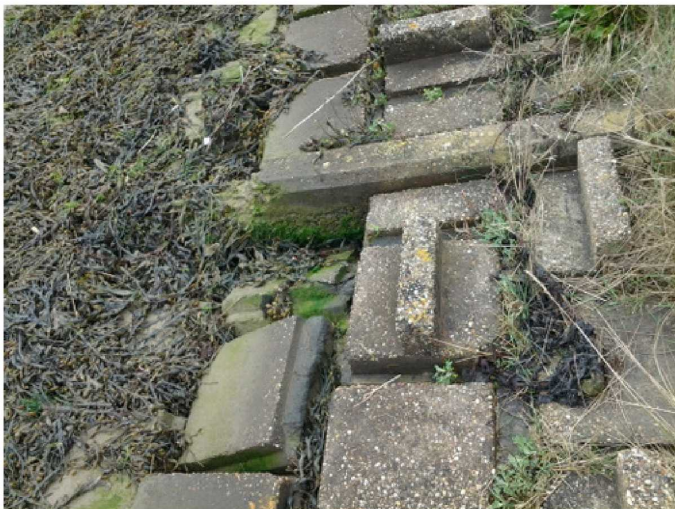
8. Small revetment collapse at the stile (TM 4241 4873). This was reported in 2013 and 2014 but has not changed since then (this is the April 2014 photo).
