# THE ALDE & ORE ASSOCIATION

## ALDE AND ORE ESTUARY ASSESSORS' REPORT

<b>NAME:</b> Robin and D Alderson, John Grayburn	<b>DATE OF INSPECTION</b> Spring 2013
<b>LOCATION:</b> Flood Cell 6 & 7	<b>MARCH/SEPTEMBER/TIDAL EVENT</b>
<b>Area of Assessment:</b> South bank from Snape sluice to Iken Church. North bank from Snape sluice to the point opposite Iken Cliff.	Send to

## South bank, Snape sluice to Iken Church and North bank, Snape sluice to higher ground at TM39174 57523

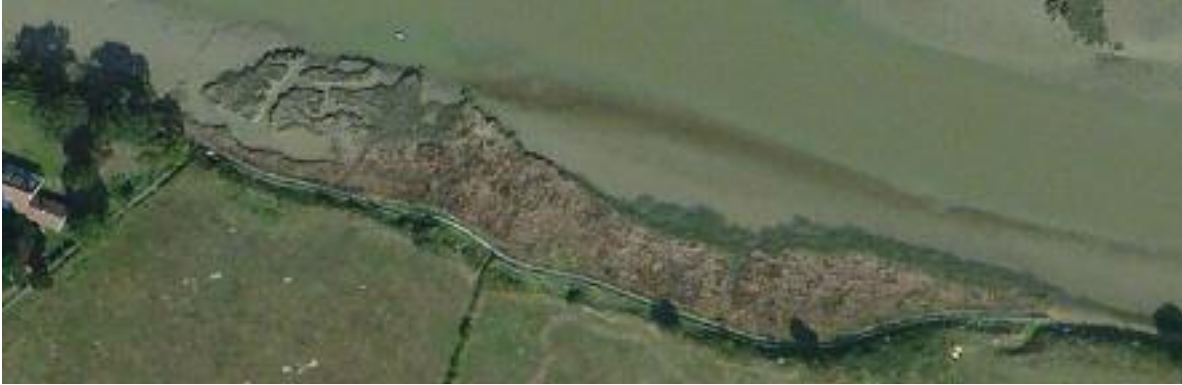
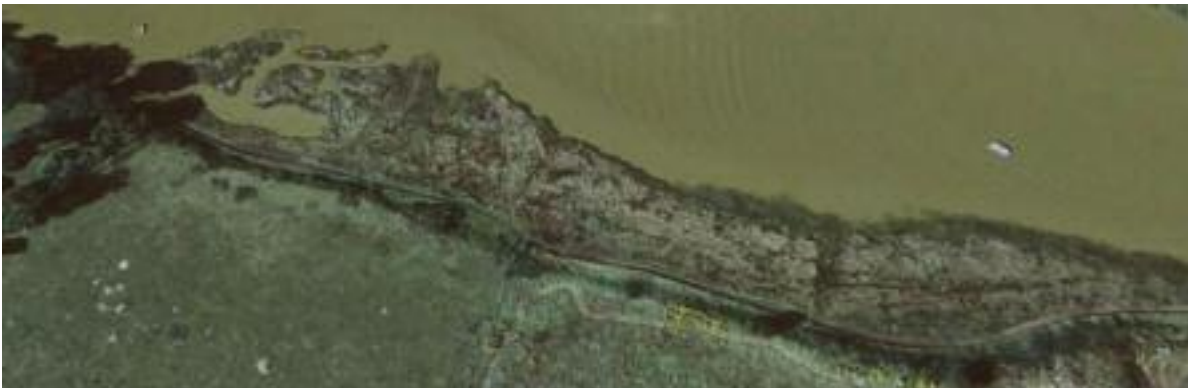
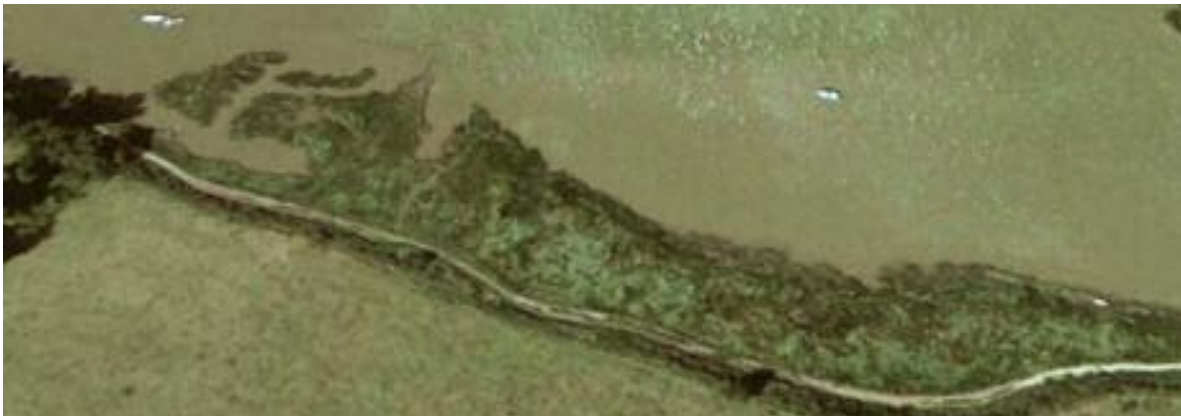
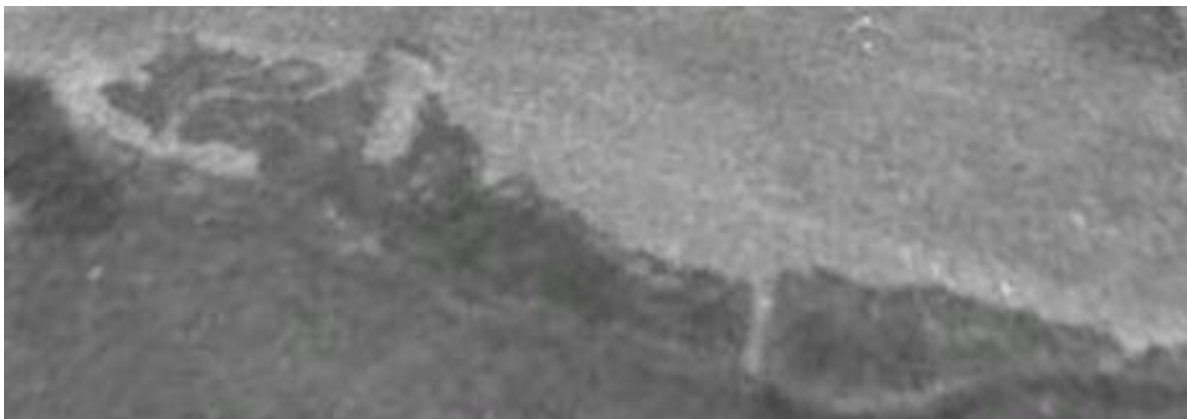
## Iken Cliff Saltings historical

followed by length of saltmarsh to Iken Cliff. Some of the marsh at the west end is eroding with creeks and islands. Details logged to keep an eye on rate of erosion although from historical data, erosion appears to be slow.

From historical data, it would appear that the area of sand at the bottom of the cliff is unchanged from 1945.

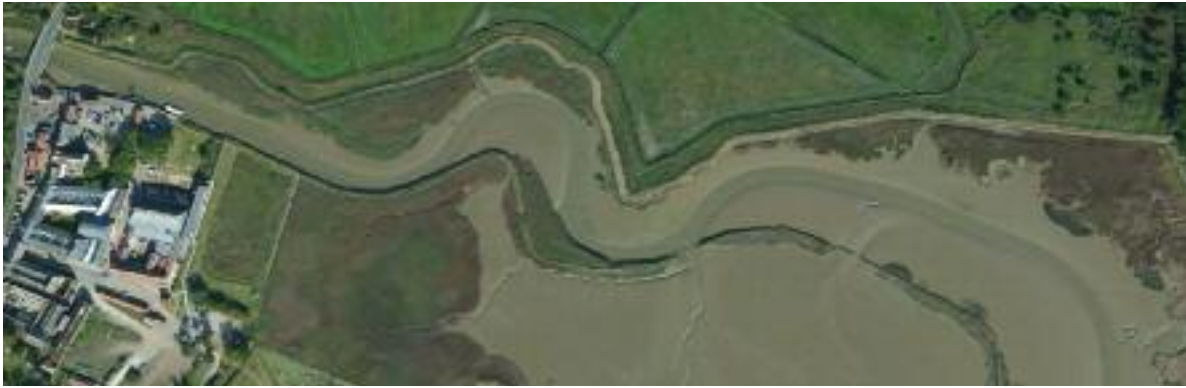
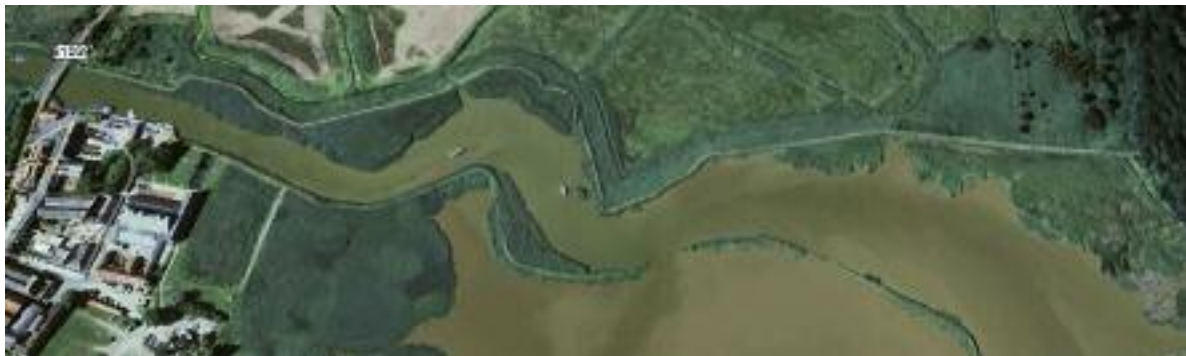
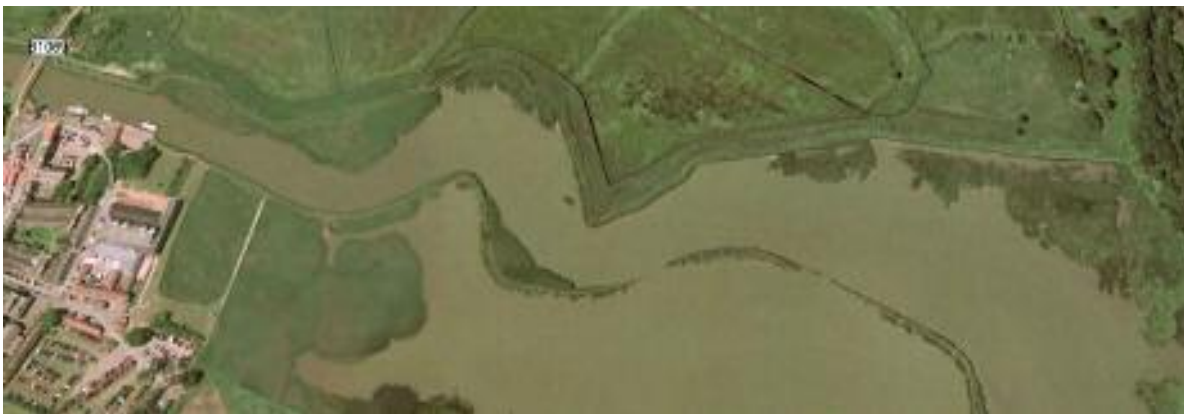
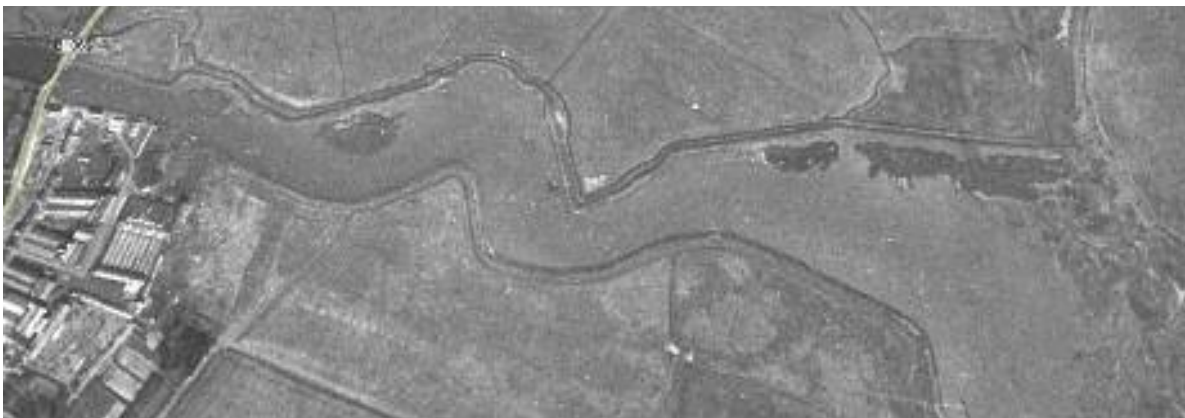
## North bank from Snape bridge: historical

Historically the saltings from Snape bridge to the higher ground at the wood have been stable since 1945 with some accretion upriver from Blackheath sluice (TM39535 576).

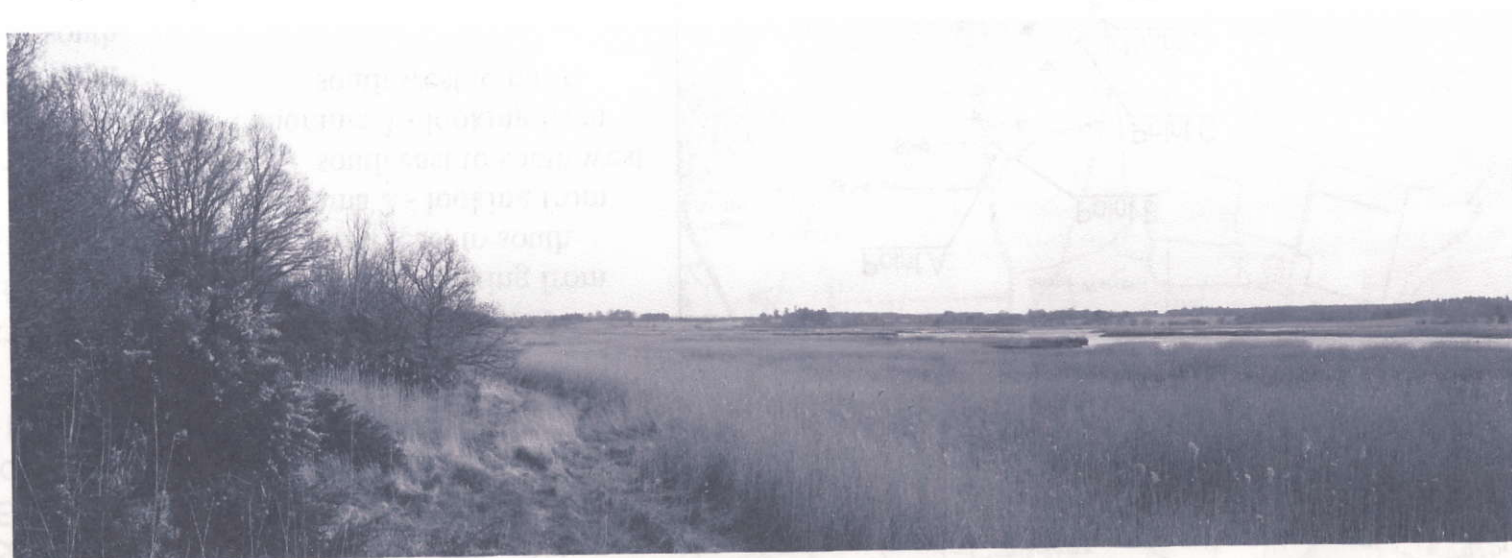
Photograph A1:

The top of the river bank has recently been levelled with a hogging path presumably with a geotextile underlay. (How would hogging and underlay perform compared with grass in the event of overtopping?)

View looking West looking towards Snape Maltings, showing the recently surfaced foot path along the top of the river wall.

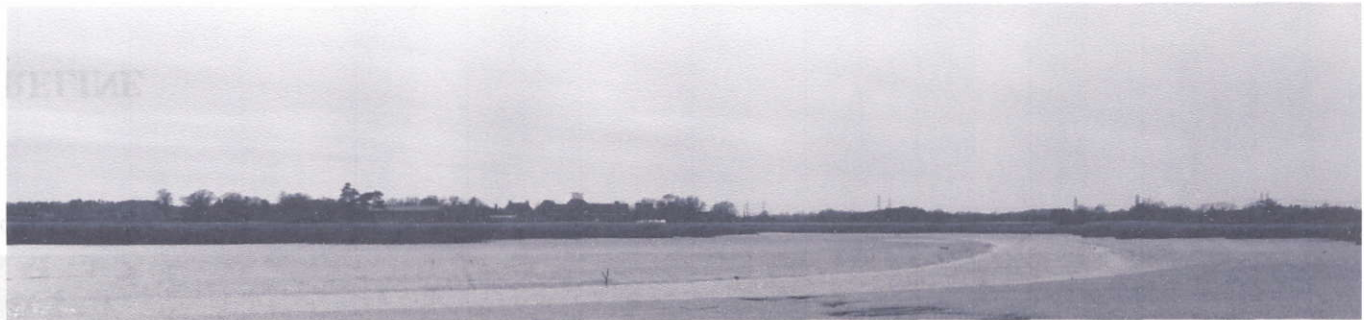
### Photograph B1:

View looking North looking towards the point at which the foot path atop the river wall enters the trees.  
Houses in Priory Road, Snape, are visible in the distance.

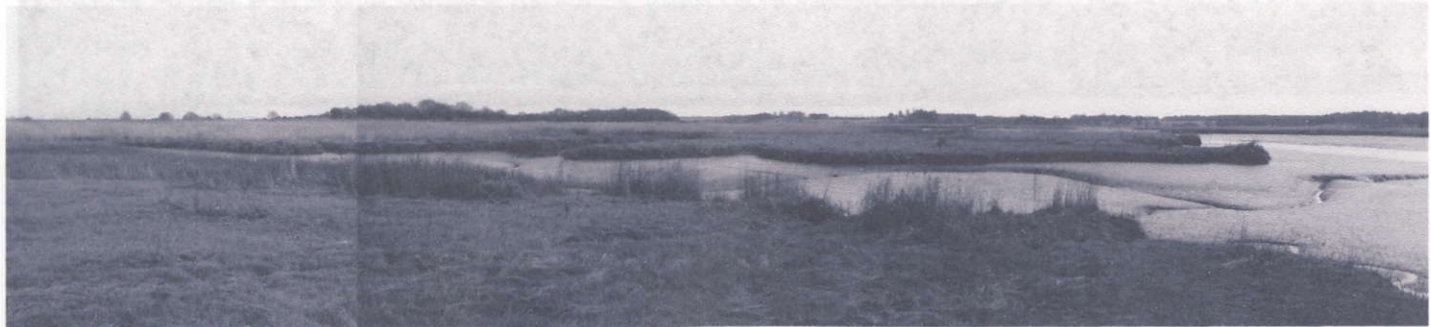
### Photograph B2:

View looking West looking towards Snape Maltings.

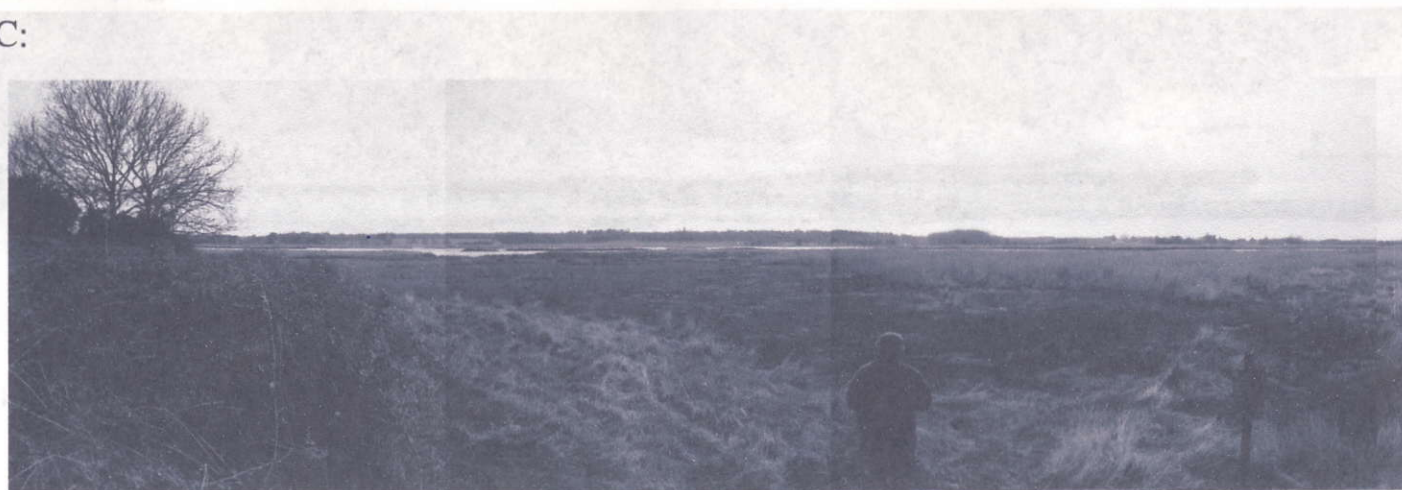
Photograph C:

Panorama from South (looking towards Iken) to East (Snape Maltings visible).

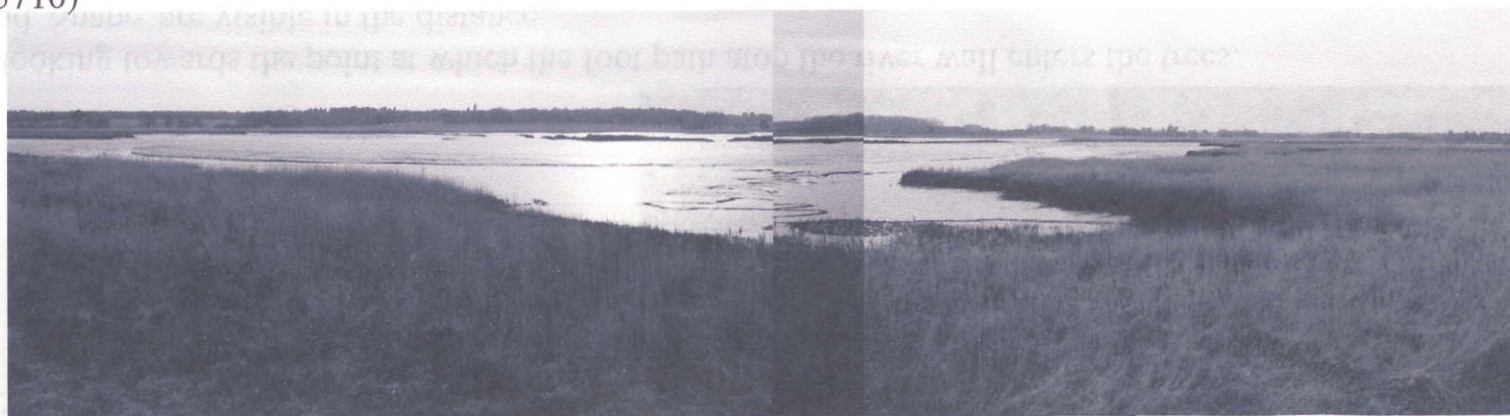
Photograph D:

Panorama from South (looking towards Iken) to East (Snape Maltings visible).

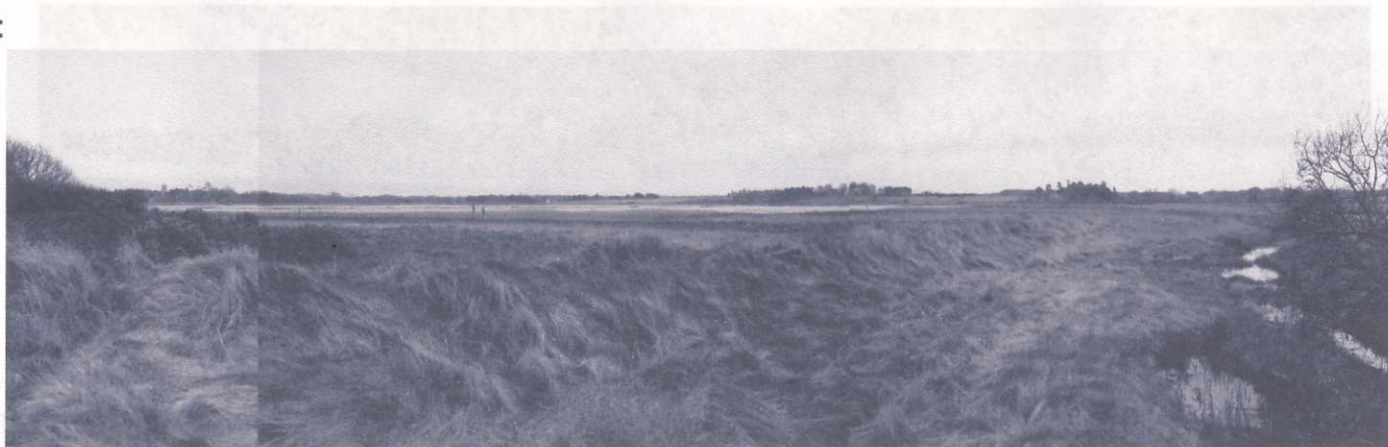
Photograph E1:

Panorama from East (towards Iken Church) to South (towards Iken Car Park); panorama continues in Photograph E2.

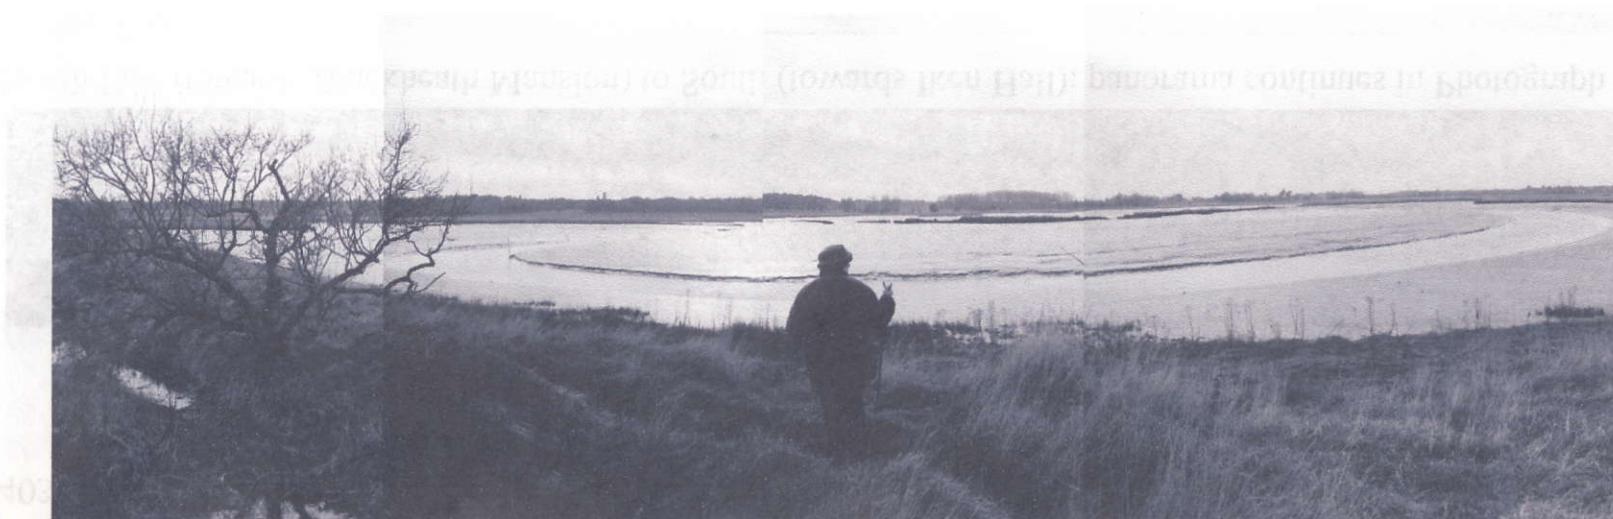
Photograph E2:

Panorama from South (towards Iken Car Park) to West (Snape Maltings visible); panorama continued from Photograph E1.

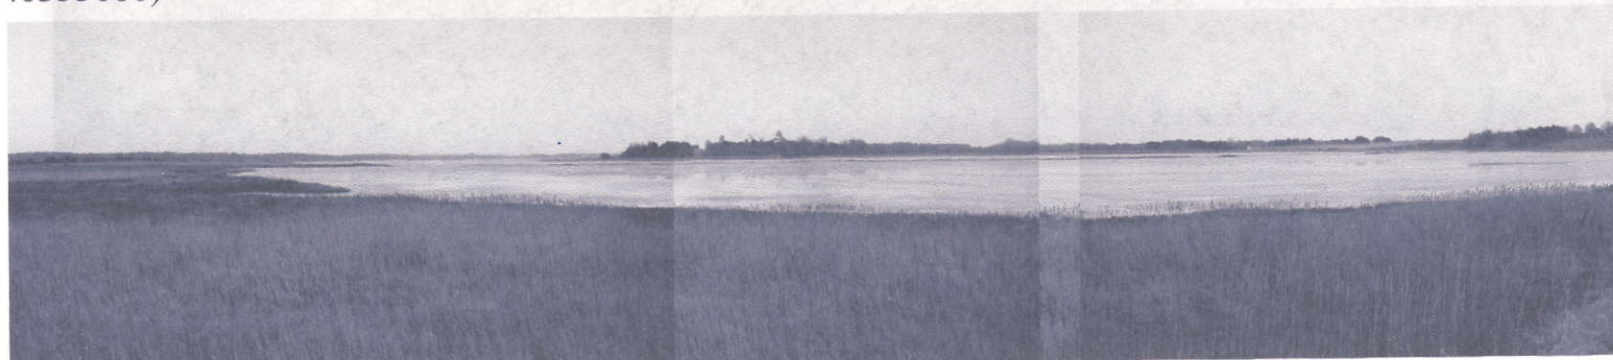
Photograph F1:  
Panorama from North East (towards Blackheath Mansion) to South (towards Iken Hall); panorama continues in Photograph F2.

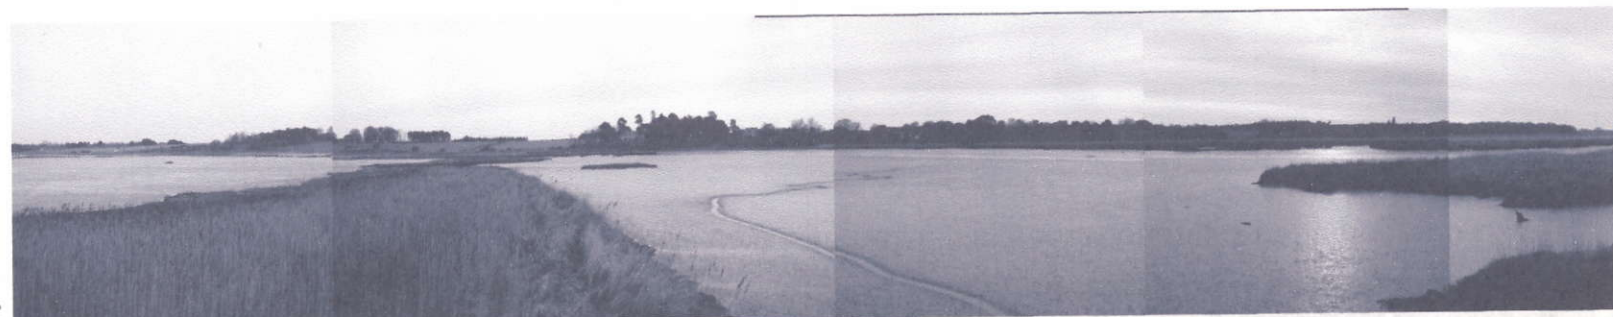
Photograph F2:  
Panorama from South East (towards Iken School) to South West ; panorama continues from Photograph F1 and to F3.

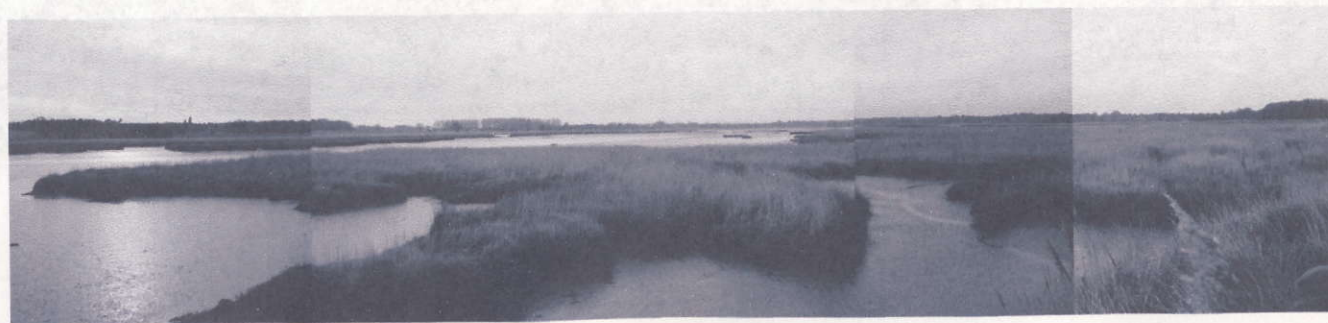
Photograph F3:  
Panorama from South West to North; panorama continues from Photograph F2.
