THE ALDE & ORE ASSOCIATION

ALDE AND ORE ESTUARY ASSESSORS' REPORT

NAME: Robin and D Alderson, John Grayburn	DATE OF INSPECTION Spring 2014
LOCATION: Flood Cell 7	MARCH/SEPTEMBER/TIDAL EVENT
Area of Assessment: North bank from Snape sluice to the point opposite Iken Cliff.	Send to

1. North bank.

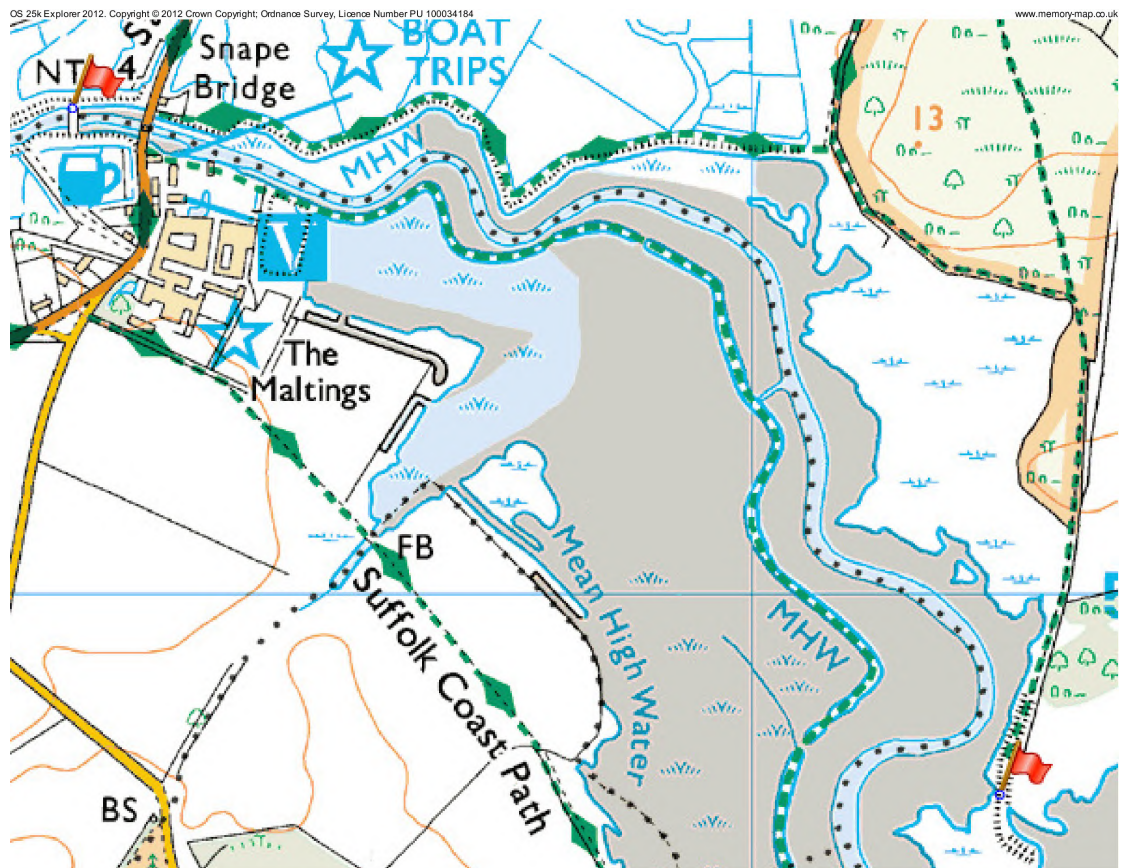
Picture 1: TM3976 5757 looking North

The damage from the surge in December 2013 is not repaired and it is unlikely that the bank would withstand a further overtopping in its present condition. The bank forms part of the Suffolk Coast and Heaths Path and as such carries heavy foot and some cycle traffic.

In the December 2013 surge when the bank was significantly overtopped, much of the recently installed hoggin had washed away taking with it the inner crest of the wall in several places. Chestnut paling has been placed to protect the worst affected areas from further damage, but the heavy foot traffic has churned up the underlying clay, exposed when the hoggin washed away. Coming into drier weather, the exposed clay is now beginning to show surface cracking.

In many places, the hoggin has been washed off the top of the bank by the December surge. Collapsed bank top protected by temporary chestnut paling.
