David Black checked his stretch 6/12 from the pump house to boundary with John Grimsey. I am pleased to report all good, in fact I'm genuinely impressed with how it stood the test. Along most of it there are just odd spots where the water ran over with no damage.

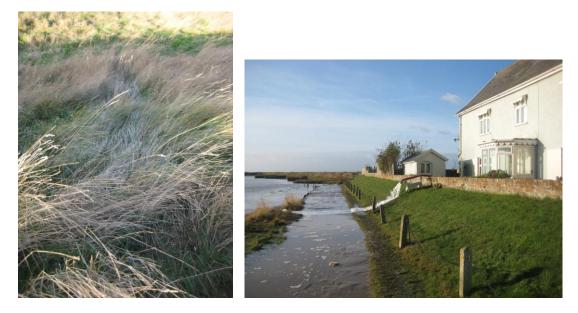
There is one stretch that is lower, from the boundary with John Grimsey, the double fence, to the next style heading to the pump. There were several 25 m+ stretches that overtopped, no damage still excellent grass cover but enough water to cross the delph and cover about six acres the other side, though this quickly drained away.

Overtopping on Cordle wall west of Orford Quay,
