THE ALDE & ORE ASSOCIATION

RIVER DEFENCE COMMITTEE BULLETIN NO. 2 JULY 2007

1. RIVER DEFENCE COMMITTEE REPORT JUNE 2007

Members of the Committee have surveyed the banks of the Alde, Ore and Butley Rivers from Snape Bridge to the mouth. Nine locations have been identified which are in need of urgent repairs. These are listed below as follows:-

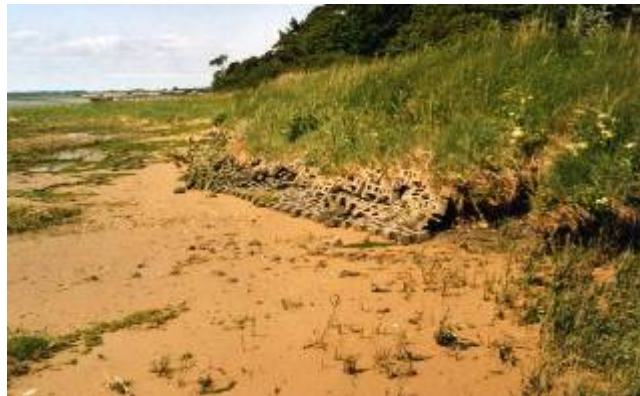
1. **HAM CREEK (Grid Ref 4315.5780)** River Wall showing erosion and break down of concrete armour

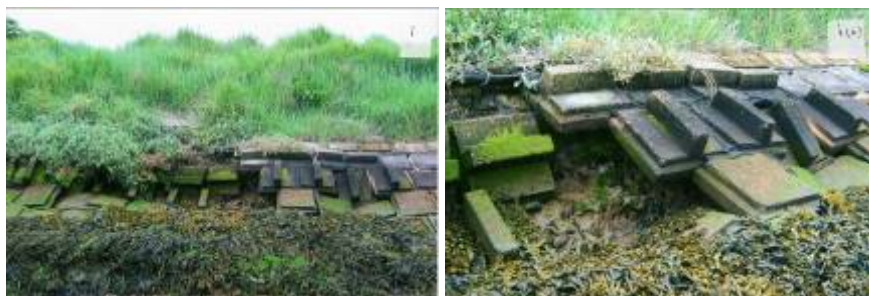
- i. **Grid Ref 458557** River Wall either side of Aldeburgh Corporation Sluice TM45857 17-25 feet to west of Sluice steps, 6 revetment blocks wide, above two lines of blocks, the blocks have gone or are displaced exposing the earth in the bank.

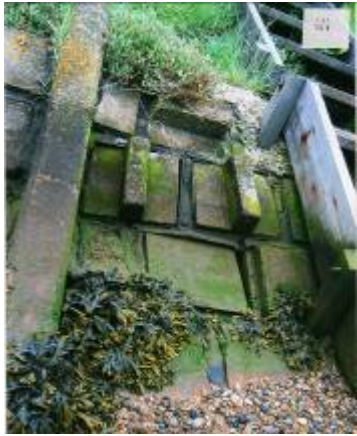
ii

- ii. Around 15 feet from the steps to the west, some loose revetment blocks so likely to get washed away (one in photo already lying on shore)
- iii. Blocks coming loose at west side of sluice steps

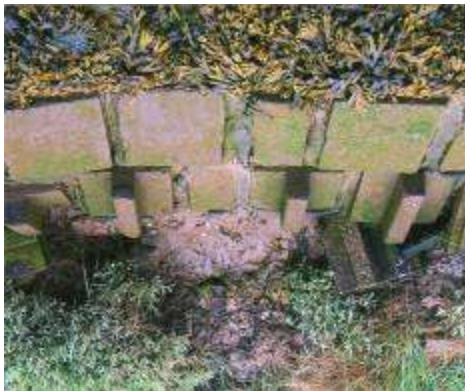
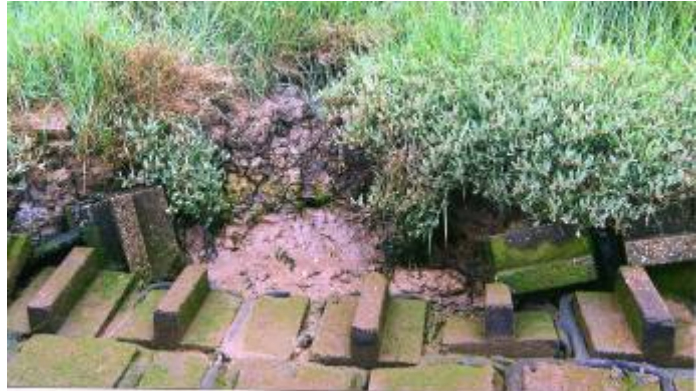
- iv. 36 feet to east of steps, revetment blocks gone leaving a 4-5 foot gap where the bank earth has been eroded back about 18 inches (at that point the whole river wall is only 5 feet wide at the top)

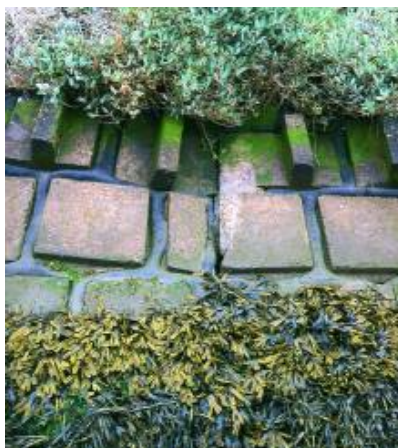
(v)

- v. Beginnings of block loosening a few yards to east of sluice steps
- vi. A further 40 feet east a couple of blocks are dislodged

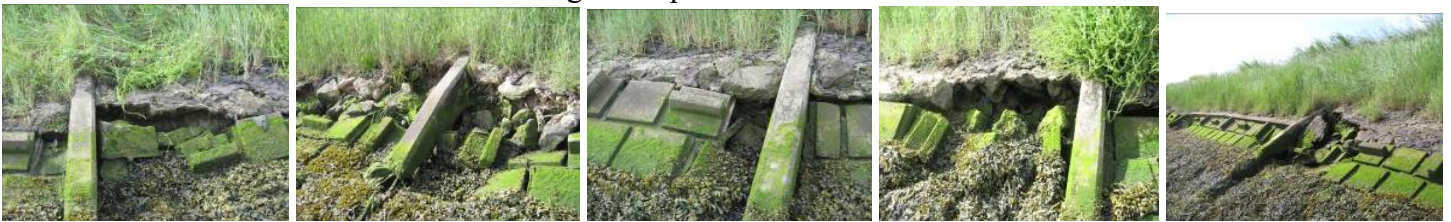
i. Grid Reference between 425564 and 430563 Landowner: Richard Mann

200 metres of broken armour allowing water penetration into the foundations of the wall

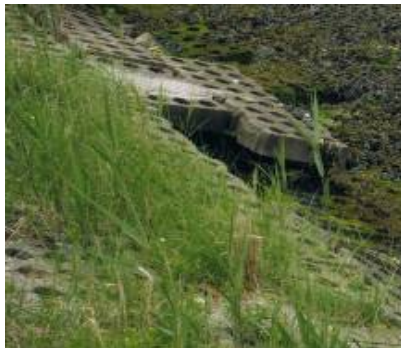
(ii)

ii. Grid Ref 438567
Broken armour with water penetration

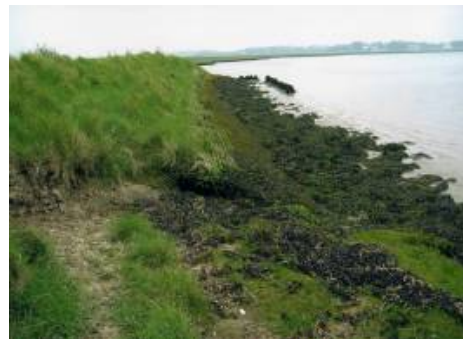
(iii)

iii. Grid Ref 443559 Severe erosion where mattress armour ends

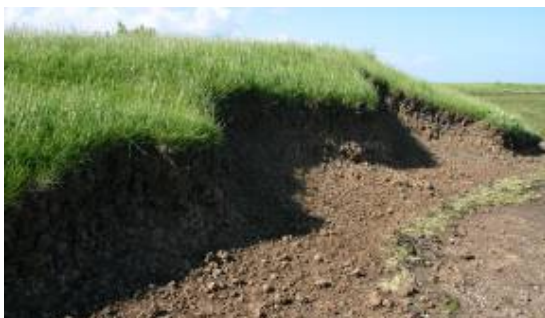
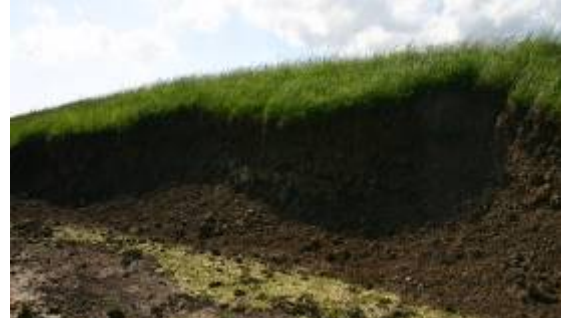
Grid Reference: TM 443 520 Area of seriously collapsed and eroding wall approximately by Blackstakes Reach Grimsey/Black boundary. This will, in time, become more costly to repair.

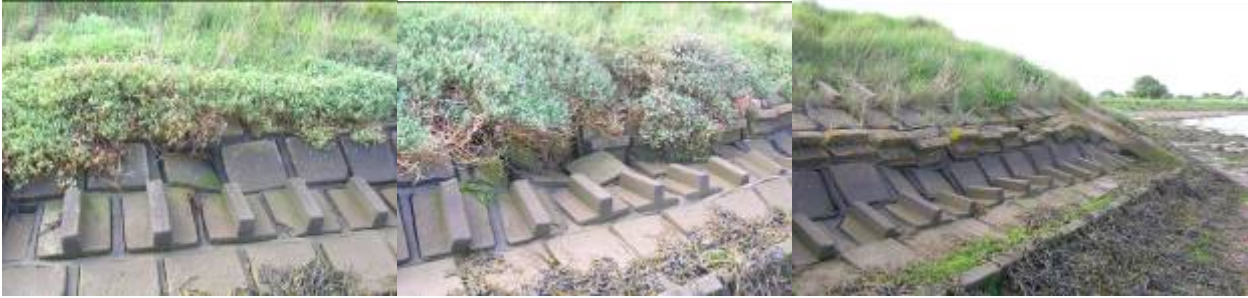
GPS N52 05 338 E001 32 192 (Grid Ref 423493)

20+ metres of seriously dislodged and collapsed armour with water penetration and erosion.

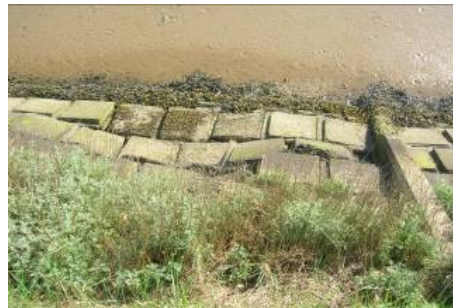
GPS 662.712 (Grid Ref 395497) Area of 6 blocks 2 deep seriously dislodged and water penetrating and eroding

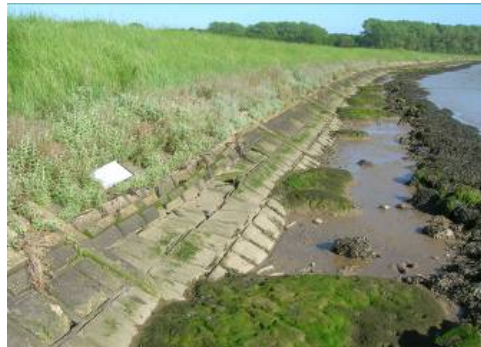
9. GPS 591 803 (Grid Ref approx 398494) Area of 2 rows of 12 blocks collapsed with water penetration
