THE ALDE & ORE ASSOCIATION

RIVER BANK ASSESSMENT FOR 2012

FLOOD CELL 1 Boyton and Butley Marshes

Inspections on 30 March, 6th, 12th, 13th and 15th April 2012

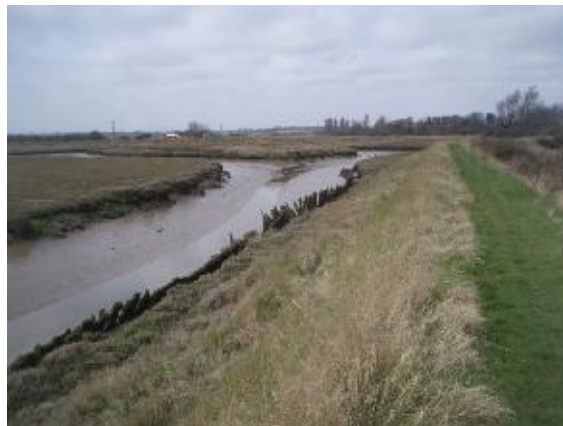
1. north bank of Barthorp's Creek from 368440 to junction with river at 376446 (see photo below)

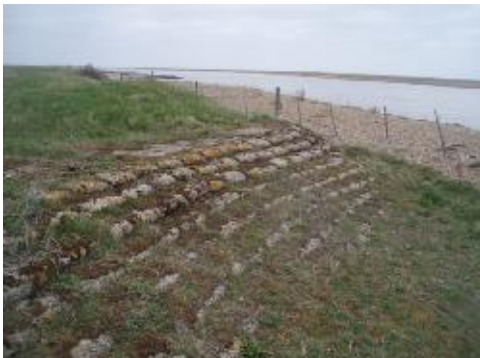
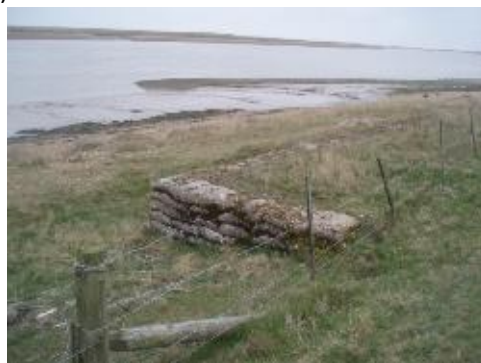
2. Colony beach 381451 (see photos 12.4 and 5)

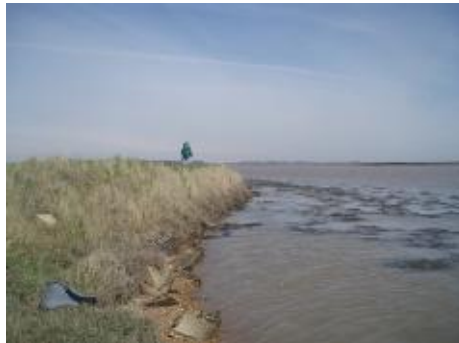
3. Flybury Point 397461 to 397467

Note the foot of this length of wall is under water at high tides of 3.9 and above see photo 12. 8 (These are not surge conditions) Possibility of damage is therefore high and should be regularly checked.

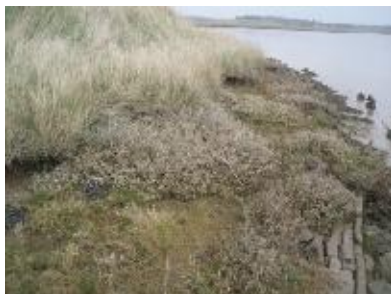
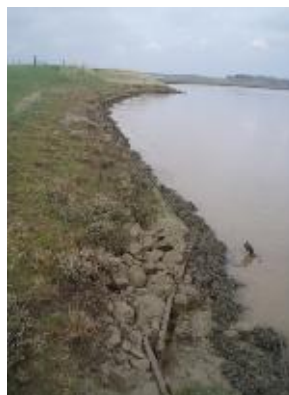
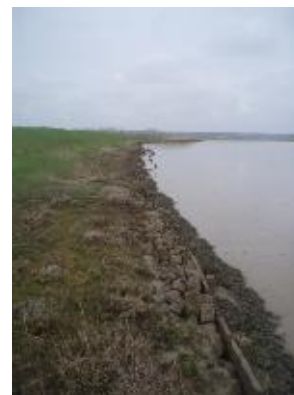
4. Butley River 395496 to 394497

2012 condition of 4 above see photos 12.19, 20 and 12. 22 No significant change from 2011 but condition of timber toe to river edge remains poor. Immediately upstream of 394497 for app. 30 M bottom of bank is undercut see photos 12.19 and 23 This should be regularly inspected for slippage.
