FC 1 Surge Report

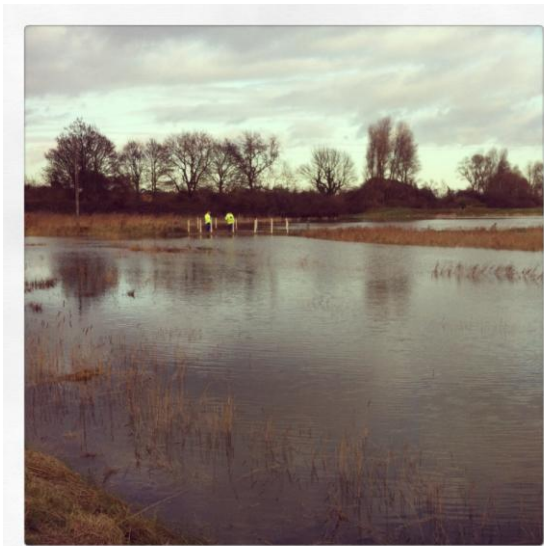
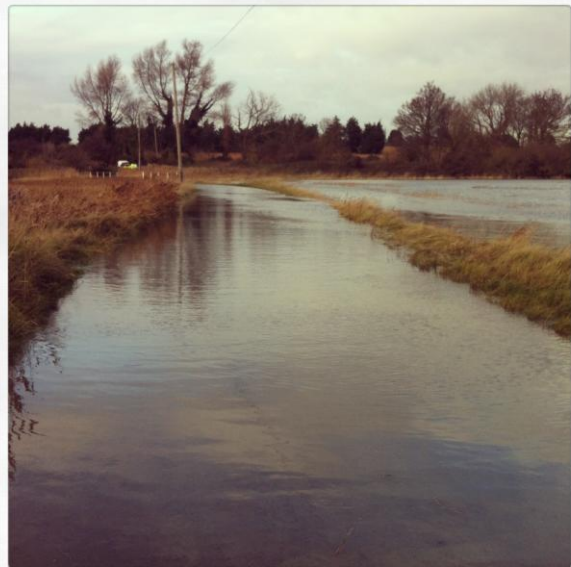
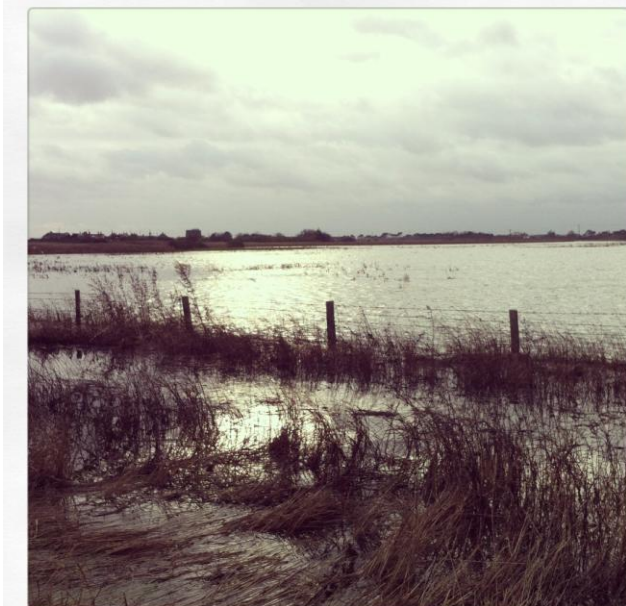
FLOOD CELL 1.I have walked the river bank from 379447 to Butley Ferry. No damage to levees, evidence of overtopping between Flybury Point and junction with Butley River and continuing for app. 200M along Butley River wall (but not continuous overtopping,) Some further undermining of protection around Boyton Dock since inspection in March, not sure if this is surge damage or normal tidal wear.
